**Historic building recording at
Frogs Hall Farm,
Bambers Green Road,
Takeley, Essex, CM22 6PE**

November 2019

CAT Report 1540
April 2020

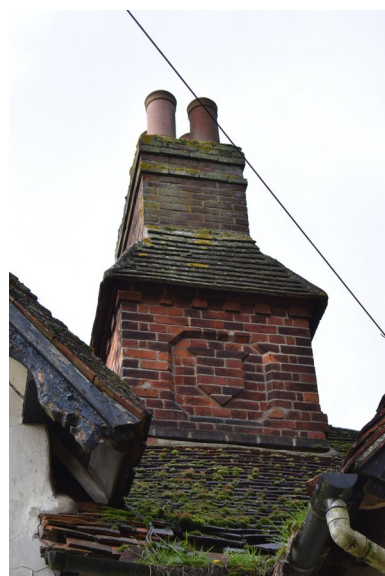
Photograph 5 East side of chimney-stack, showing shield emblem. Photograph taken facing north-west.

The two-storey ranges have a large chimney projecting from their centre, rising high above the ridge-line (Photograph 4). On the western face of this chimney stack is a section of moulded brickwork in the design of a shield (Photograph 5). The single-storey ranges also have a chimney, but it is of a far more modest design.

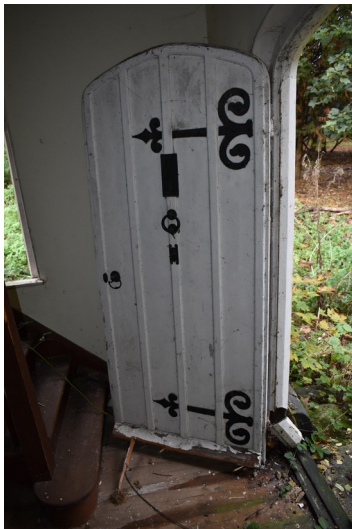
The eastern elevation of the house (Fig 7) has a surviving vertical-planked door with applied fillets and ornate hinges (Photograph 10). Also present on this elevation is a projecting large bay and oriel window extension, containing 18-light awning and casement windows on both the ground and first-floors (Photograph 9). A smaller bay window extension, on only the ground-floor, is also present on the southern half of this elevation, as is a four-light awning/casement window within a dormer and front-facing gable.

Photograph 9 Exterior door on eastern elevation, with ornate hinges. Photograph taken facing north.

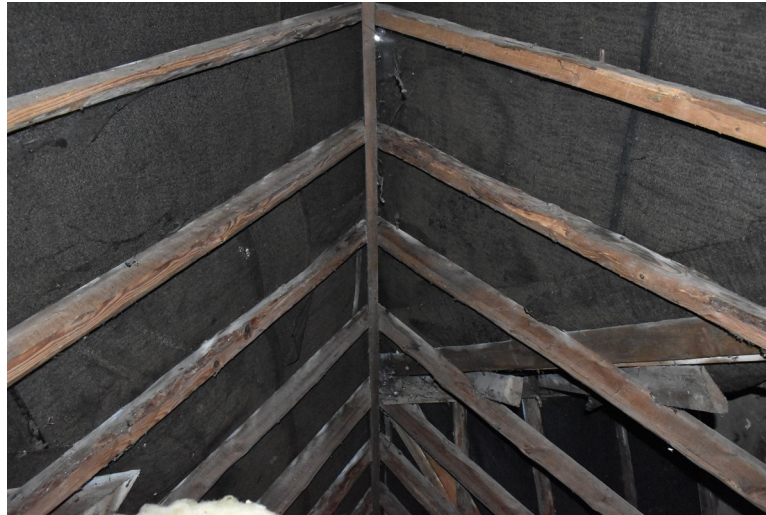
Where the roof of the building could be observed through loft hatches it was shown to be constructed of modern machine-cut timber, with rafters meeting at a ridge-board at the roof's apex, supported by occasional upper collars (Photograph 11).

Photograph 11 Roof structure of two-storey range. Photograph taken facing east.

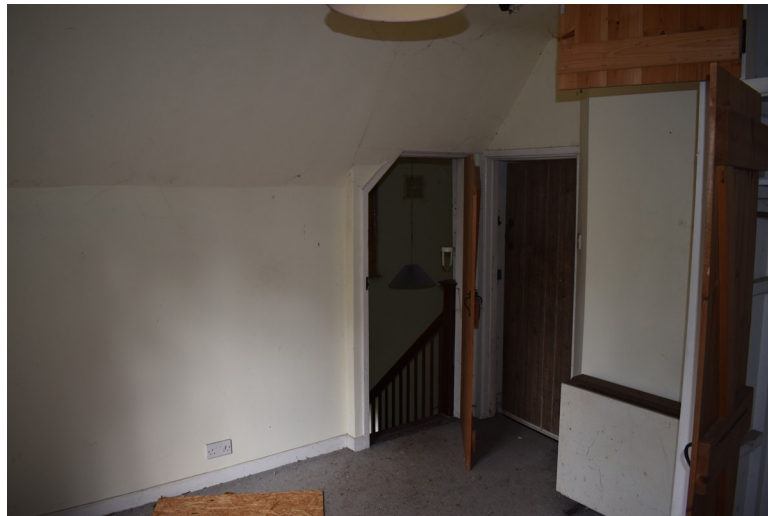
This room has a carpeted floor and is access via doorways from rooms 7, 12 and 14. All of these doorways contain vertical-planked doors, the ones leading to rooms 7 and 14 are very clearly modern replacements, whereas the one leading to room 12 appears original (Photograph 22).

Photograph 22 Interior of room 11, showing doorways to room 7 (to left) and room 12 (to right). Photograph taken facing north-east.

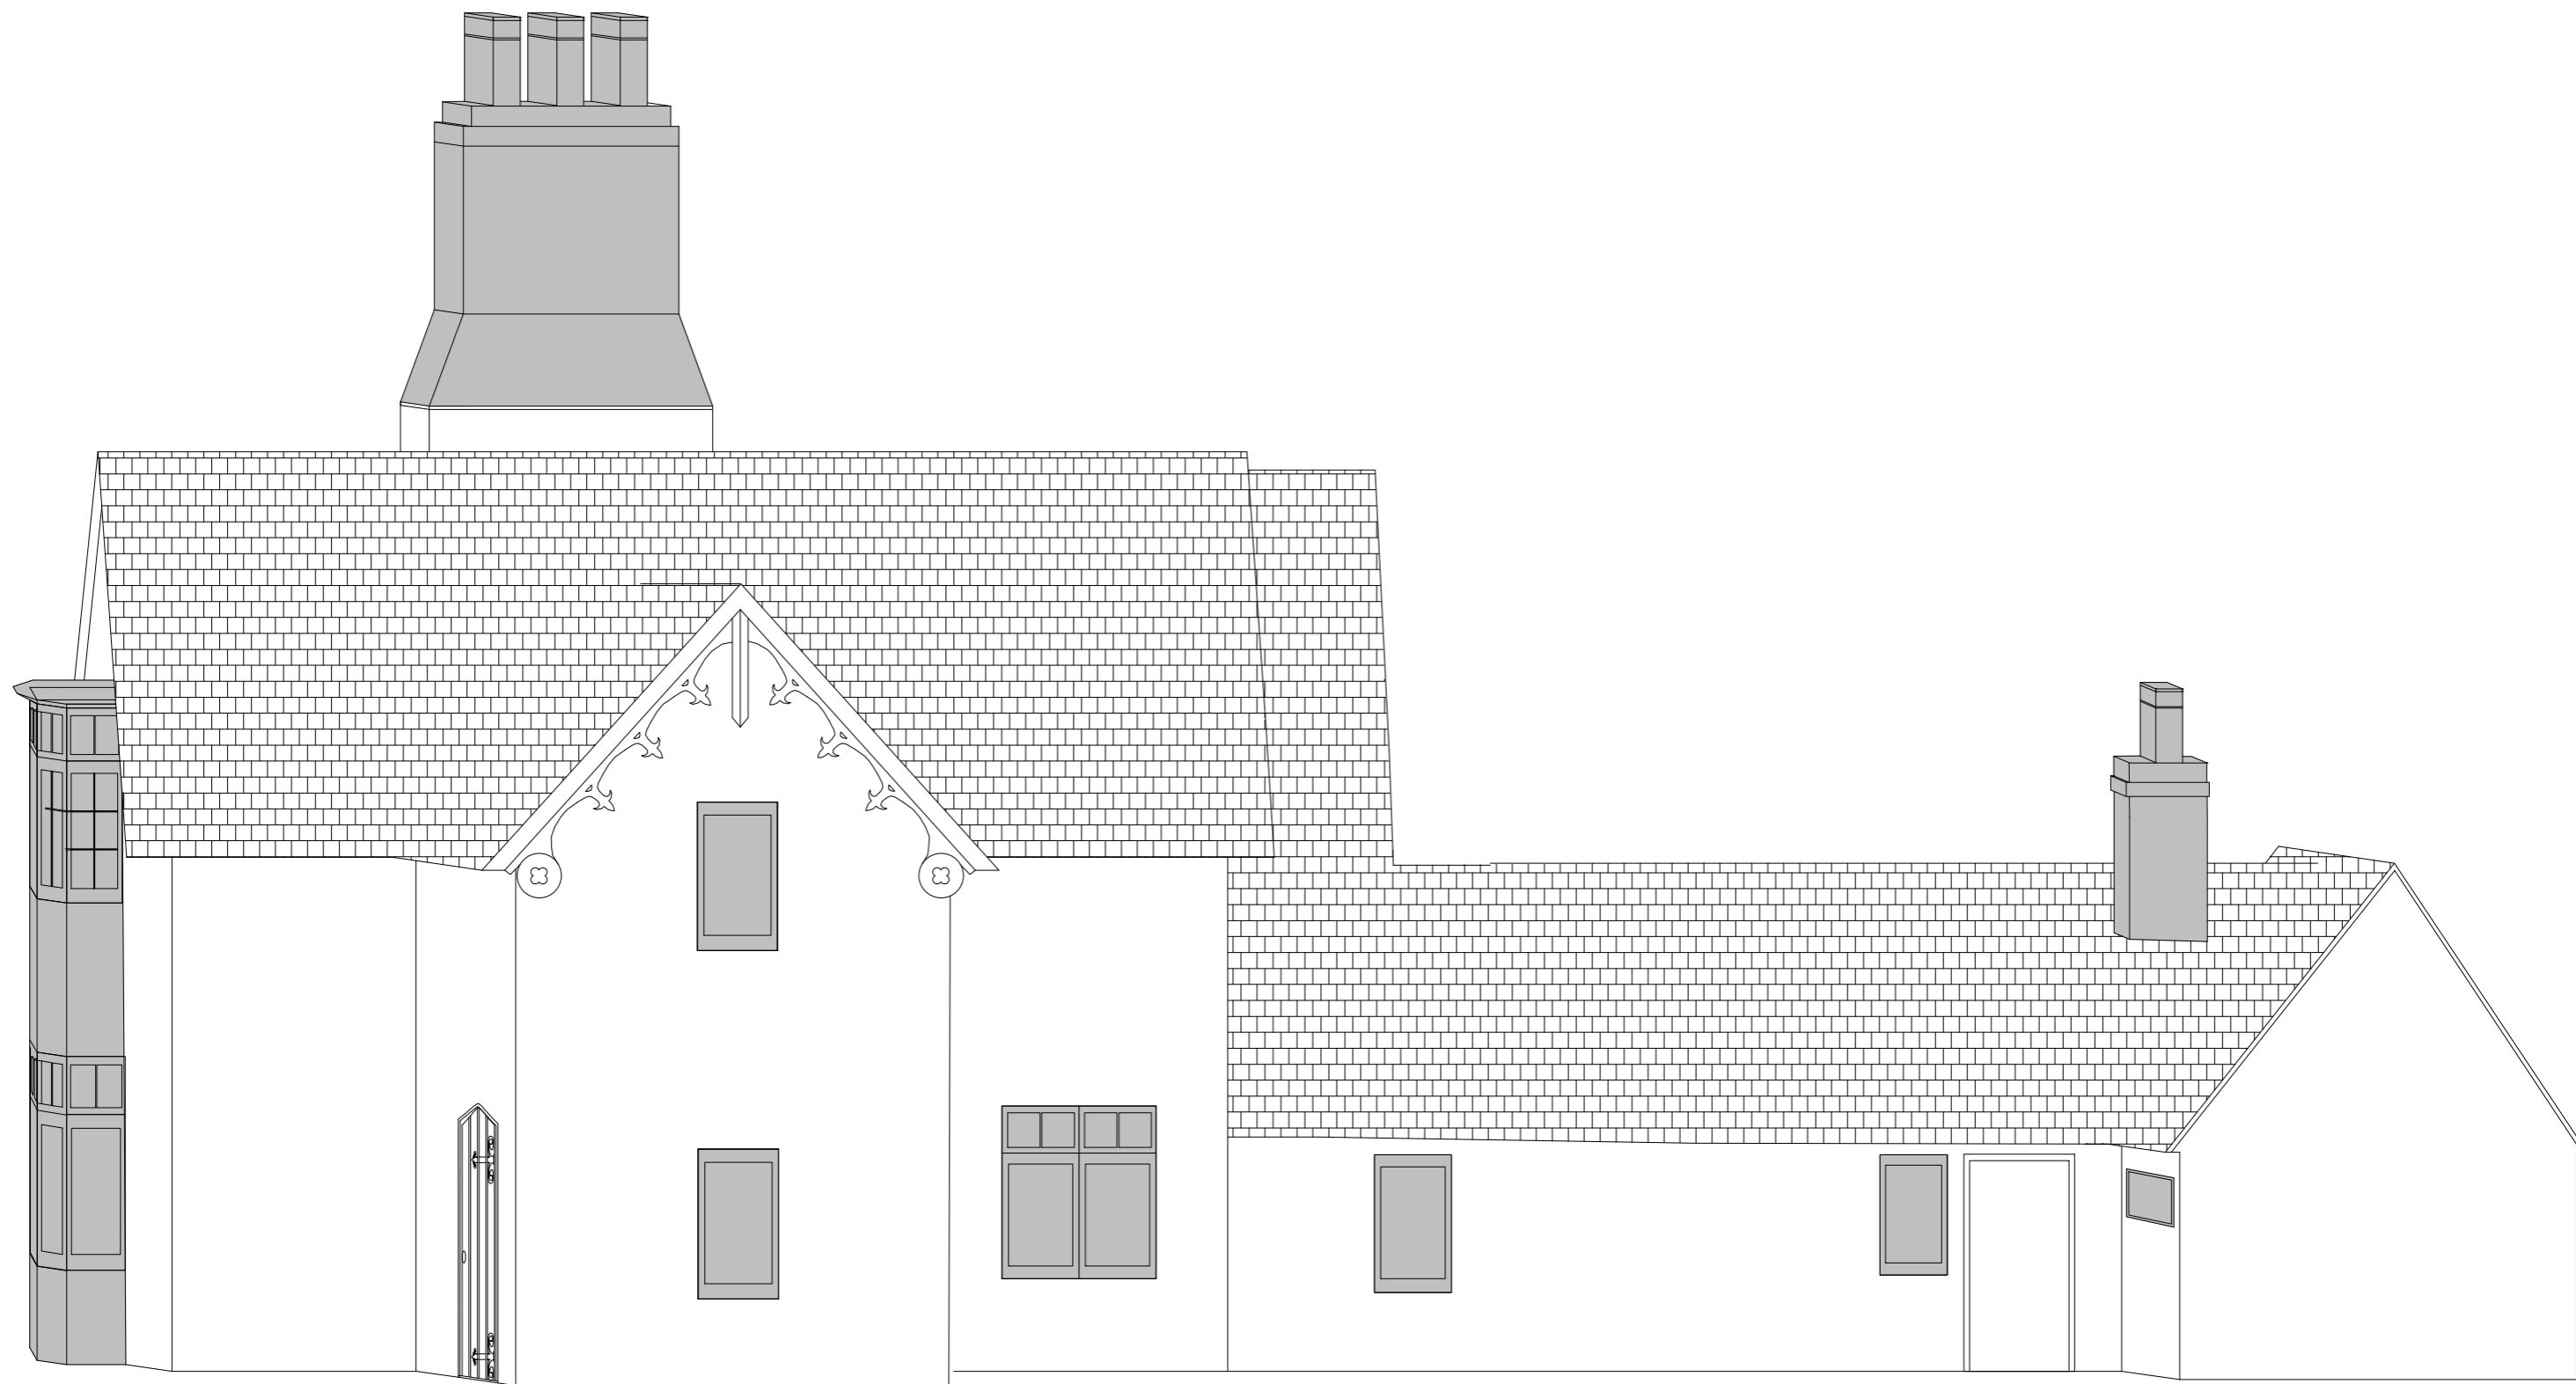
Fig 6 Northern elevation of building.

The northern elevation of the house has two windows on the single-storey range; only the frames survive so their exact form is unclear. Also on the single-storey range is a doorway containing a damaged vertically-planked modern door (Fig 6). On the two-storey, north-facing gable end are two more windows, again with only the frames

remaining (Photograph 8). This northern facing gable of the two-storey range has damaged decorative bargeboards containing *fleurs-de-lys* patterns (Photograph 8). A six-light casement/awning window survives on this elevation to the west of the north-facing gable (Fig 6).
