# Historic building recording of Foley House, 115 High Garrett, Braintree, Essex, CM7 5NU

CAT project ref.: 2021/02g  
NGR: TL 77626 27165 (c)  
Planning reference: 20/01391/FUL  
ECC site code: BTFH21  
OASIS project id: colchest3-417194

**CAT Report 1695**  
August 2021

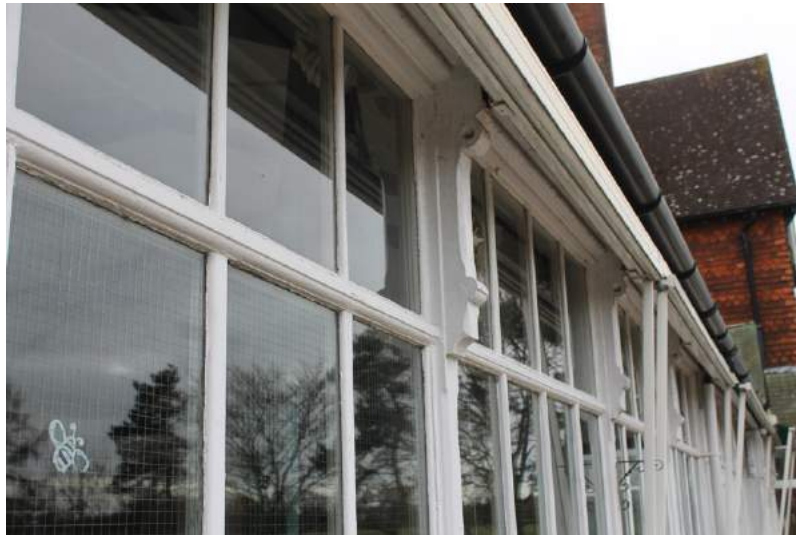
The south-west elevation of the building is extremely busy, with multiple ranges visible. The ground-floor is dominated by the conservatory, which has three rows of fixed windows (Photograph 4). The lower two rows are modern safety glass, but the top row is plate glass, and probably original. At the top of each mullion between the windows is a carved corbel supporting the eaves above, although some of these have been damaged (Photograph 5).

**Photograph 5** Detail of corbels at top of mullions between windows on conservatory on south-west elevation. Modern safety glass visible on middle panes, original plate glass visible on upper panes. Photograph taken facing east.

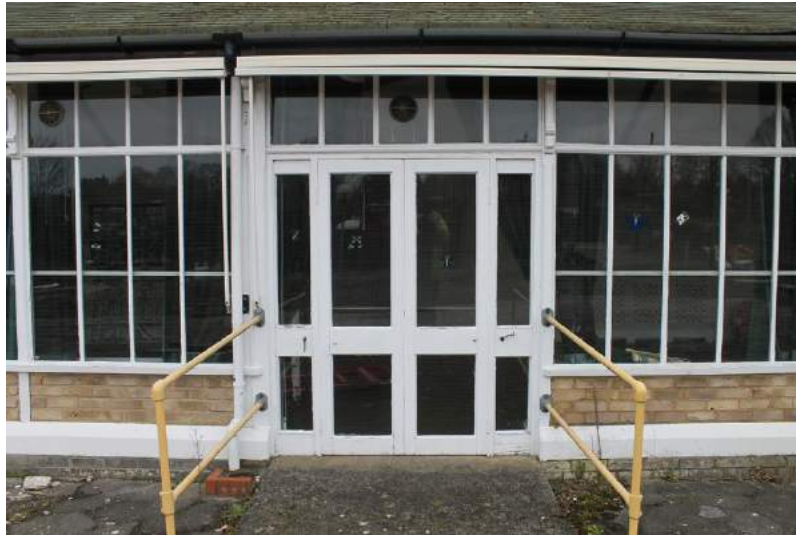
There is another external opening into the conservatory on this elevation; it is filled within a glazed modern double-door but the opening appears original (Photograph 6).

**Photograph 6** Original opening into conservatory (with modern doors). Modern brickwork visible below. Photograph taken facing north-east.

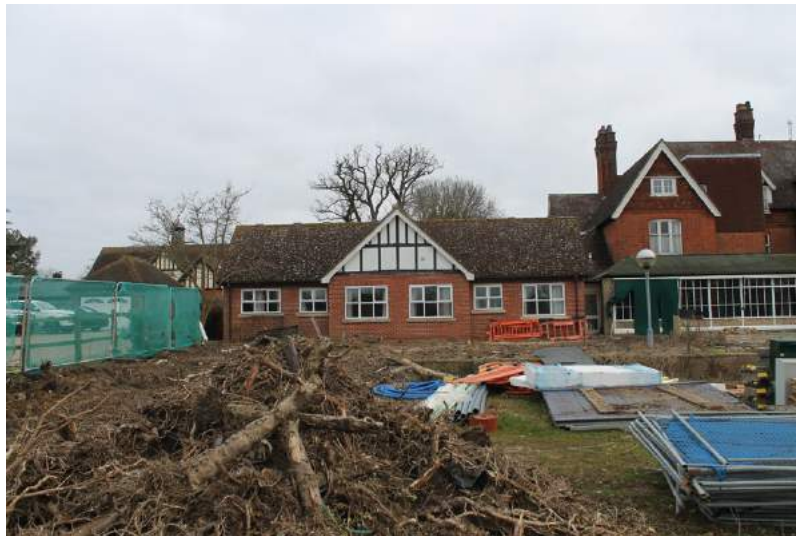
Immediately to the west of the conservatory is a single-storey extension, presumably added to the building in 1993 (see historical background above). It is constructed of red brick, laid in stretcher bond with measurements of 210mm x 100mm x 60mm. The extension has a centrally-located front-facing gable with imitation timber-framing. There are six awning and fixed windows, with between 4-6 lights each, on this elevation. All of these windows are styled to appear to be sashes, mimicking the original windows on the main three-storey range (Photograph 7).

**Photograph 7** Modern extension at western end of south-west elevation. Photograph taken facing north-east.

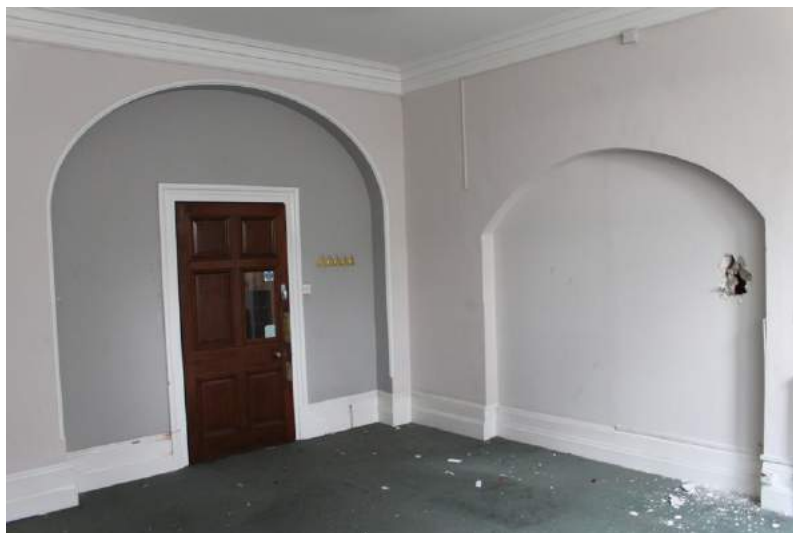
The ground-floor of Foley House is expansive, with multiple rooms that have been added to the building or subdivided at a later date (Fig 3). The three large rooms forming the eastern wing of the building (6, 7 & 11) are largely original with no later additions (excluding an inserted modern staircase in room 11) and would have been the drawing room, morning room and dining room respectively (Fig 3). Originally rooms 7 and 11 would have been joined by a large arch, but this has since been infilled (presumably at the same time the modern staircase was added). Room 7 would also have originally been joined to the main hall (8) by a similar arch, which has again been blocked (Photograph 20).

**Photograph 20** Detail of blocked arches leading out of room 7 into rooms 8 (left) and 11 (right). Photograph taken facing north.

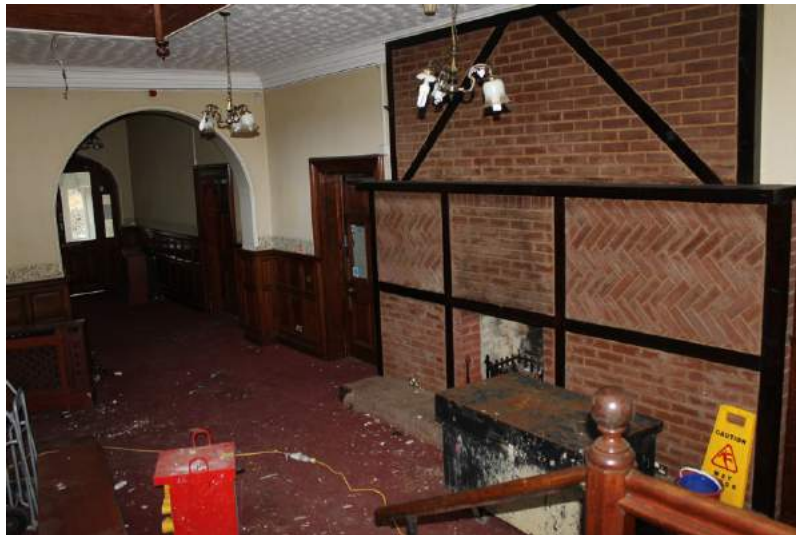
**Photograph 24** Room 8, with heavily altered fireplace to right of frame. Photograph taken facing east.

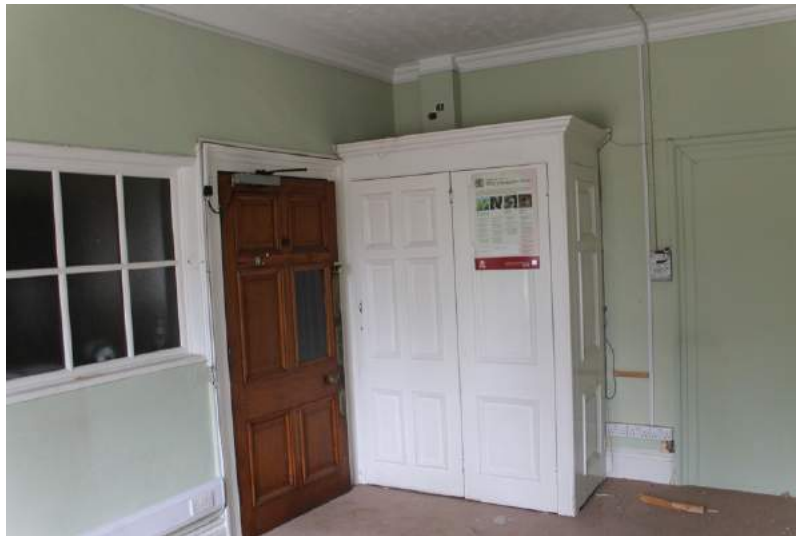
Room 15 has been converted into a reception room, with a large modern window inserted in its south-west wall (Photograph 26). Also present in this room is an original cupboard with panelled doors (Photograph 26) and an original tiled fireplace and mantelpiece (Photograph 27). A doorway leading into the corridor (14) from this room has been blocked (Photograph 26).

**Photograph 26** Detail of original cupboard in room 15, along with inserted window to left of frame and blocked window to right. Photograph taken facing south.

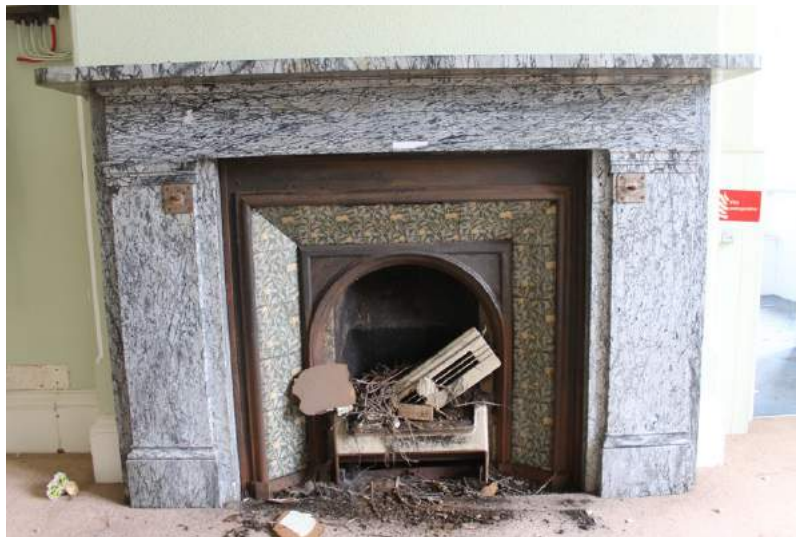
**Photograph 27** Detail of fireplace with original tiled surround and mantelpiece in room 15. Photograph taken facing north-west.

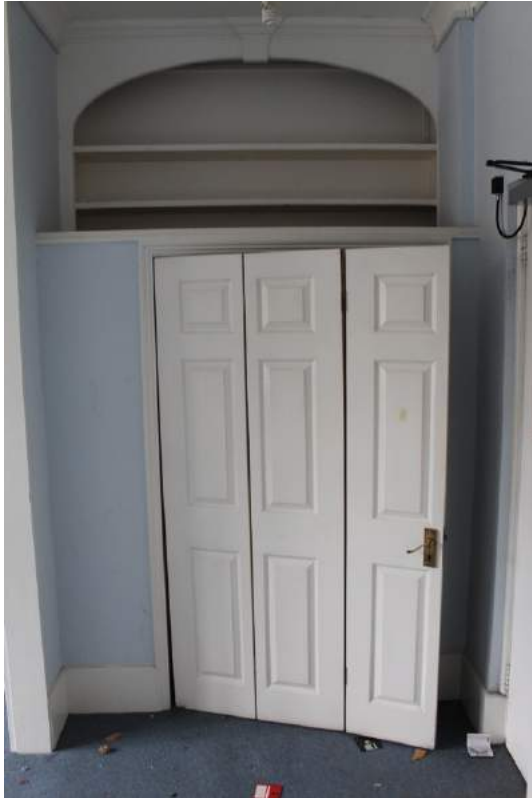
**Photograph 28** Detail of original display cupboard in room 16, and later modern cupboard partially obscuring it. Photograph taken facing south-east.

Room 16 has an original display cupboard to the south of the blocked fireplace, which is partially obscured by an inserted modern cupboard (Photograph 28). The entrance from this room into the corridor (14) is a later addition, suggesting it was originally only accessible from room 15.

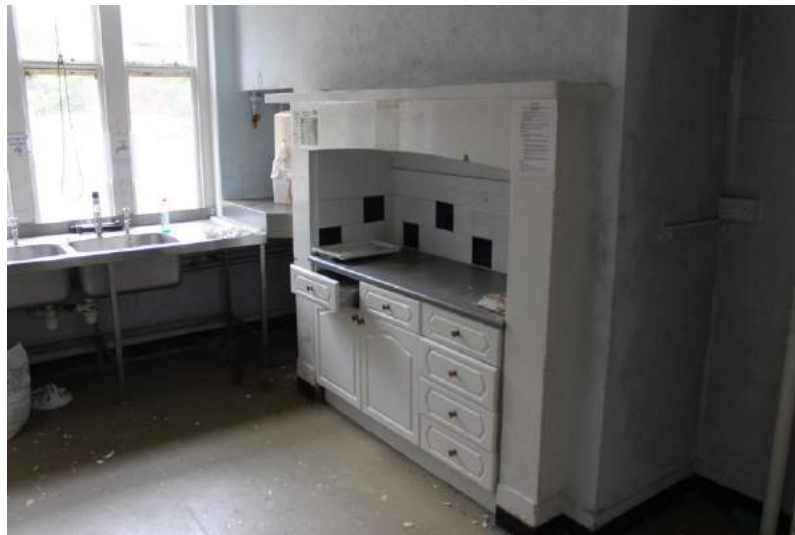
Room 17 is a kitchen, with modern tiling. Room 18 contains an alcove for a cooking range, and was probably the building's original kitchen (Photograph 29). Both these rooms today only contain modern features. There is a blocked doorway from room 18 leading into room 37 that was probably the location of an external door, prior to the construction of any extensions (Fig 3).

**Photograph 29** Alcove in room 18 that would have housed original range in kitchen. Photograph taken facing east.

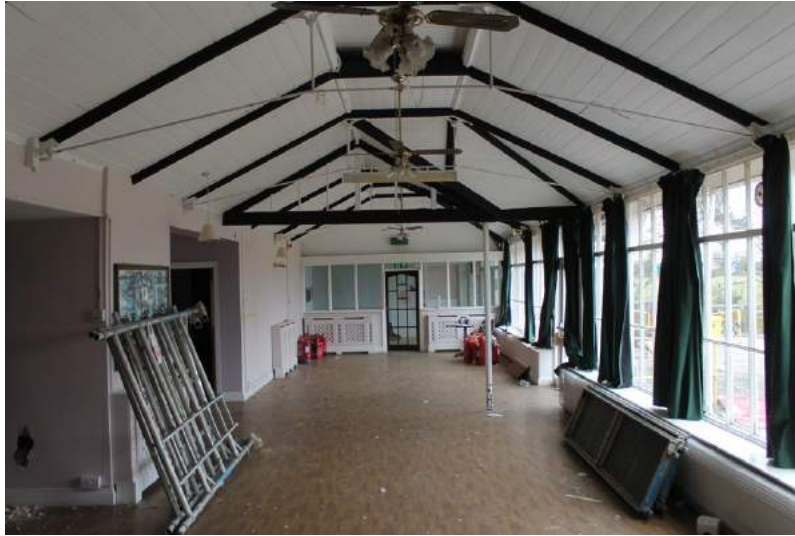
supporting the rafters (Photograph 31). The entire interior roof space is covered in timber-panelling (Photograph 30).

**Photograph 30** Interior of conservatory. Photograph taken facing south-east.

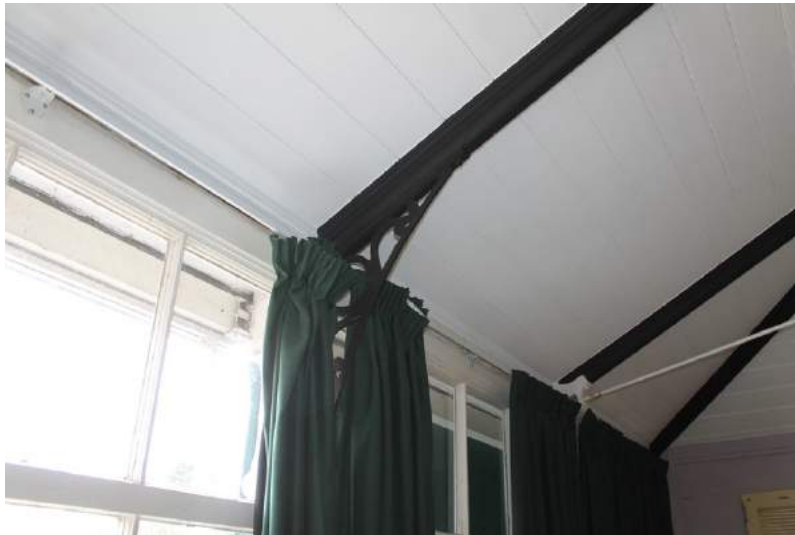
Rooms 20 and 21 form the conservatory added to the building sometime in the late 19th century. The division between these two rooms is modern; originally the conservatory would have been a single room. These rooms have metal tie-braces supporting the roof, with ornate metal braces

**Photograph 31** Detail of metal braces supporting roof of conservatory. Photograph taken facing west.

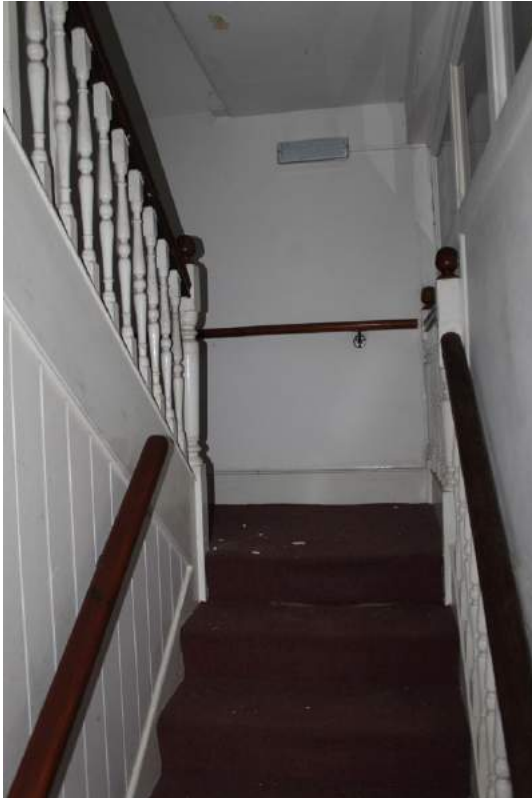
Based on their plan form, rooms 9 and 10 appear to be an original part of the building, but they now contain modern W.Cs (Fig 3). Rooms 22 and 23 are part of the buildings western range, added to the structure in the late 19th century. Room 23 includes a staircase that leads to the basement below and the first and second-floors above. Like the main staircase, this one has turned balusters and newels, but they are less ornate (Photograph 32). Rooms 32-36 are modern subdivisions of a single room, again in the western range.

**Photograph 32** Detail of staircase in room 23. Photograph taken facing north-west.

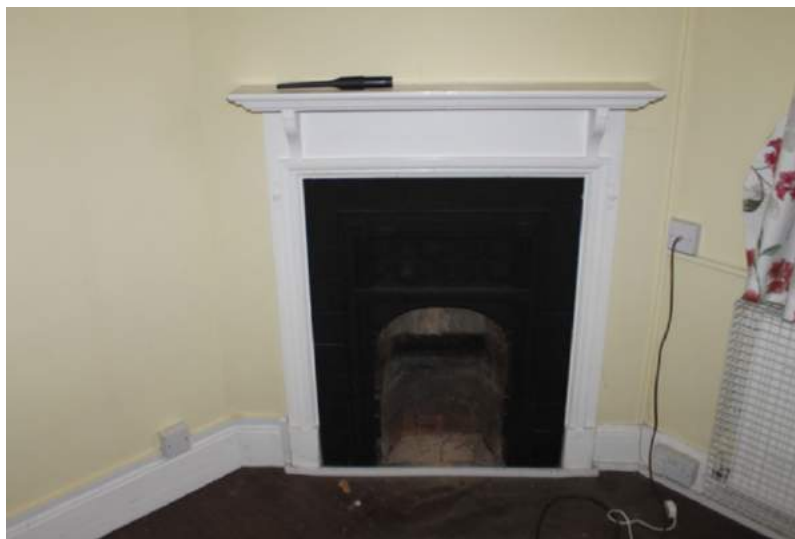
The first-floor of Foley House is by far the most impacted by modern alterations and additions. Almost every room has been extensively subdivided into modern bedrooms, cupboards and W.Cs (Fig 4). All the fireplaces on this floor, with the exception of the one in room 85 (Photograph 33), have been blocked. Room 60 contains an inserted modern staircase, leading up from room 11 below (Fig 4).

**Photograph 33** Original fireplace in room 85. Photograph taken facing south.

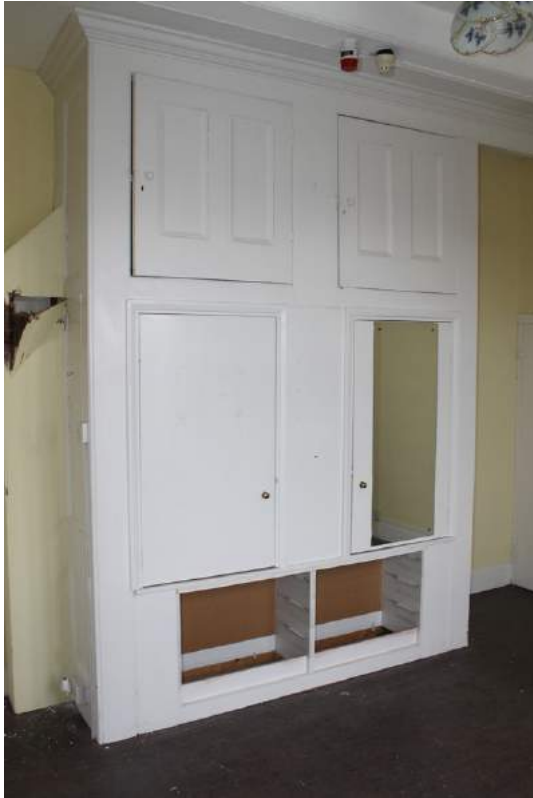
Despite this, several features of interest remain. Room 82 contains an original cupboard, with a four-panel door, adjacent to its blocked fireplace. Similarly, on the north wall of room 85 is a larger cupboard, probably original to the extension (Photograph 34).

**Photograph 34** Detail of cupboard in room 85. Photograph taken facing east.

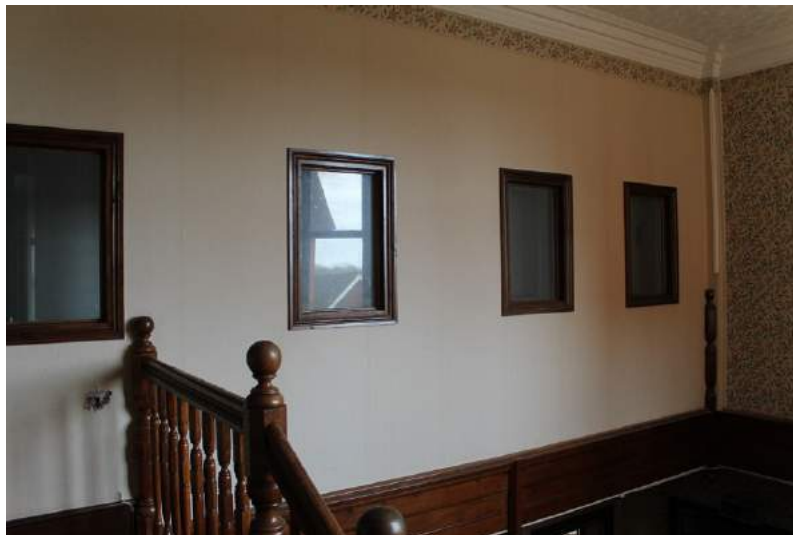
The landing above the main stairway (68) would originally have been open, with a railing around the edge of the landing, much as still survives in room 69 (Photograph 35). A modern wall with windows has been inserted in this location, but a surviving newel post in the south-west corner attests to the original railing (Photograph 35).

**Photograph 35** Modern wall inserted on landing above main staircase, with windows. Note newel post to right of frame from original railing. Photograph taken facing south.

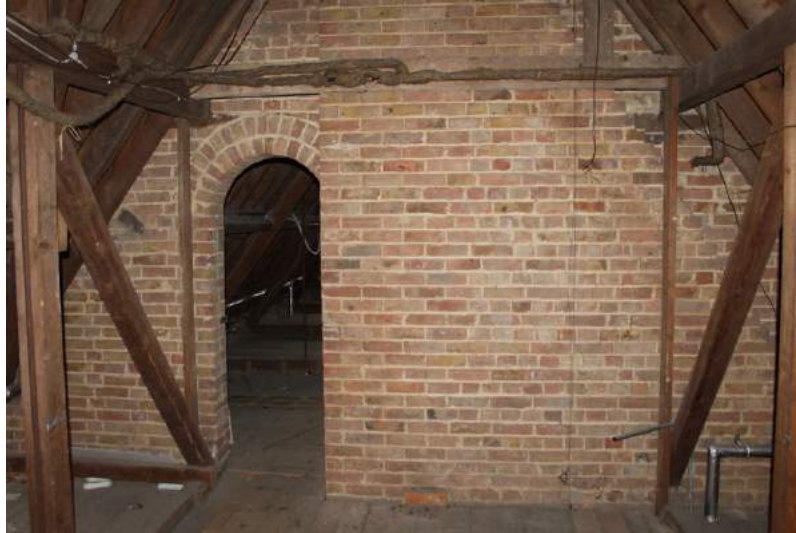
Rooms 90 and 91 are unfurnished with exposed brickwork and no wall coverings (Photograph 36), whereas rooms 92-95 are entirely modern insertions into a similarly previously unfurnished space (Fig 5). The roof of the east wing is visible in rooms 90 and 91, and consists of entirely machine-cut timber, with pairs of rafters joining at a ridge-board, supported by a single butt purlin on each roof pitch, along with collars (Photograph 37). Also present on the outside of the rafters are a series of sarking boards, which could be original (Photograph 37).

**Photograph 36** Room 91, showing entrance into room 90 and chimney-stack rising from floors below. Photograph taken facing south-west.

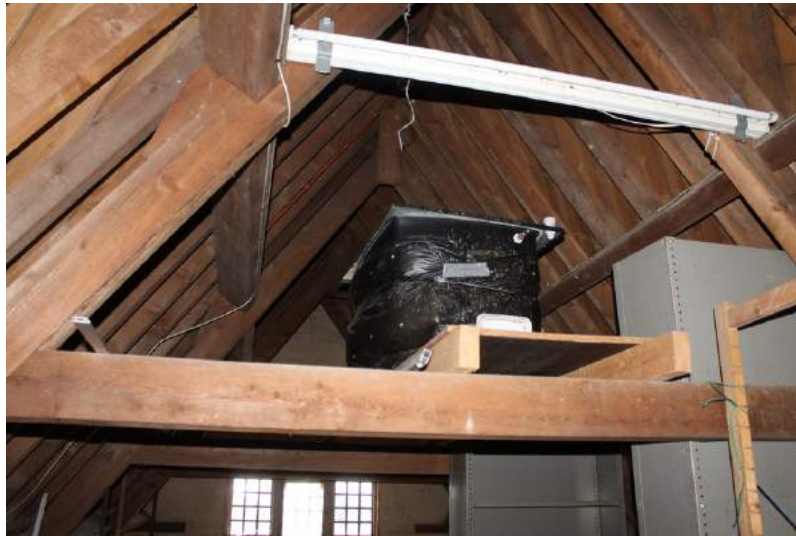
**Photograph 37** Room 90, showing exposed roof timbers. Photograph taken facing south-west.

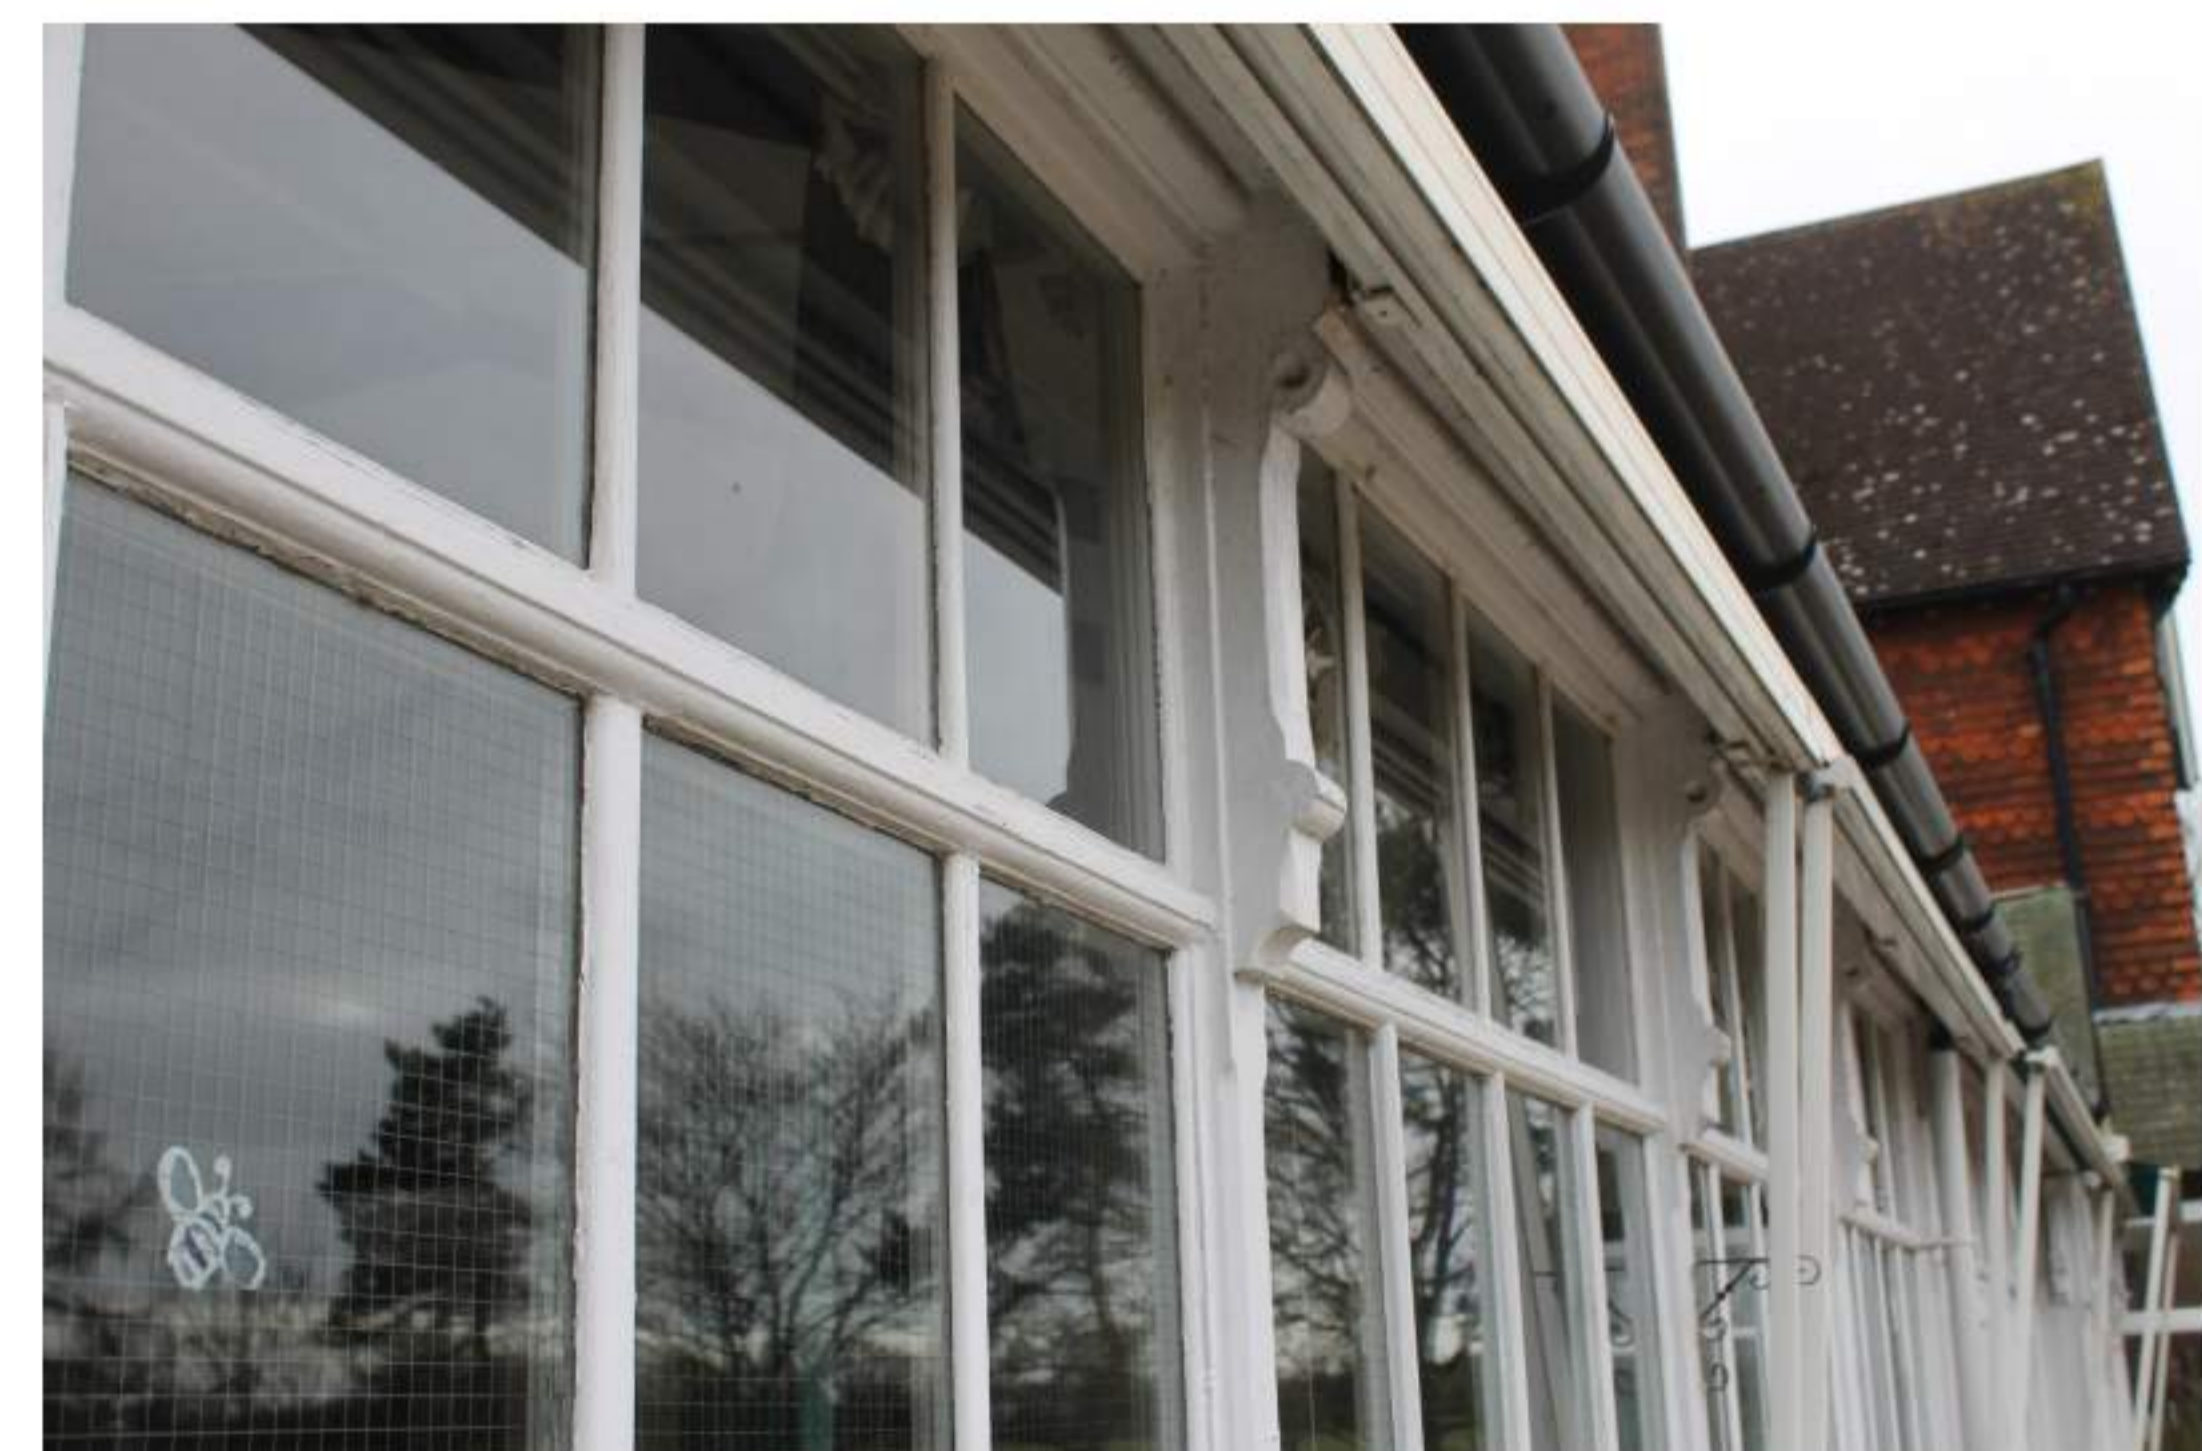
BTFH21\_Phograph042

BTFH21\_PhotoGraph\_042.JPG Detail of brick pillar and damaged carved stone finial on original boundary wall. Photograph taken facing north.
