**Historic building recording at the Coach House, Wakes
Colne Mills, Colchester Road, Wakes Colne, Colchester,
Essex, CO6 2BY**

May 2021

CAT Report 1698
November 2021

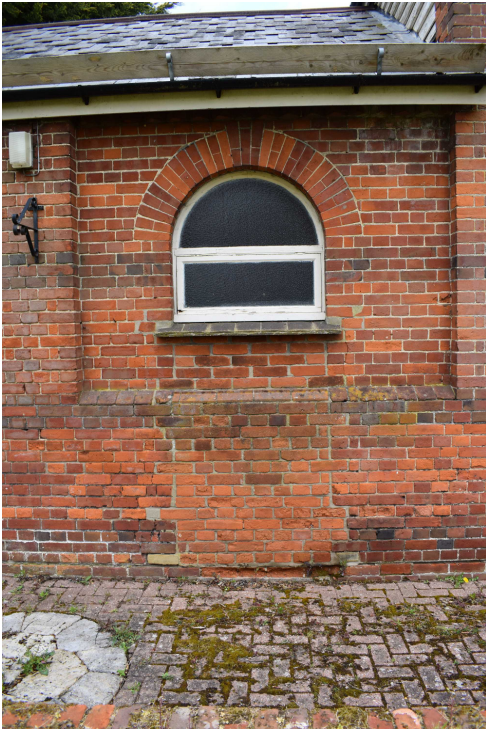
On the west side of the main door opening there are limestone blocks with iron pintles for supporting hinges embedded in them, indicating the former presence of a stable door. To the west of the cross-wing there are two original doorways; the one closest to the cross-wing has been partially blocked with brickwork and a modern window (Photograph 3). At the extreme west end of the south elevation the second original doorway contains a modern timber and glass door (Photograph 4). As these doorways lack the limestone blocks used to support the stable door of the main opening they were probably entrances to tack rooms.

Photograph 3 Detail of blocked doorway with modern window on southern elevation of the main range – view north.

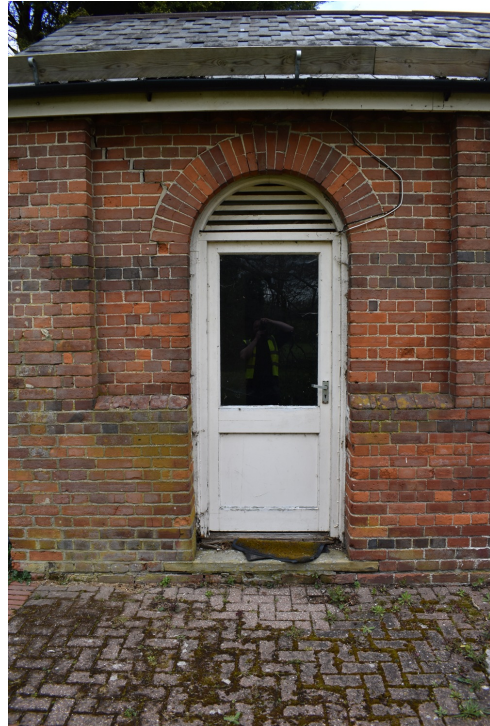
Photograph 4 Detail of modern door in original opening on the south elevation of the main range - view north.

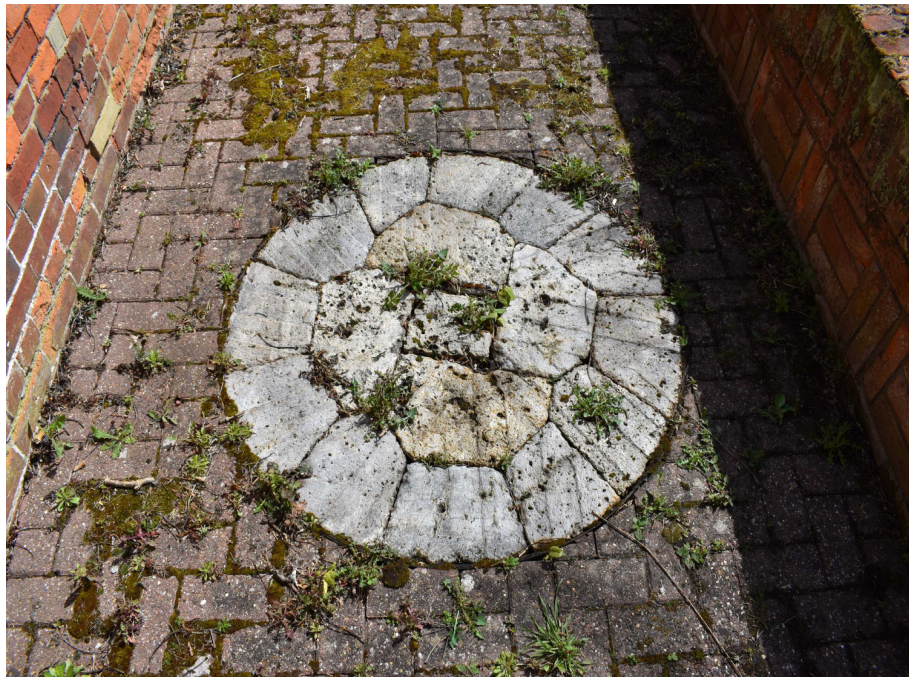
Although not an original feature, on the south side of the main range there is a modern brick floor where fragments of millstones have been used a decorative feature (Photograph 7).

Photograph 7 Detail of millstone fragments in brick floor in front of the main range to the coach house - view east.

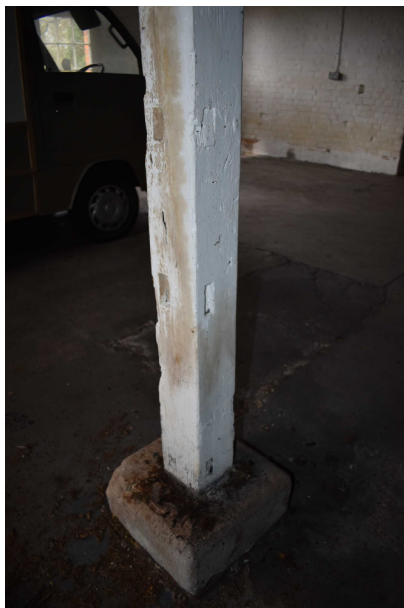
The largest room is located in and comprises the entire footprint of the main range (Room 1 on Fig 2) (Photograph 13) although inserted walls have created three small chambers in the west end (labelled Rooms 1a, 1b and 1c on Fig 2). The floor is of screeded concrete which either obscures or has replaced the original flooring which would have probably been formed from stable bricks. The ground-floor has five original posts, centrally located and aligned east to west although the central one has been relocated slightly to the north. The posts have straight-braces bolted on two sides and each support a tie-beam. There are a number of joists between the tie-beams supporting the floor of the cross-wing. Baltic timber marks are present on at least seven of these joists (Photograph 15). Mortices with the remains of sawn off tenons on the posts indicate this room was once subdivided (Photograph 14).

Photograph 14 Empty mortices on post in Room 1 – view south-west.

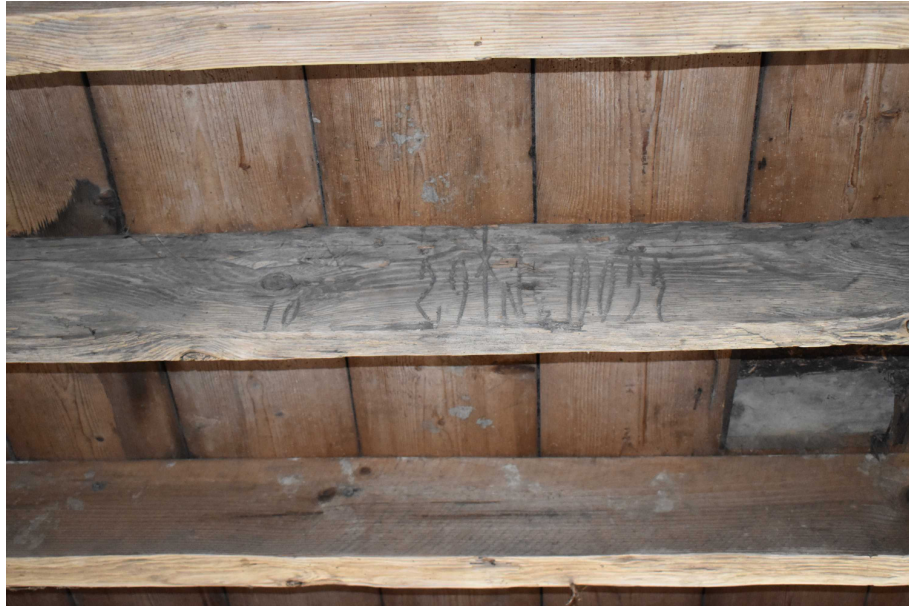
Photograph 15 Detail of Baltic timber mark on joist supporting the first floor of Room 1 - view east.

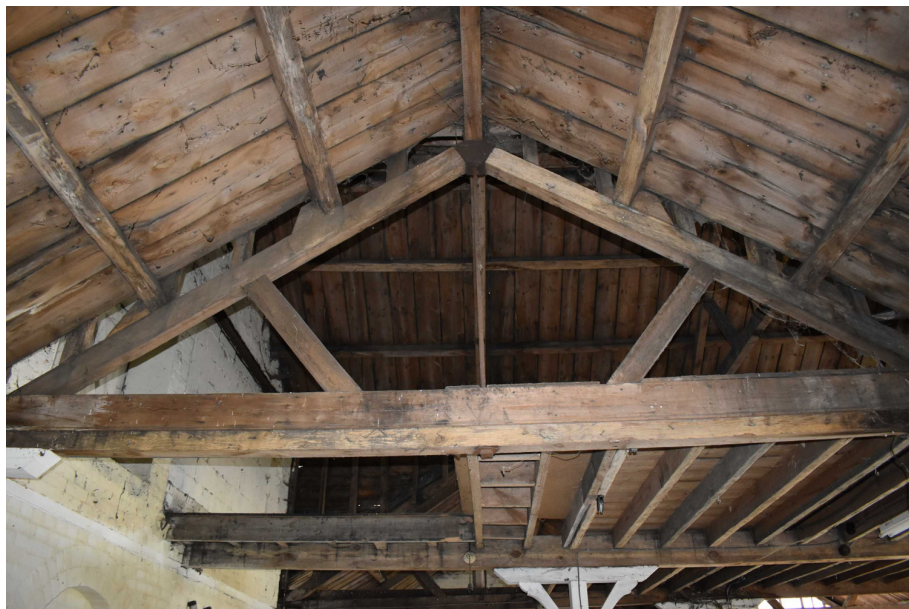
In the single storey areas of the main range the roof trusses (Photograph 16) are also supported on the posts and tie-beams. These have inclined struts rising to support a pair of rafters, which meet at the top of a metal king-post, which also rises from the tie-beam. The rafters carry two purlins, supporting sarking boards which meet at a ridge-board.

Two splayed two-peg scarf joints were recorded in the purlins of the east end of Room 1.

Photograph 16 Truss above western end of Room 1 - view east.

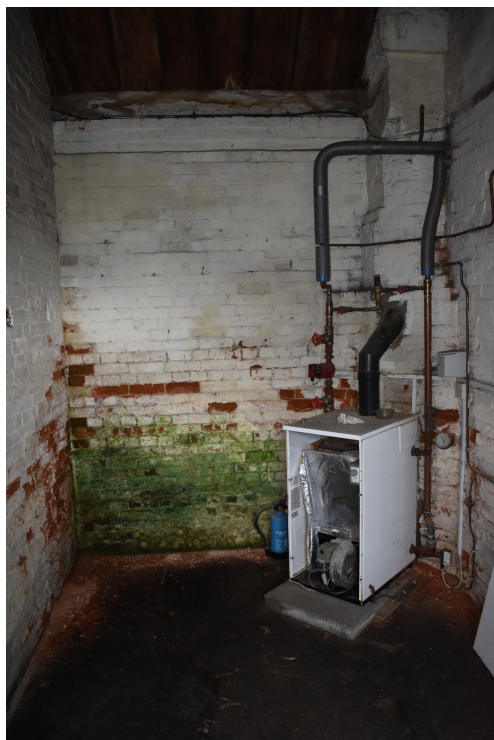
Room 2 has two original door openings with arched heads, one leading to Room 1 and the other to Room 3. Both door openings have a single vertical-planked door which are clearly replacements as the brick arches above the lintels have been partially filled in. The floor is concrete, unlikely to be original. In the north-east corner of Room 2 is an original fireplace and chimney-breast, now partially obscured by a modern boiler (Photograph 20). Baltic timber marks were recorded on the lower purlin on the northern roof pitch.

Photograph 20 Original fireplace and chimney breast in Room 2 – view north

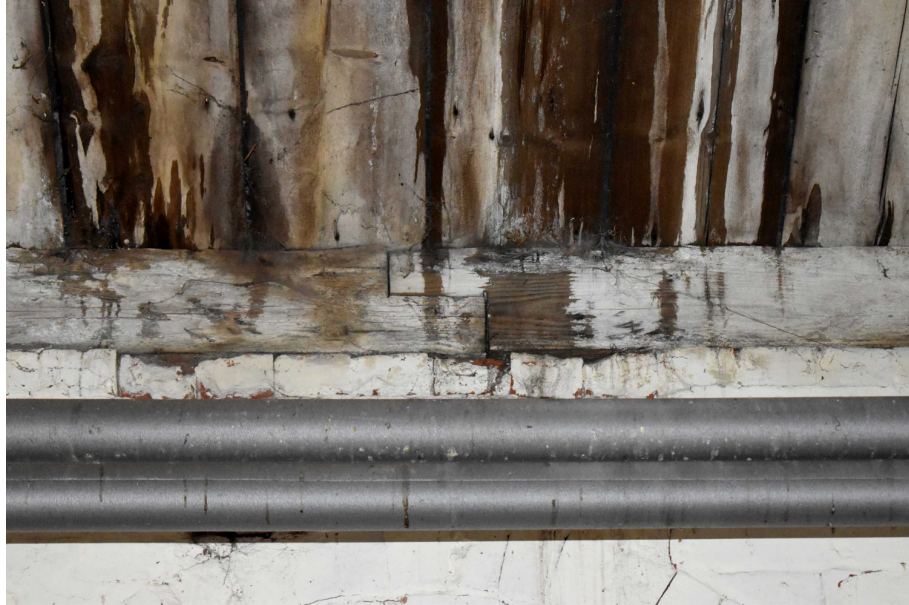
Room 3 was originally a carriage store with full height carriage doors and Room 4 likely the same but without the doors. The openings to both rooms have had modern garage doorways with a stud-wall above inserted, although the garage door is missing from Room 4. In the wall plate of the northern elevation to Room 3 is a basic side-halved scarf joint (Photograph 21). Baltic timber marks were observed on the upper purlin of the southern roof pitch in room 4. The flooring in both rooms is concrete, again unlikely to be the original floor material.

Photograph 21 Detail of northern wall-plate scarf joint in Room 3 - view north.

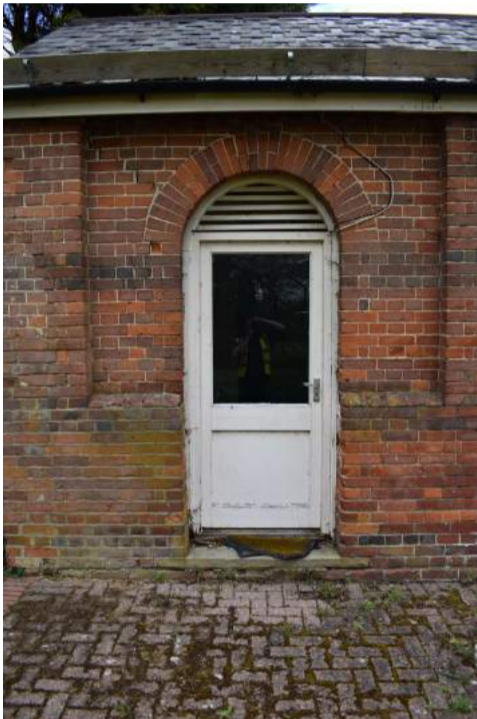
ECC4613_Photograph_005
Detail of modern door on southern elevation of main range to the coach house.

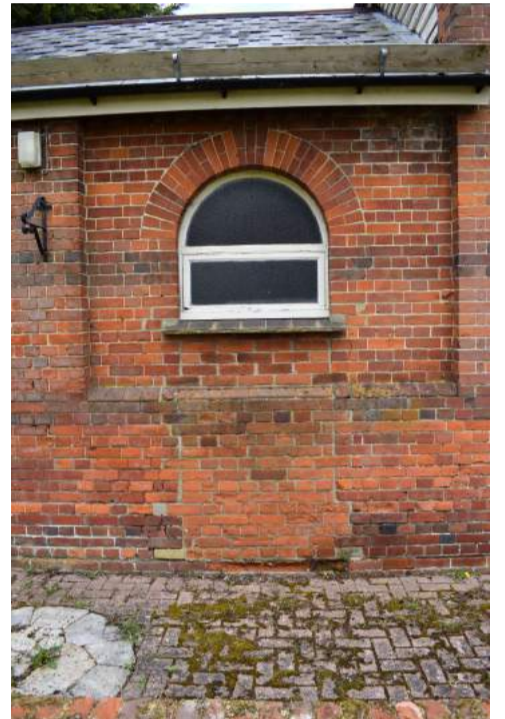
ECC4613_Photograph_006
Detail of blocked doorway with modern window on southern elevation of the main range to the coach house.

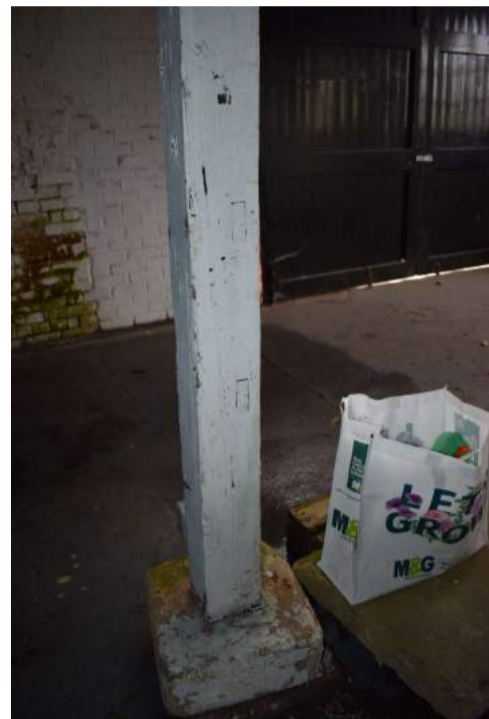
ECC4613_Photograph_066
Sawn off tenons in the mortices on post in Room 1, would have originally supported division.

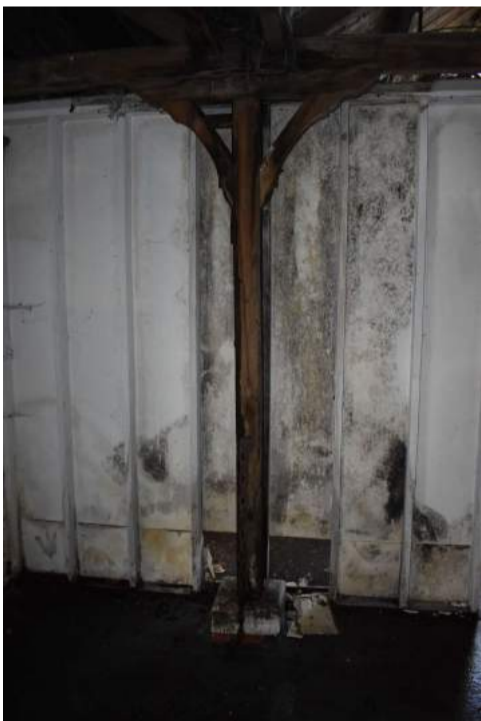
ECC4613_Photograph_067
Original unpainted post in Room 1, against modern inserted stud wall - view north-east.

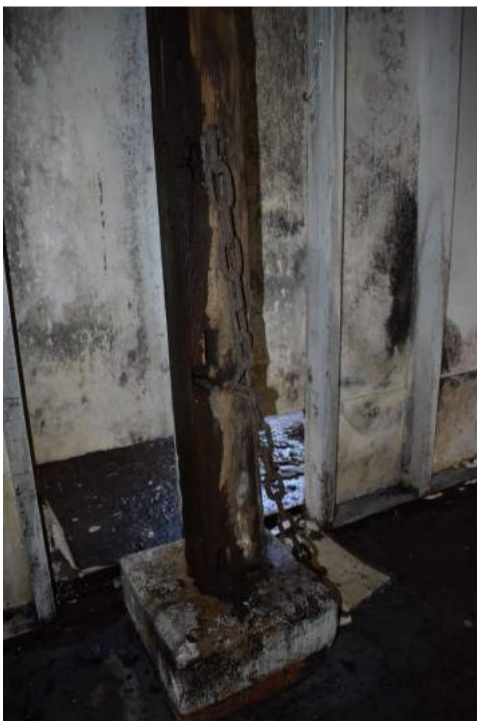
ECC4613_Photograph_068
Detail of mortices in original post in Room 1 - view north-west.

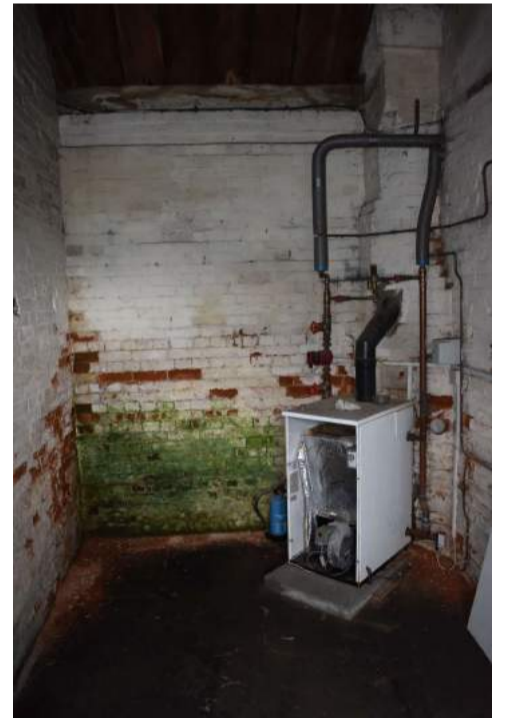
ECC4613_Photograph_081
Room 2, showing original fireplace to right with modern boiler in front - view...

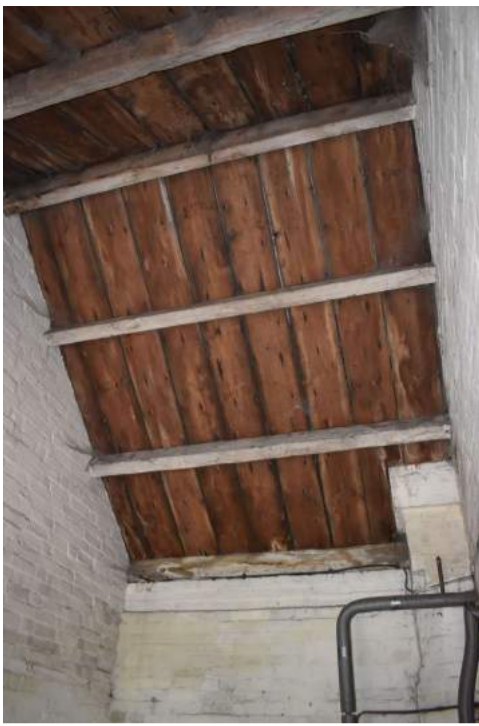
Numerous Baltic timber marks were observed on the frame of the coach house. Nearly all the marks that were decipherable bore the official quality mark associated with Danzig, a port in Prussia.

ECC4613_Photograph_085
Northern roof pitch of Room 2, with Baltic timber marks - view north-west.

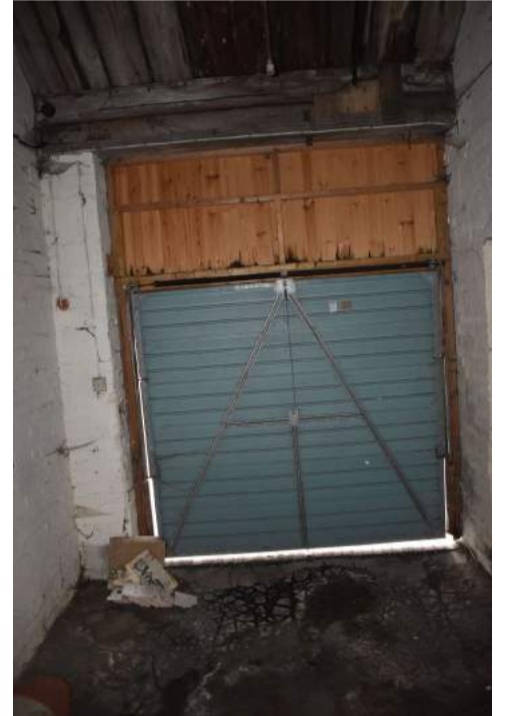
ECC4613_Photograph_090
Modern inserted stud wall and garage door in southern wall of Room 3 - view east.

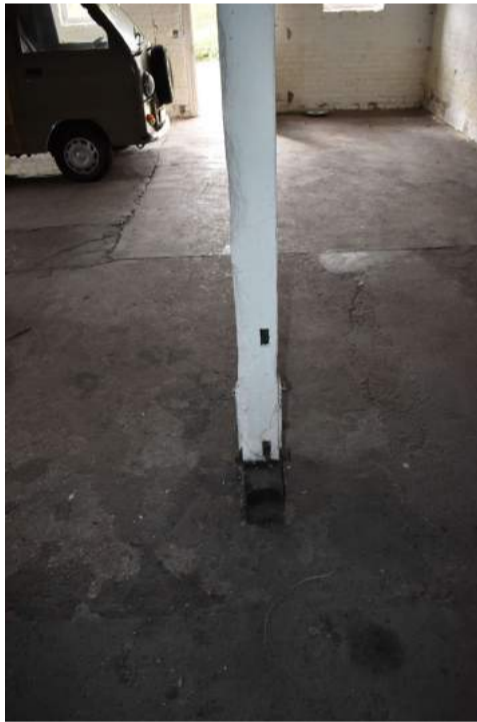
ECC4613_Photograph_092
Detail of mortices in base of post in Room 1 - view south.
