**CAT Report 1854
Issued October 2022**

**Historic building recording of a barn at
Meadow Hall Farm, Parkhall Road, Gosfield,
Essex CO9 1SQ: June 2022**

**CAT project ref.: 2022/05e
ECC code: MHGF22**

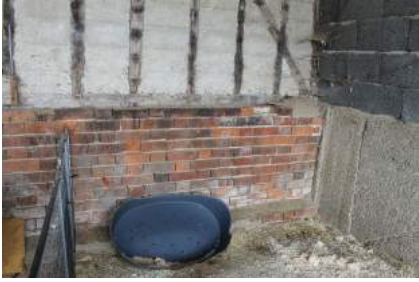
MHGF22_PhotoGraph01Brick plinth and downward wall (north-east side)

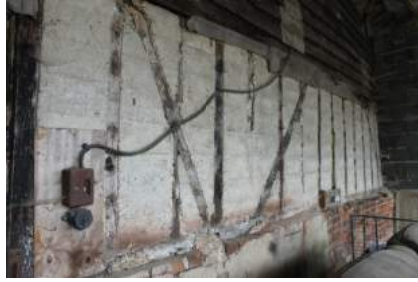
MHGF22_PhotoGraph02Concrete filled timber wall (NE side)

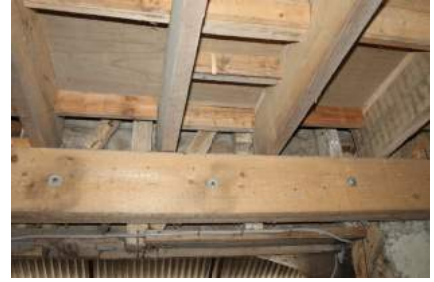
MHGF22_PhotoGraph03Detail of new floor over old timbers

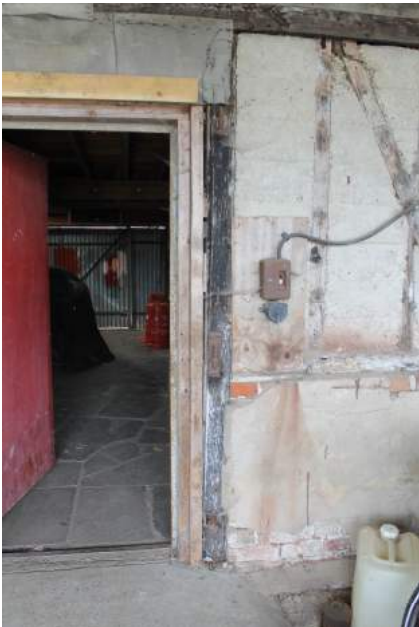
MHGF22_PhotoGraph04Doorway in north-east wall
