**CAT Report 2052  
Issued May 2024**

**Historic building recording at Wells Farm, Ivy Barn  
Lane, Margarett, Essex, CM4 0PU**

**NGR: TL 64802 02431**

**Planning district.: Chelmsford  
Planning ref.: 23/01372/FUL**

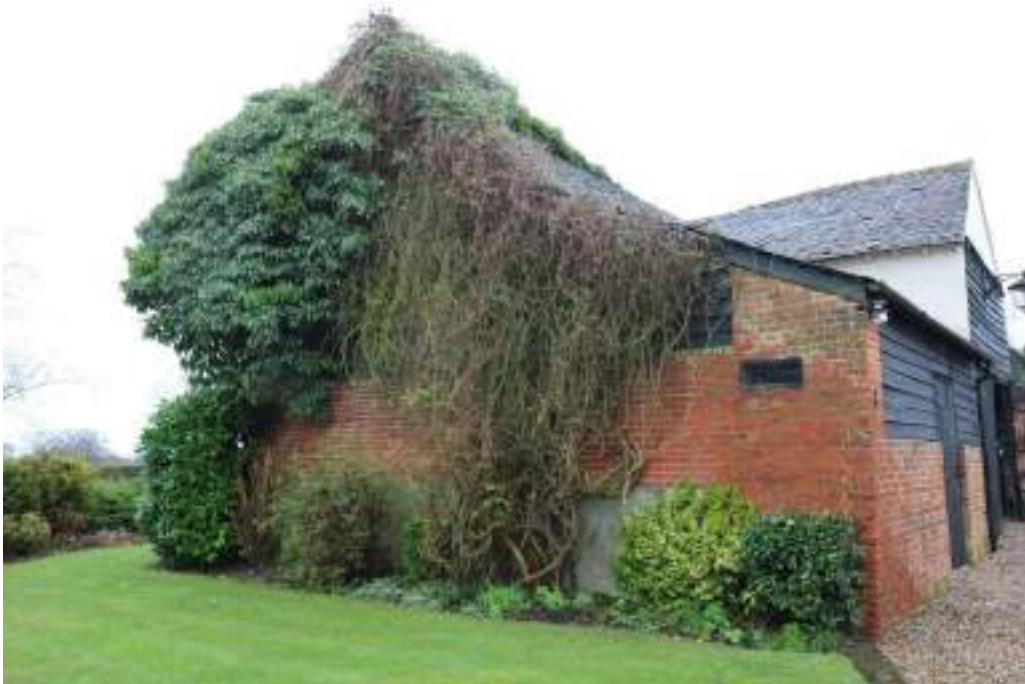
On the northern elevation, the threshing barn's plinth is partially sheathed with concrete. A modern vent is set into the brickwork of lean-to 1. Much of the northern elevation was obscured by an overgrowth of foliage but it is assumed to be featureless.

**Photograph 3** Northern elevation of building 1. Photograph taken facing south-east.

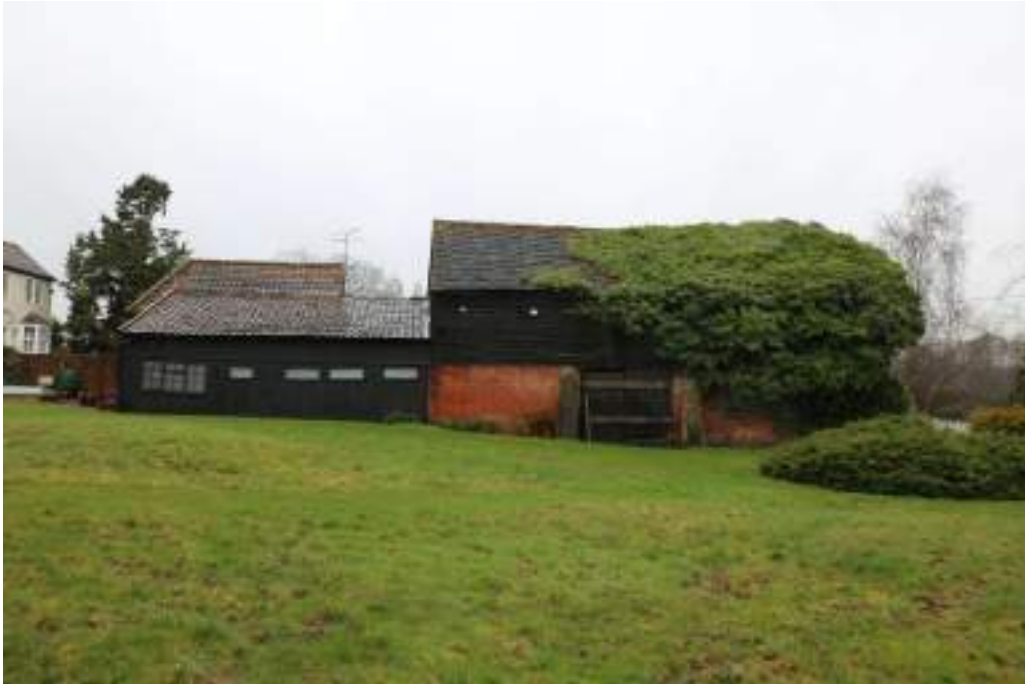
Set into the centre of the eastern elevation of the threshing barn is a pair of vertically-planked timber barn doors, which have been boarded up. Either side of this, two brick buttressed have been added, which are covered in a layer of concrete.

**Photograph 4** Eastern elevation of building 1. Photograph taken facing west.

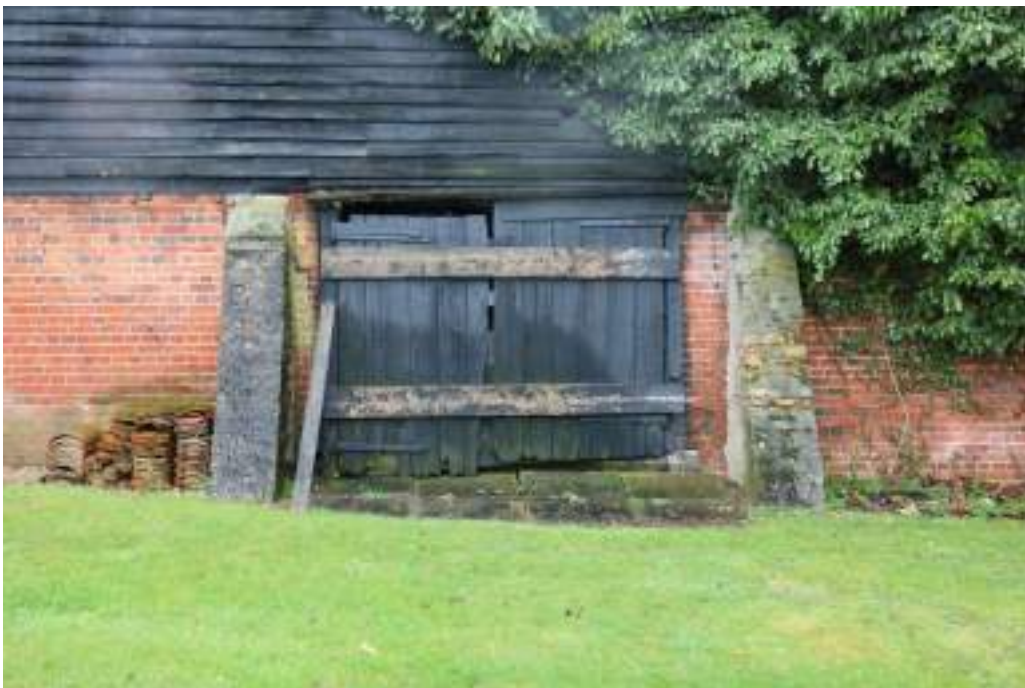
**Photograph 5** Detail barn doors on eastern elevation of threshing. Photograph taken facing west.

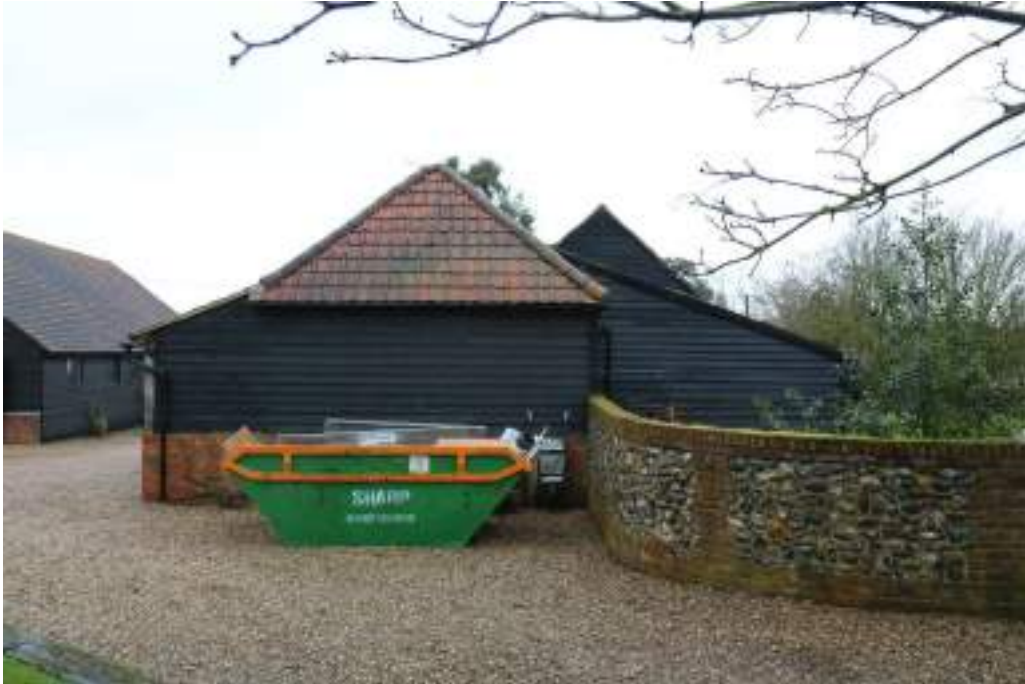
The southern elevation of the complex is plain weatherboard.

**Photograph 6** Southern elevation of building 1. Photograph taken facing north.

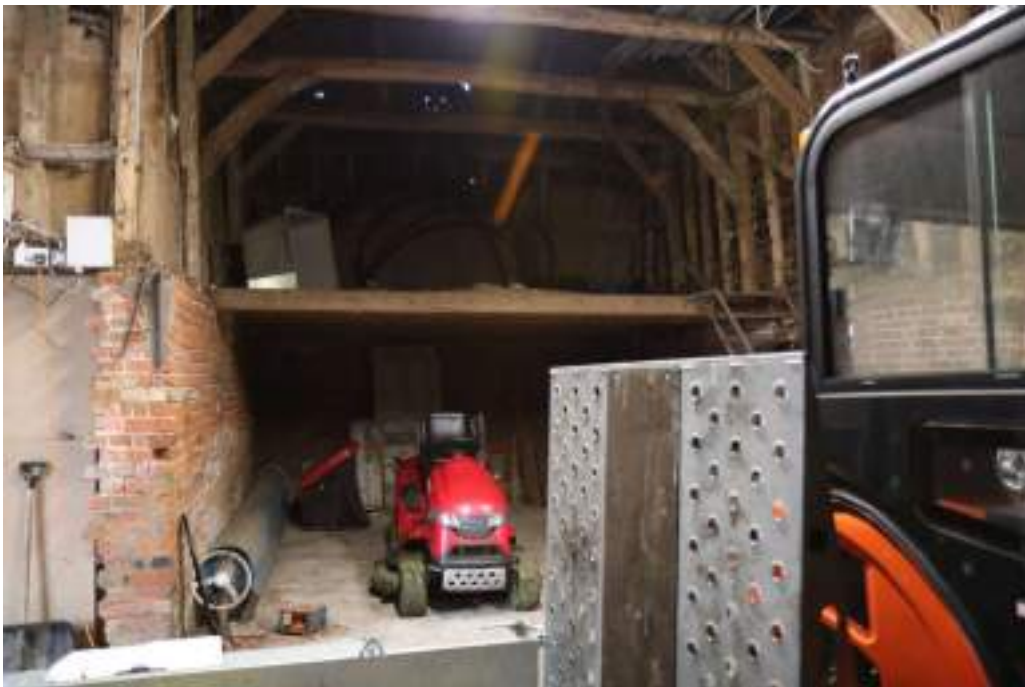
**Photograph 7** Interior of threshing barn. Photograph taken facing north-east.

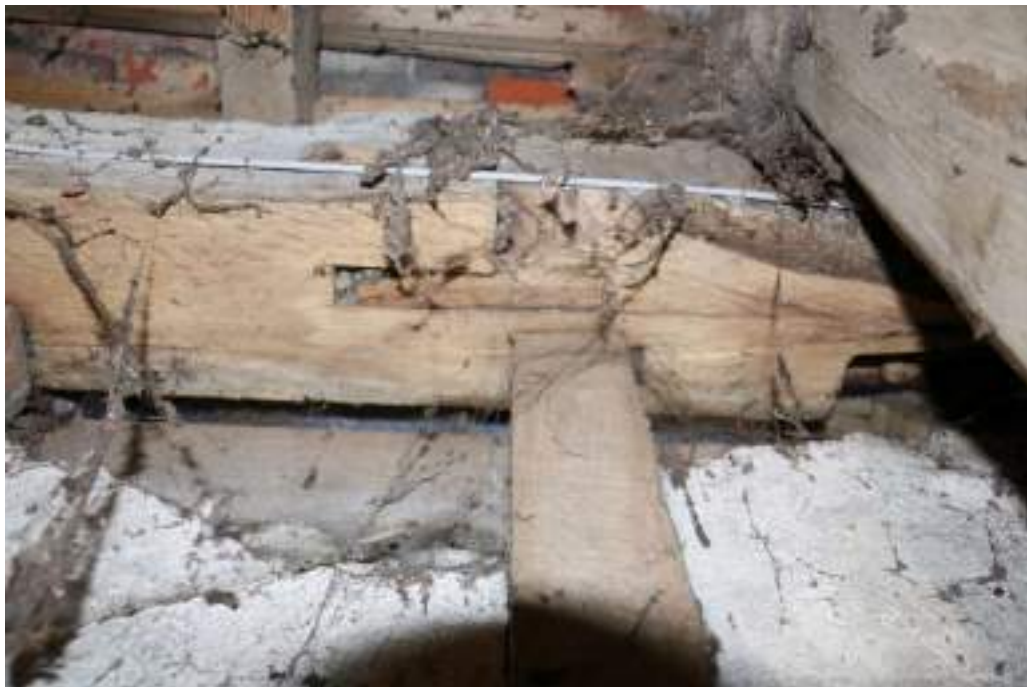
**Photograph 9** Detail of scarf-joint in wall-plate of bay 1 of threshing barn. Photograph taken facing west.

western wall there is lath and plaster infill between the studs. Three scarf-joints are present in bay 1, a face-halved and bladed joint in the eastern and western wall-plates and a straight bridling of three-quarters with squinted abutments and an over-lipped face joint in the western sill-beam.

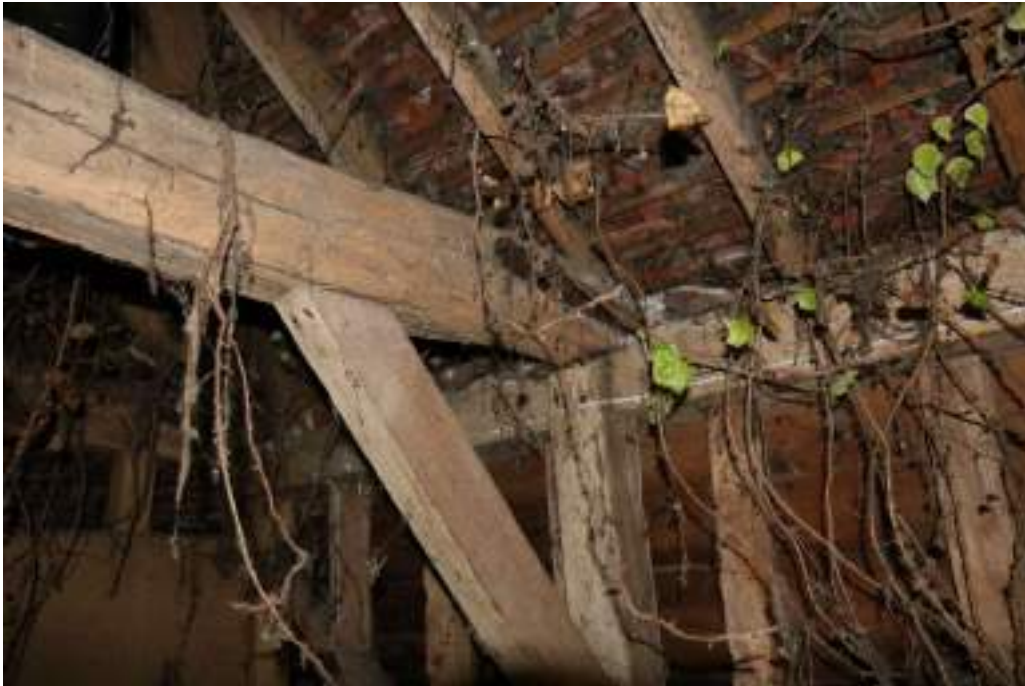
Bay 1 has a reused timber for the northern wall-plate and an inserted tie-beam roughly central to the bay. Both the original and inserted tie-beams have iron straps. In the

**Photograph 10** Detail of inserted tie-beam with straight brace and iron strap, in bay 1 of threshing barn. Photograph taken facing north-east.

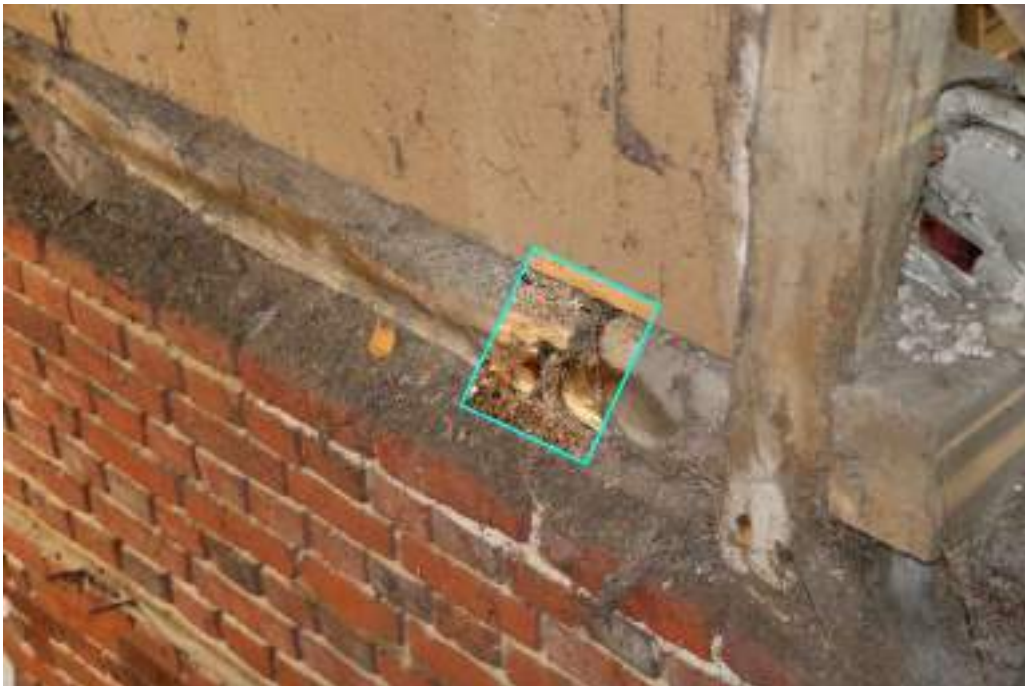
In bay 4, two additional tie-beams have been inserted. The northern-most one almost abuts the gable end and does not have any supporting intermediate posts or bracing; it is also a reused timber. The central inserted tie-beam has an iron strap on the western end. A hole has been broken through the brick plinth in the south-western end of the bay to form a crude entrance into lean-to 3. The western wall has lath and plaster infill.

**Photograph 12** Detail of scarf-joint in bay 4 of threshing barn. Photograph taken facing south-west.

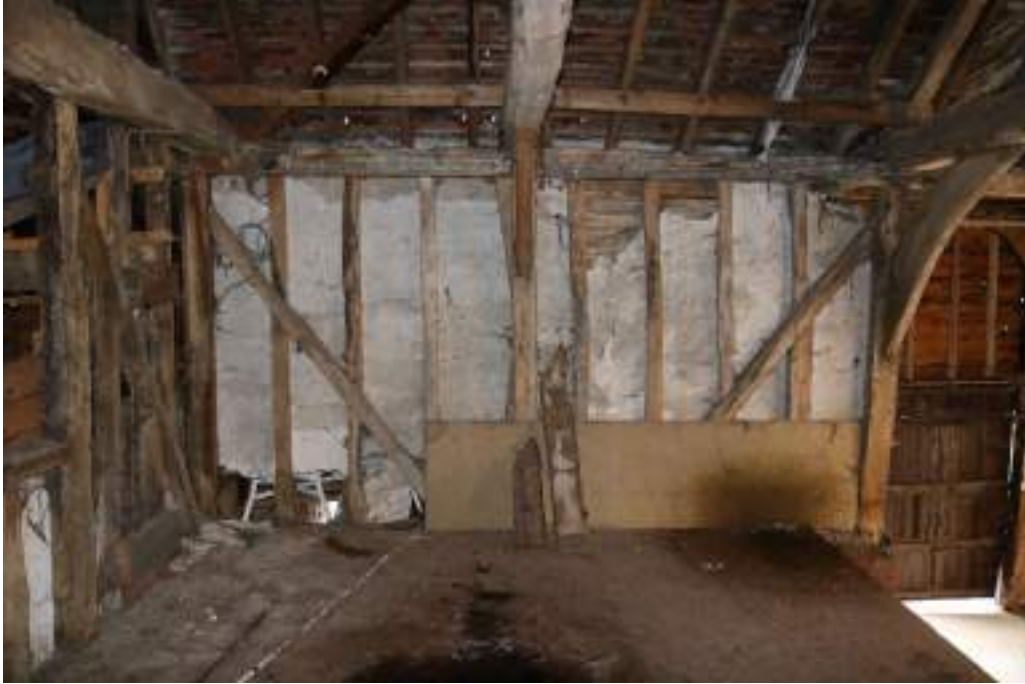
**Photograph 13** Western wall of bay 4 of threshing barn. Photograph taken facing west.

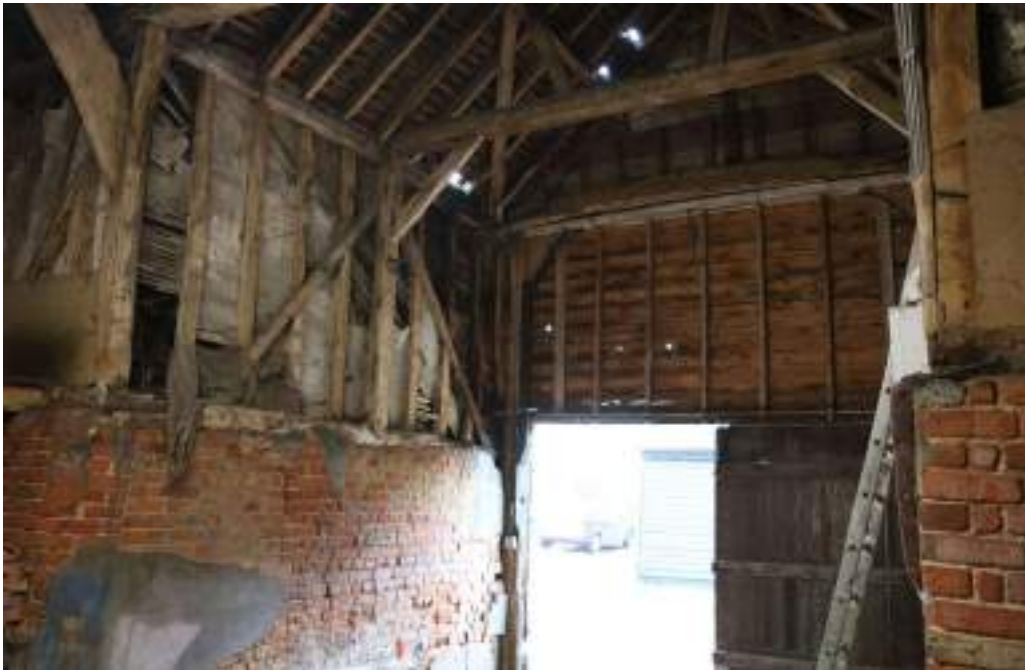
In the midstrey, the doorway set into the western wall would have originally been the full height of the wall but has been halved in height. The corner posts either side of the door are reused timbers, and the gable end tie-beam has iron straps on both ends. An original doorway has been blocked off in the brick plinth of the southern wall and another doorway has been inserted in the northern wall. The timber-framing of both the northern and southern walls have lath and plaster infill. The intermediate-post on the southern wall displays signs of reuse. A tie-beam has been inserted into the centre of the midstrey.

**Photograph 14** Interior of midstrey of threshing barn. Photograph taken facing south-east.

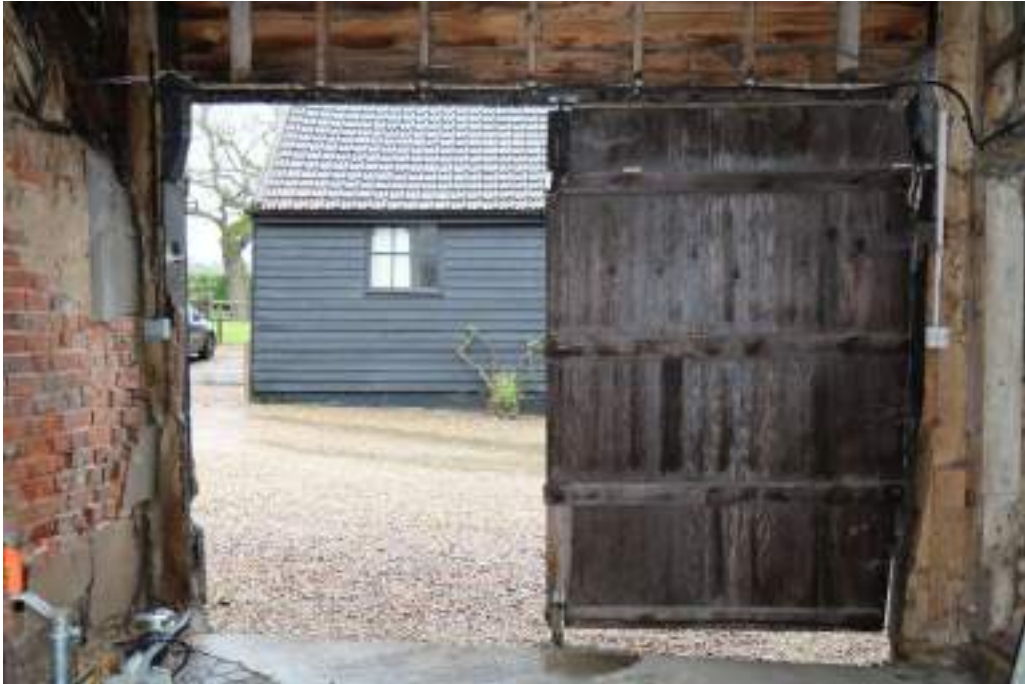
**Photograph 15** Detail of doorway in midstrey of threshing barn. Photograph taken facing west.

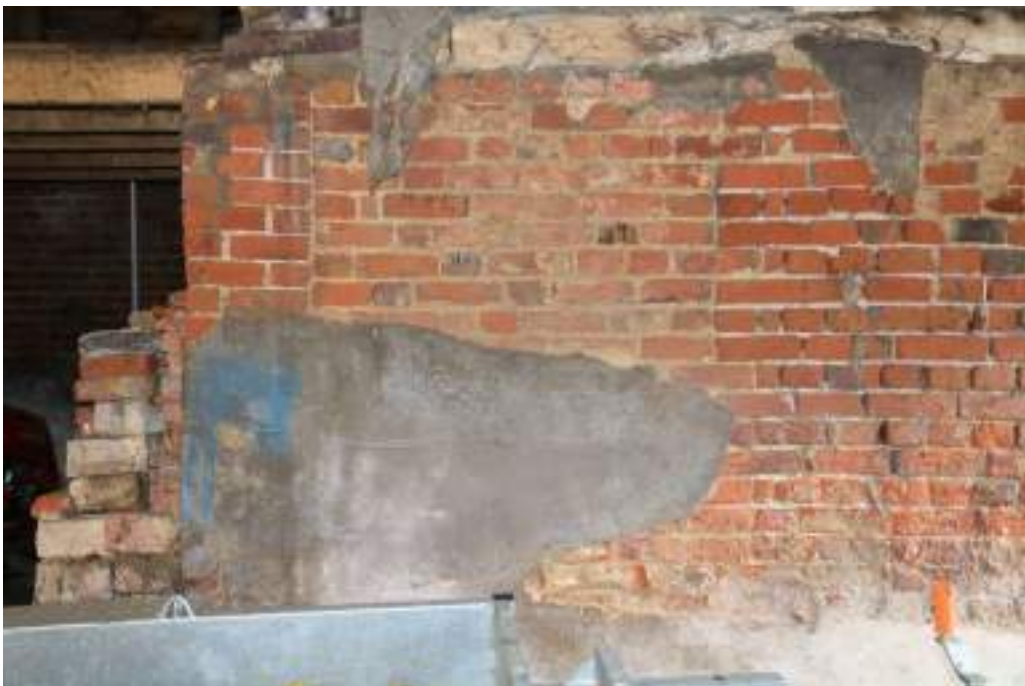
**Photograph 16** Detail of blocked doorway in midstrey of threshing barn. Photograph taken facing south.

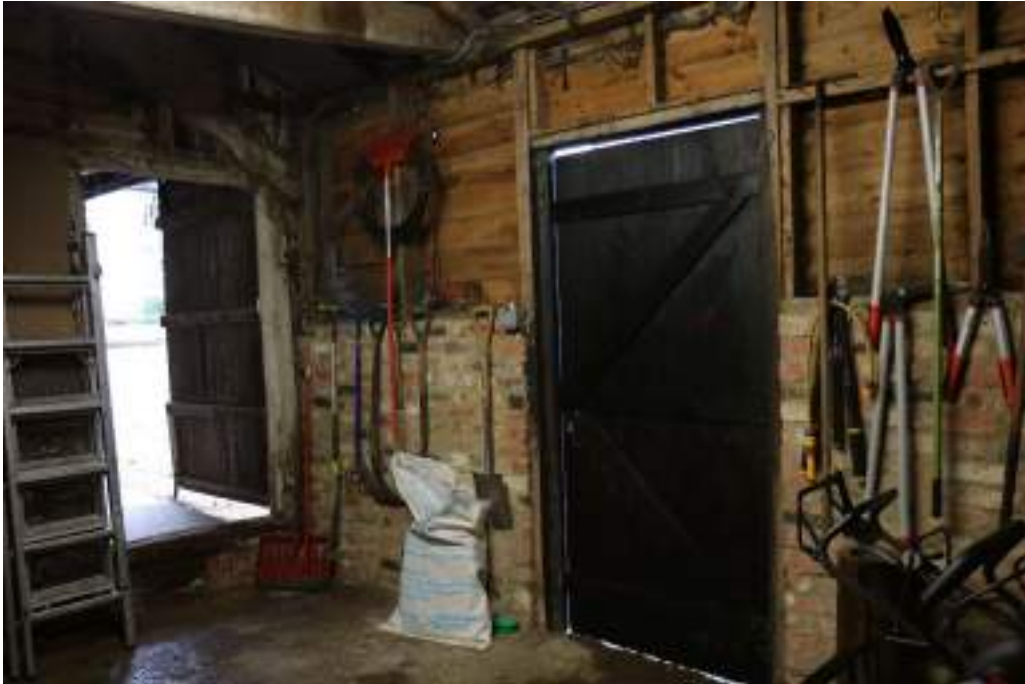
**Photograph 17** Interior of lean-to 3. Photograph taken facing south-west.

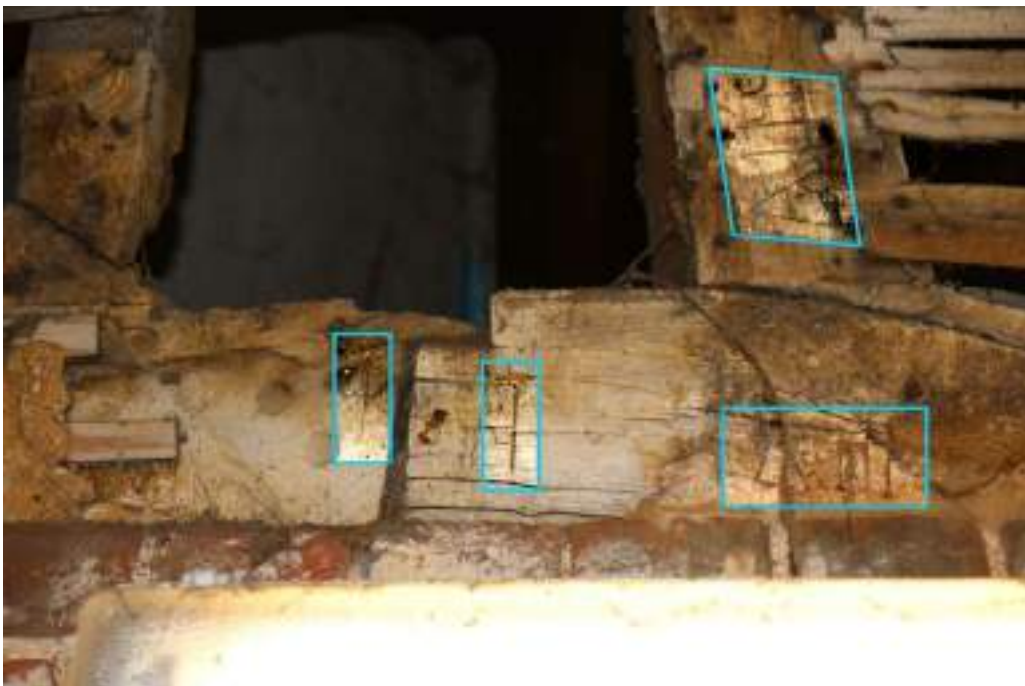
Above the exposed brick plinth, the eastern and southern walls are covered with lath and plaster. Due to the dilapidated state of the plaster, a number of the threshing barns carpenter's marks and scarf-joints can be seen within lean-to 1.

The sill-beam of the eastern wall has two straight bridling of three-quarters with squinted abutments and an over-lipped face scarf-joints, with a 'I' carpenter's mark either side of the northern joint. The intermediate-post in the eastern wall has the mark 'IIIV' with a corresponding carpenter's mark on the sill-beam. There is also a 'IIX' on second stud from the south. Above the inserted doorway, the sill-beam has two 'III' carpenter's marks, either side of a straight bridling of three-quarters with squinted abutments and an over-lipped face scarf-joint.

**Photograph 18** Detail of scarf-joint and carpenter's marks visible in lean-to 1. Photograph taken facing east.

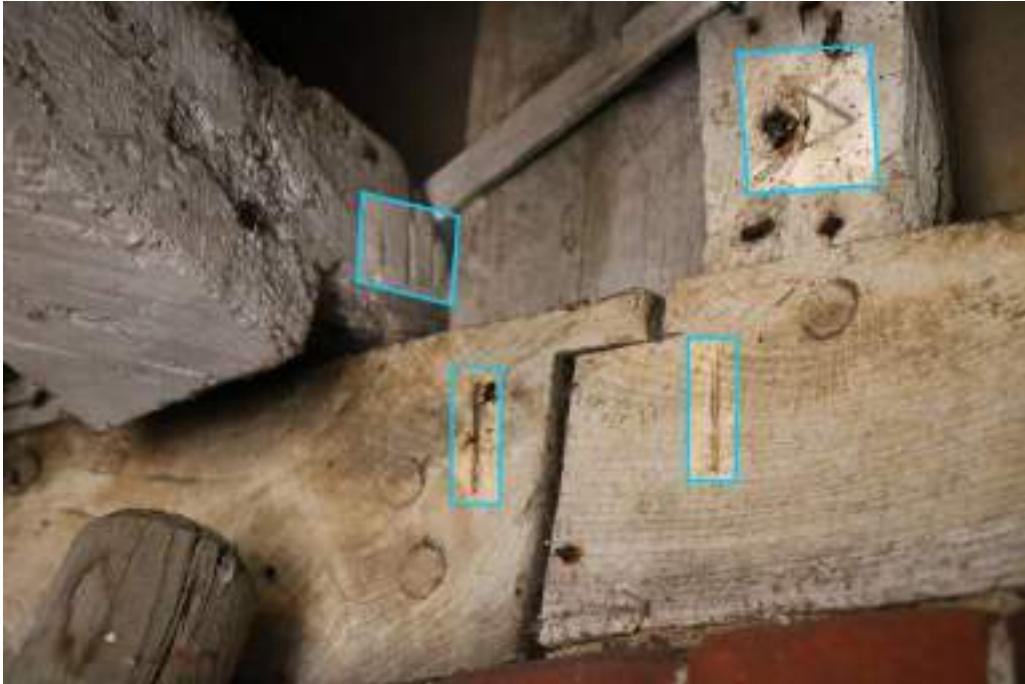
From north to south, the studs of the eastern wall have a series of carpenter's marks: 'V' on the first stud, 'III' on the next two studs, 'V' on the subsequent two and 'II' on the final stud. The diagonal wind-brace has a 'IIV' carpenter's mark. The sill-beam has a straight bridling of three-quarters with squinted abutments and an over-lipped face scarf-joint beside the tie-beam and forth stud, all of which also have corresponding carpenter's marks. Either side of the scarf-joint is a 'I' carpenter's mark, while the tie-beam has a 'III' carpenter's mark.

**Photograph 20** Detail of scarf-joint and carpenter's marks visible in lean-to 2. Photograph taken facing east.

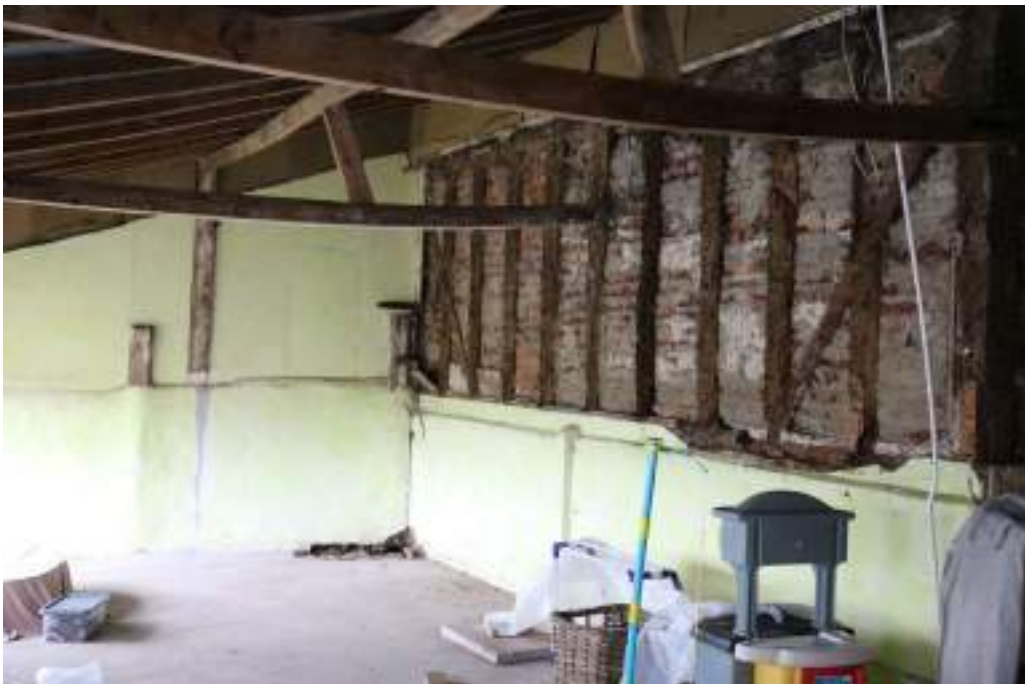
The roof of lean-to 3 is largely mono-pitched and constructed from single rafters, which rise from the wall-plate to meet the western wall of the carport, with a single purlin. Diagonal braces rise from the tie-beams to clasp the purlin. Two tie-beams cross the room where it connects with the carport, neither is the height of the wall-plate. Where the room bridges the space between threshing barn and the carport, the roof comprises pairs of rafters meeting at a ridge board. The single purlin from the mono-pitch roof continues to this part of the roof. Most of the timber used for lean-to 3 is machine-cut. The floor is poured concrete.

**Photograph 21** Interior of lean-to 3. Photograph taken facing south-west.

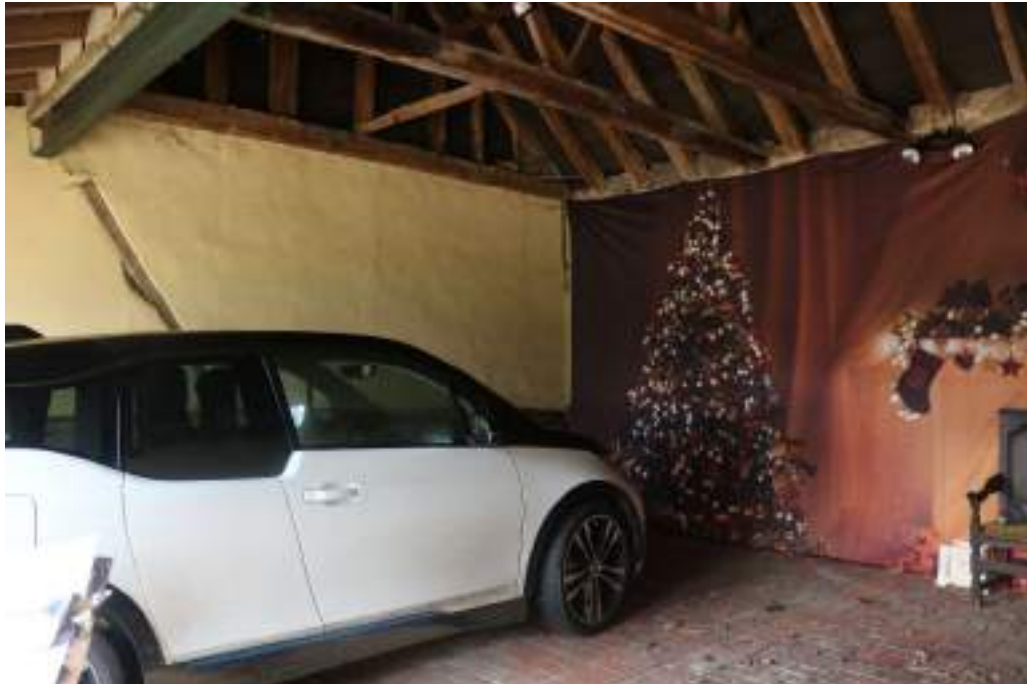
The structure of the timber walls is obscured by render and modern fixtures; however, a single diagonal wind-brace is visible through the render in the north wall. The roof timbers comprise a combination of hand-sawn and machine-cut timber. The floor of the carport is laid with modern bricks, some in a herringbone pattern and others laid flat.

**Photograph 22** Interior of carport. Photograph taken facing north-east.

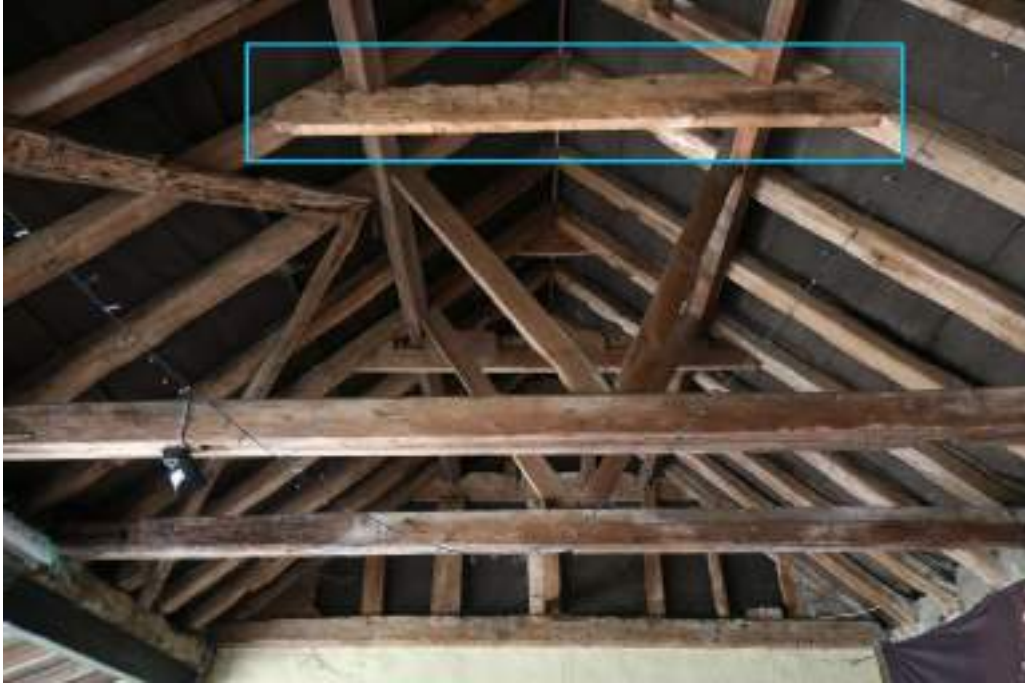
**Photograph 23** Detail of carport roof construction. A collar with lap-dovetailed joints highlighted in blue. Photograph taken facing north.

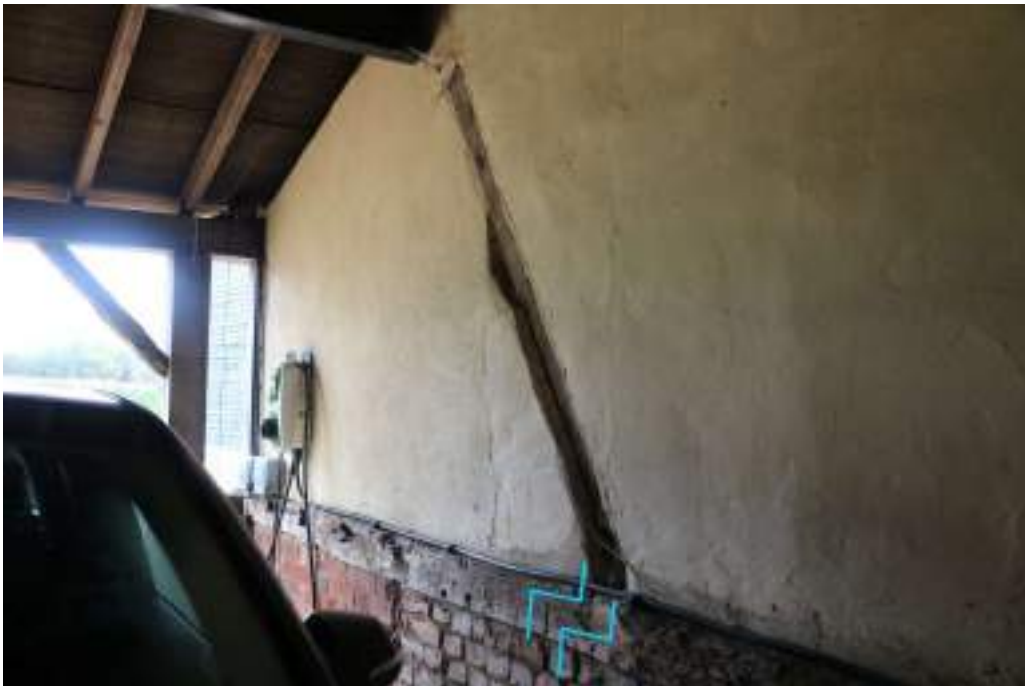
**Photograph 24** Detail of exposed wind-brace in carport. Wall-plate scarf-joint highlighted in blue. Photograph taken facing north-west.

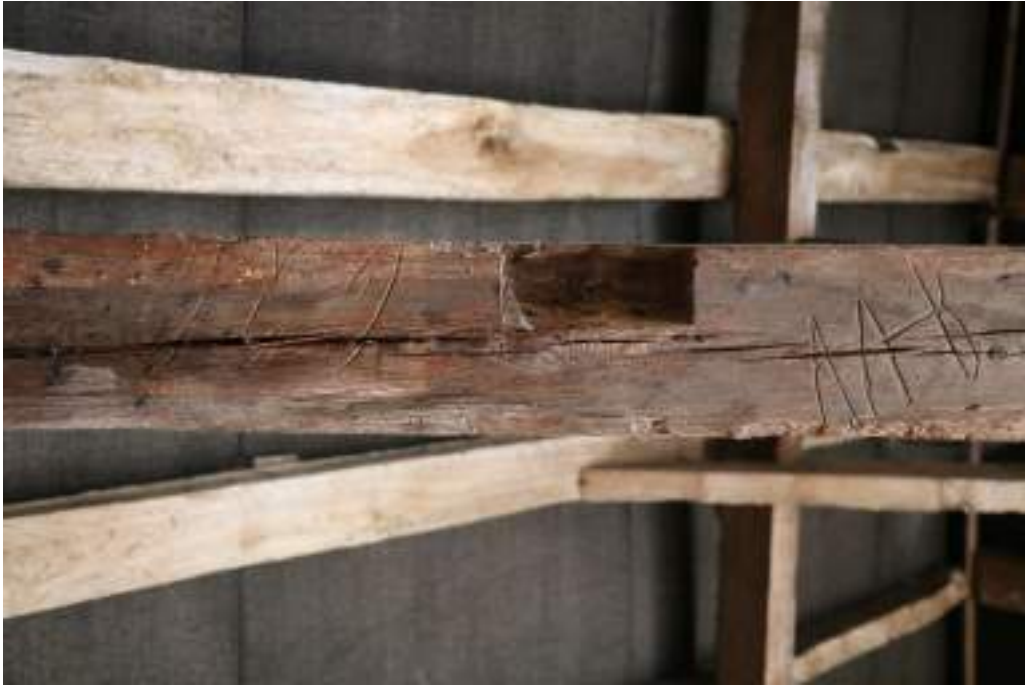
The majority of the rafters are reused timbers, as are the two collars and two of the tie-beams. A Baltic timber mark is present on one of the tie-beams.

**Photograph 25** Detail of reused tie-beam, with Baltic timber mark, in carpenter.

The presence of a Baltic timber mark in the roof of the carport can also be used to help with a construction date. The importing of timber into Britain began in the 17th century but increased dramatically during the 19th century (Vandenabeele et al. 2016). The small number of marks identified in the building suggests the building was raised whilst import levels were still relatively low. The collars in roof of the carport are hand-sawn and have lap-dovetail joints at either end, a technique found in timber-frames in the

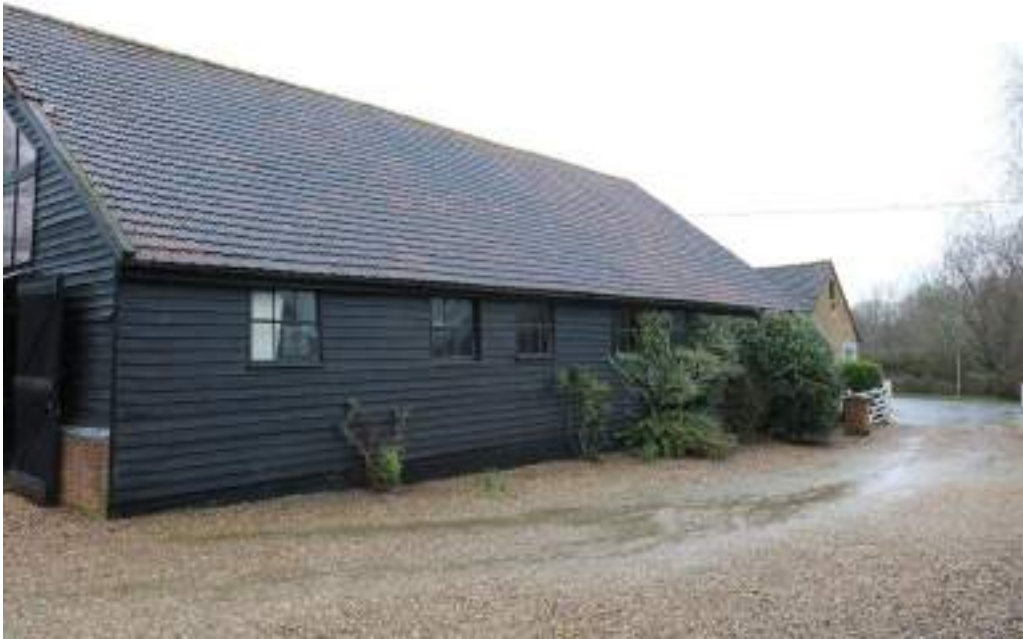
Along the eastern elevation, the cowshed has six six-light windows. Of these, two are timber-framed (the central window and the second from southernmost) whilst the rest are metal-framed. On the northern-most end of the cowshed is a single, vertically-planked door with a three-light fixed window directly above it. A single wooden post is set into the brickwork of the building between the third and fourth windows. The brick building has two six-light timber-framed awning windows.

**Photograph 26** Eastern elevation of building 2. Photograph taken facing north-west.

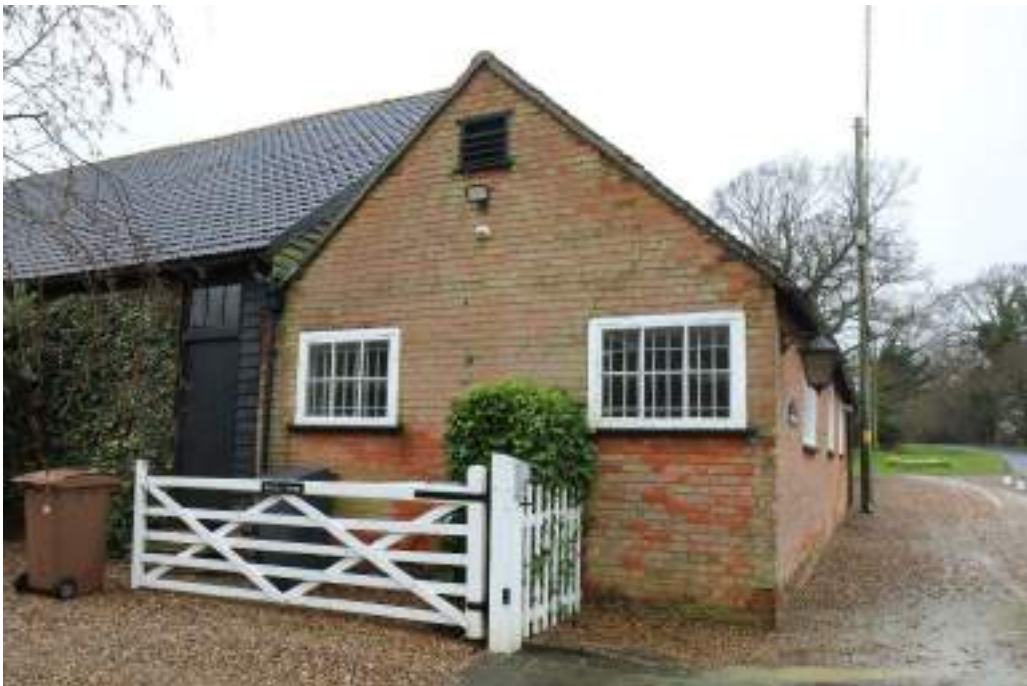
**Photograph 27** Eastern elevation of brick building. Photograph taken facing south-west.

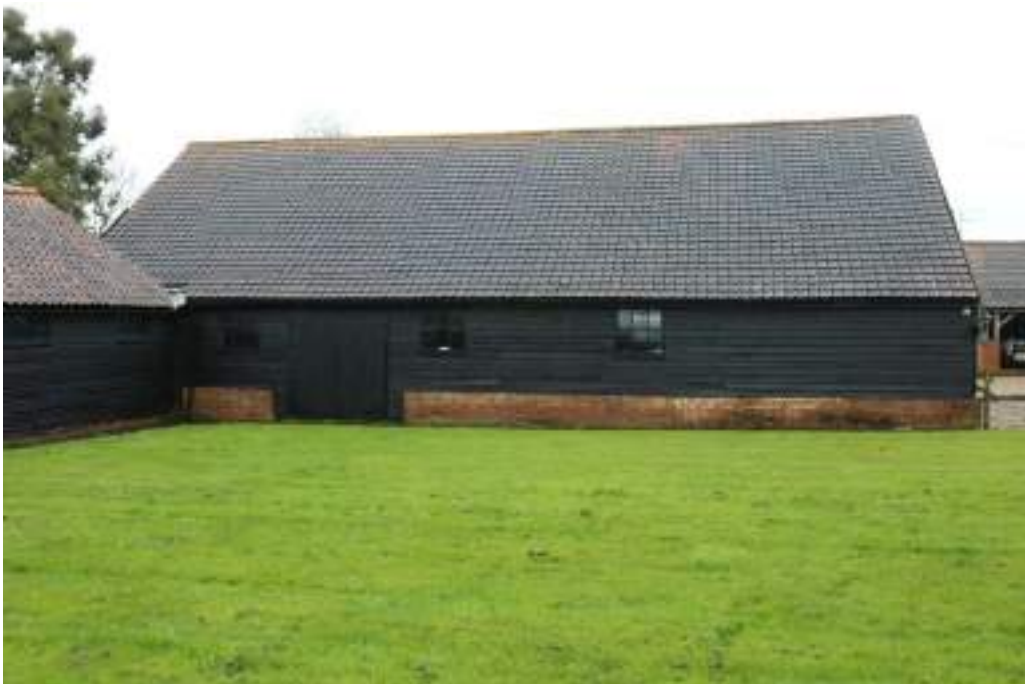
The western elevation of the cowshed has a pair of vertically-planked timber barn doors set on the northern end, flanked by two metal-framed six-light windows. A third metal-framed six-light window is located halfway towards the southern end of the elevation. The brick plinth breaks either side of the doorway with a small section of weatherboard bridging the gap. The western elevation of the small barn is featureless.

**Photograph 29** Western elevation of building 2. Photograph taken facing east.

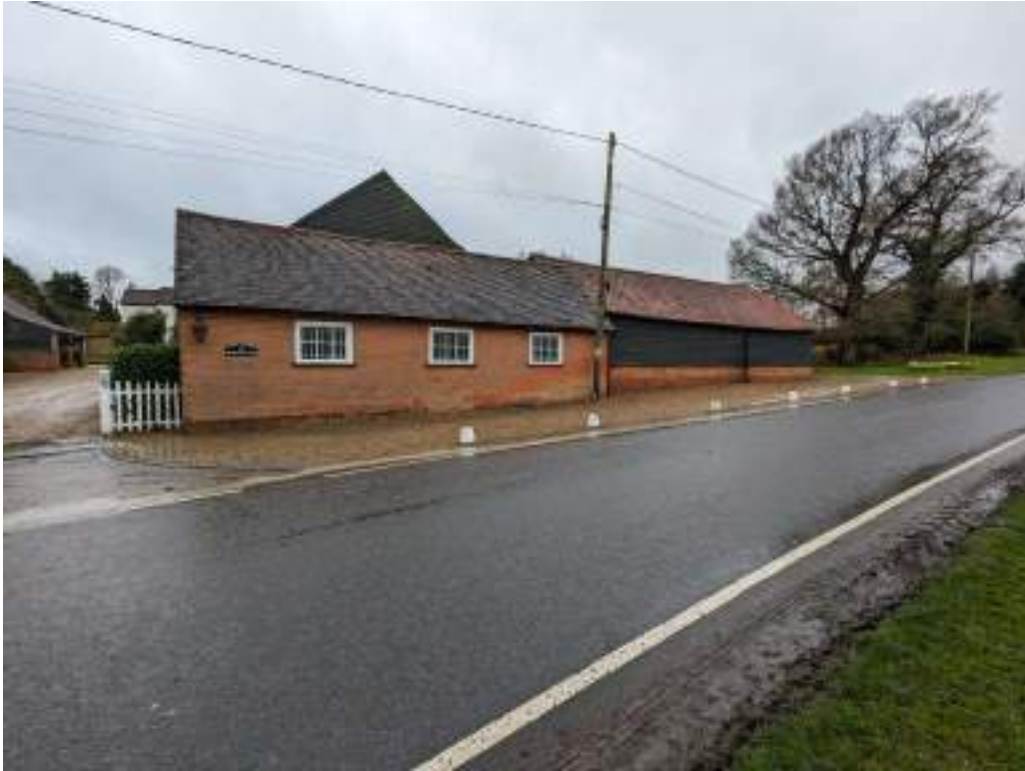
**Photograph 30** Northern elevation of building 2. Photograph taken facing south.

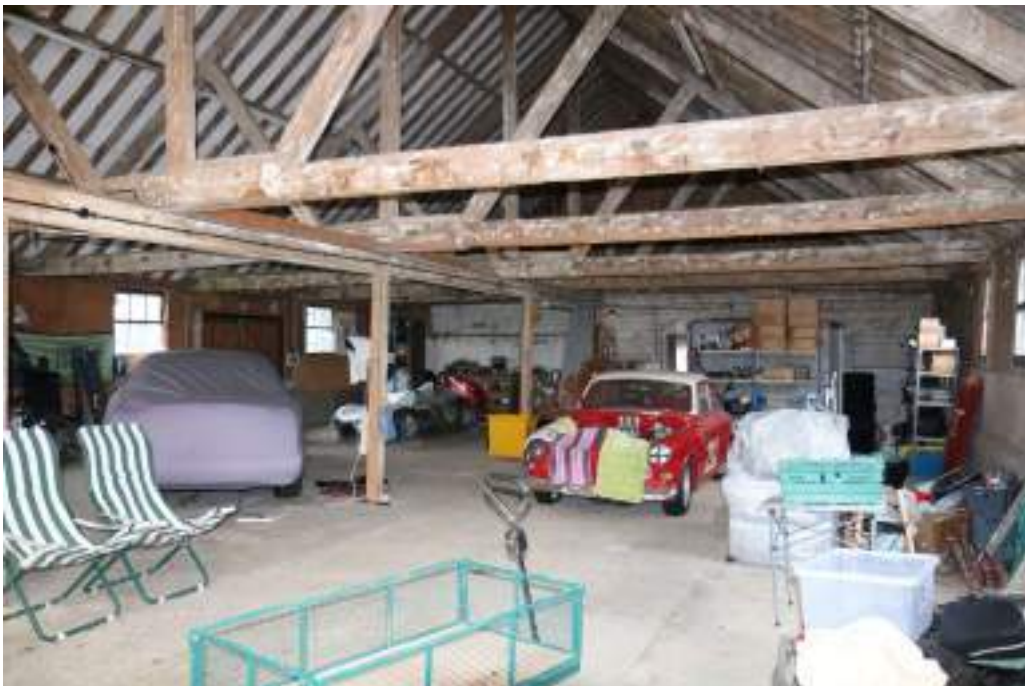
**Photograph 31** Interior of cowshed. Photograph taken facing north-west.

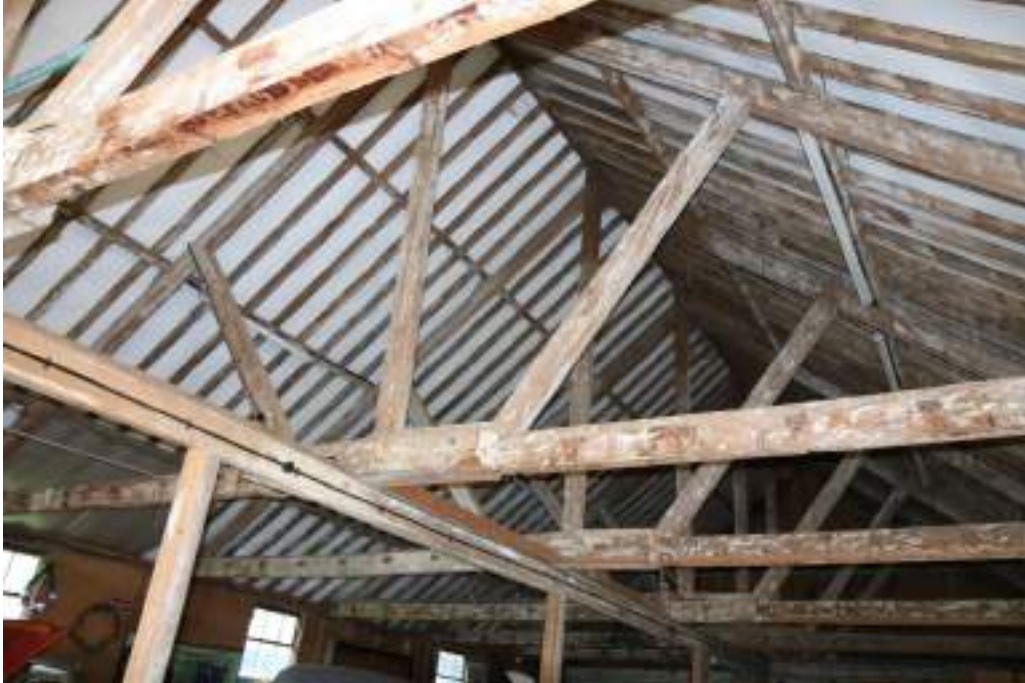
The roof of the building is gabled and comprises pairs of rafters rising from the wall plates meeting at a ridge-board. Each tie-beam has a pair of corresponding principal rafters. Three purlins are present on each roof pitch which are supported by cleats on the principal rafters. A diagonal wind-brace is present on both roof pitches across bays

1 and 2 as well as bays 6 and 7. A timber king-post and two inclined struts project from each tie-beam. Each tie-beam is formed from two lengths of timber joined in the centre with a timber fish plate, all of which have iron straps (however, no pattern to which side they are applied to). A supporting joist runs the length of bays 1-6 under the centre of the tie-beams, supported by central posts (unless otherwise stated). All timber in the cowshed is machine cut.

**Photograph 32** Detail of cowshed roof construction. Photograph taken facing north-west.

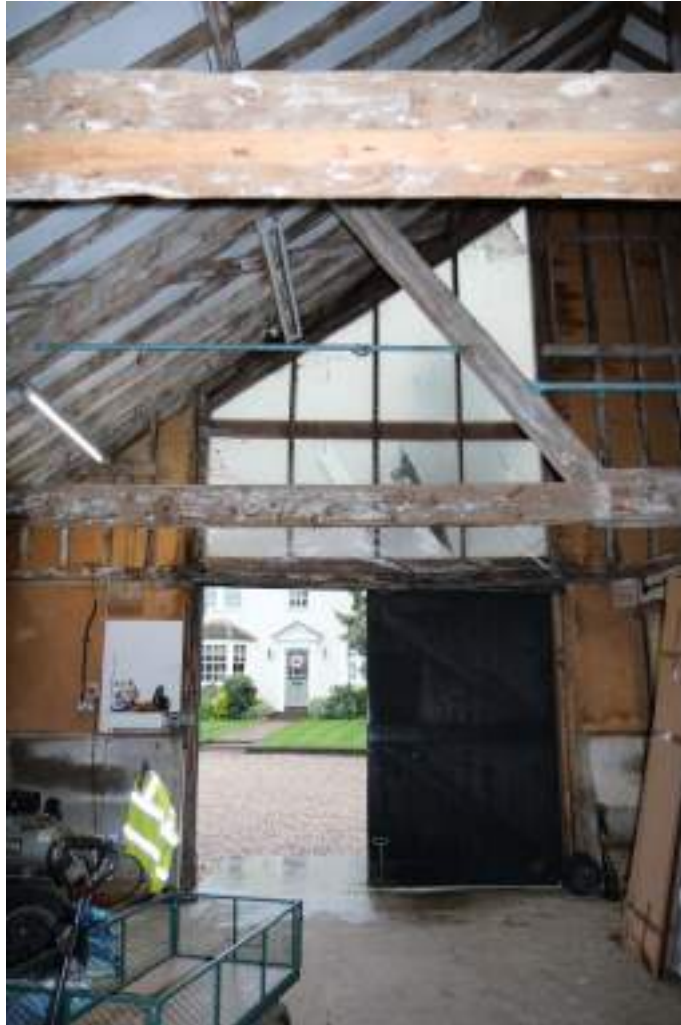
In the southern wall of bay 1 is a set of double doors above which is a set of fixed windows. Empty mortices above the doorway indicate the wall-plate is reused. The metal-framed window in the eastern wall is also inserted. There are three side-halved scarf-joints in the wall-plate, one above the inserted window in the eastern wall, another above the doorway and the third in the south-western side of the southern wall-plate.

**Photograph 33** Detail of doors and windows in bay 1 of cowshed. Photograph taken facing south.

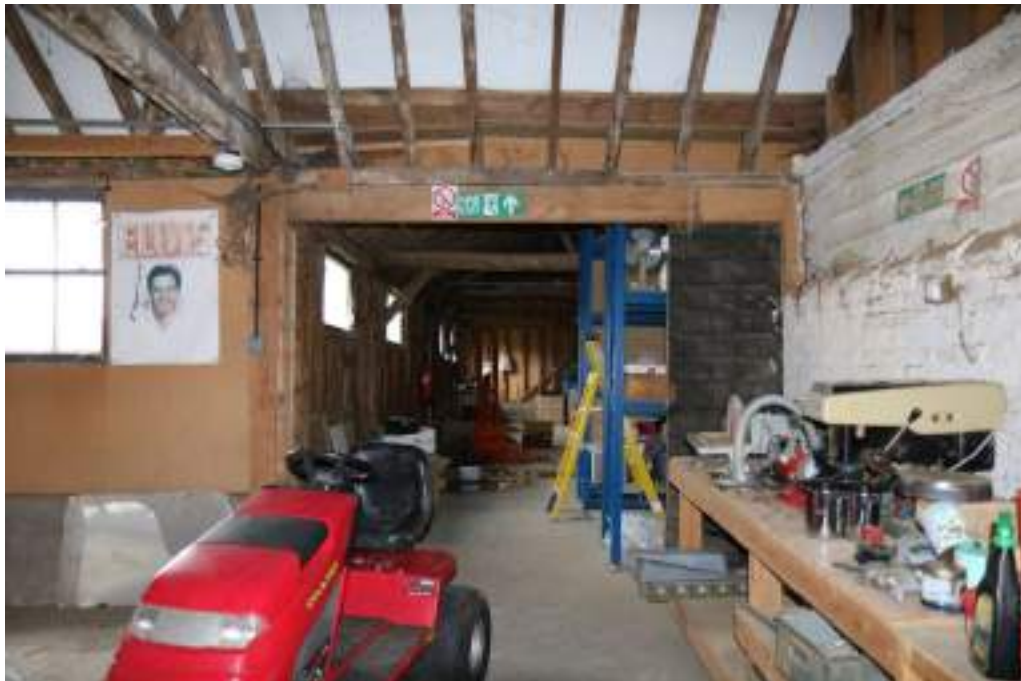
Bay 7 has been partitioned with timber walls along the centre of the bay and between it and bay 6. An open doorway between the cowshed and the small barn has been inserted in the western wall. Additionally, the northern wall plinth is roughly double the size of the other 3 walls.

**Photograph 35** Detail of opening between cowshed and small barn. Photograph taken facing west.
