**CAT Report 2052  
Issued May 2024**

**Historic building recording at Wells Farm, Ivy Barn  
Lane, Margarett, Essex, CM4 0PU**

**NGR: TL 64802 02431**

**Planning district.: Chelmsford  
Planning ref.: 23/01372/FUL**

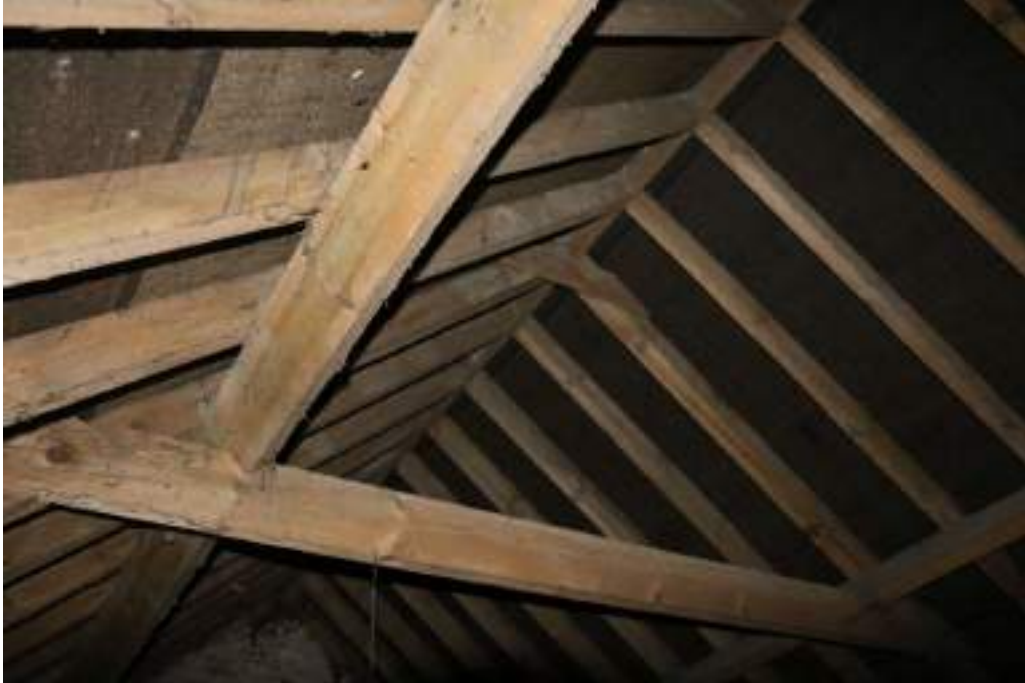
The roof is constructed from machine cut timber and consists of pairs of rafters rising to meet at a ridge-board, supported by a single clasped purlin on each roof pitch. The purlins are clasped by a series of collars. Upper collars are present alternating between the collars below. The tie-beams themselves are independent of the collars, except one which supports the collar above with inclined struts. This is a modern replacement. A suspended ceiling partially obscures the roof construction.

**Photograph 36** Detail of roof construction of brick building. Photograph taken facing north-west.

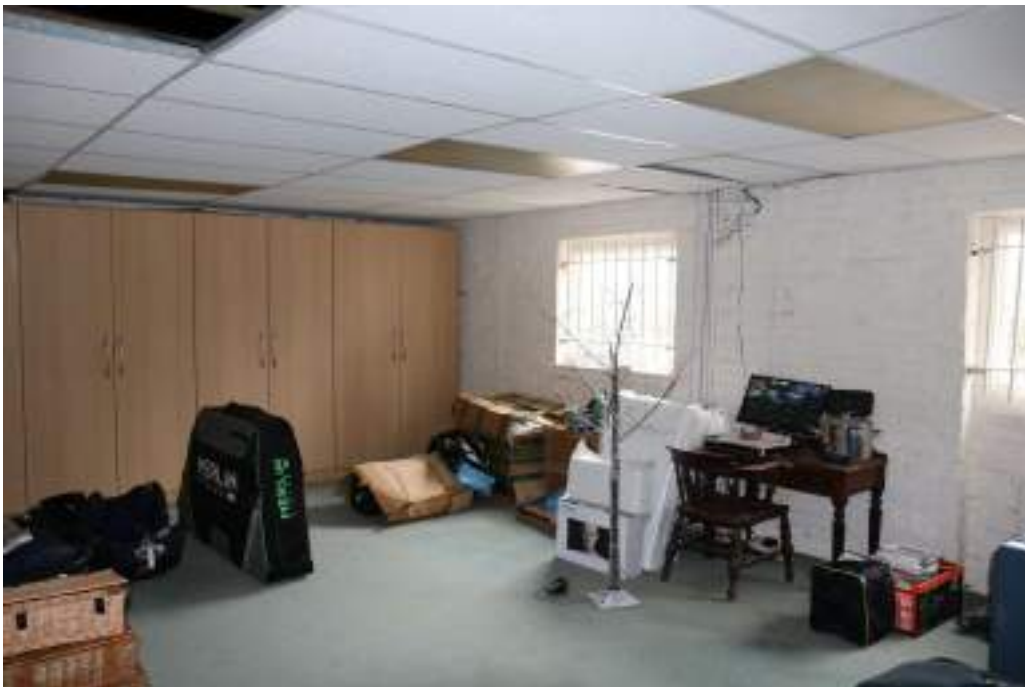
Room 1 has two timber-framed windows set into the northern wall, both covered by iron rails. A doorway is present between the brick building and the cowshed and another between room 1 and 2.

**Photograph 37** Interior of room 1 of brick building. Photograph taken facing north-west.

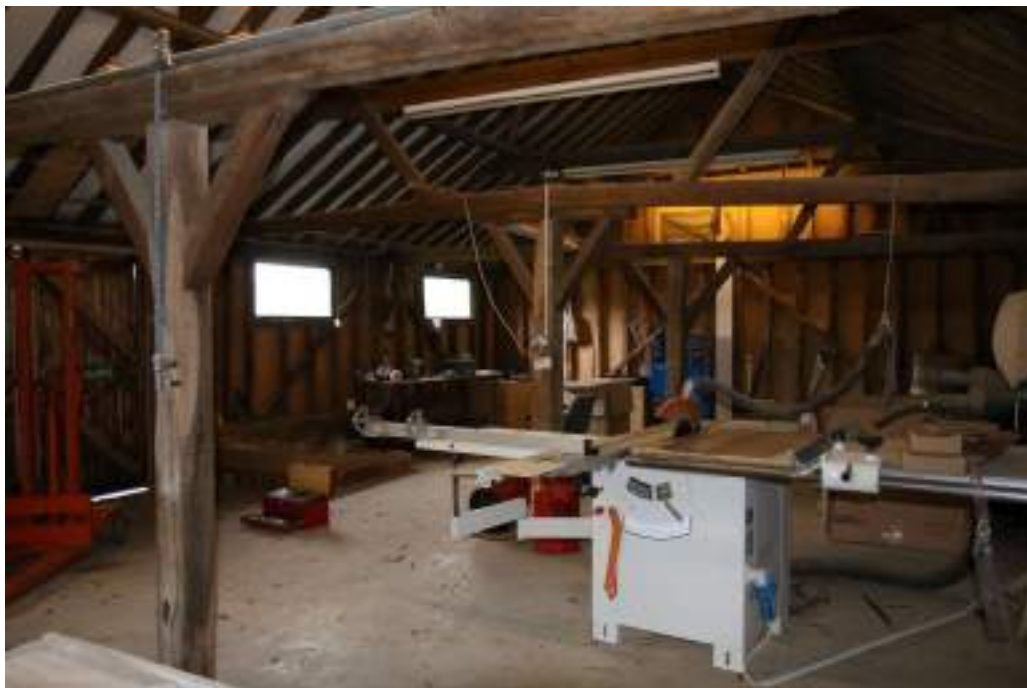
The roof has diagonal wind-bracing above and below the purlin on the northern pitch of Bays 1, 2, 3 and 5 and the southern pitch of Bay 5 but only the upper section of the southern pitch in Bay 2. All walls have diagonal through-bracing, except the southern wall of Bay 3.

**Photograph 38** Interior of barn. Photograph take facing south-west.

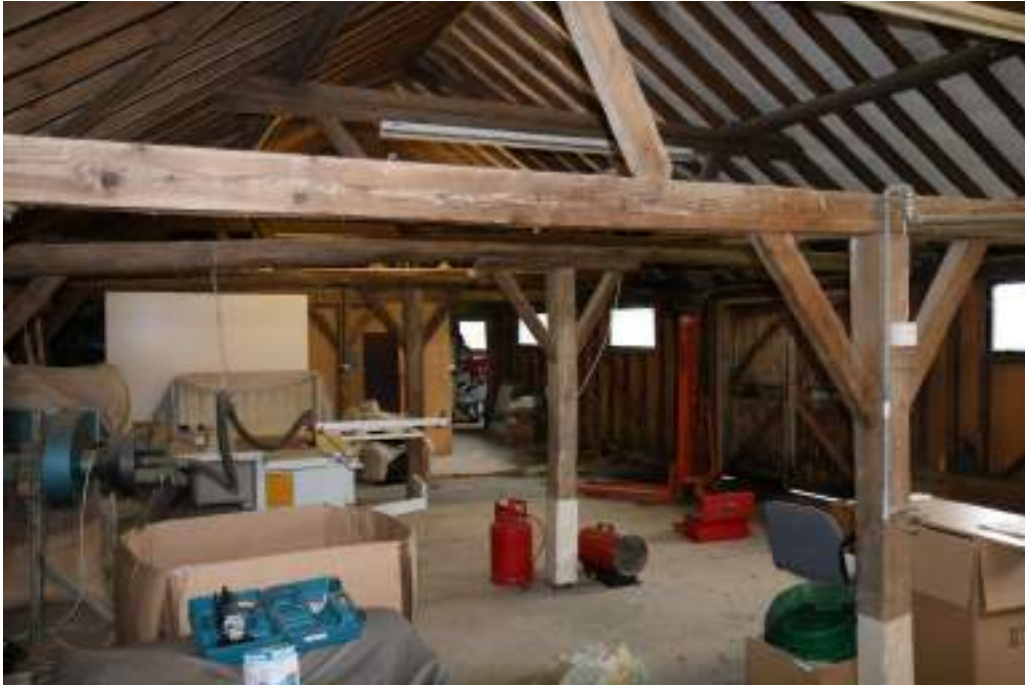
**Photograph 39** Interior of small barn. Photograph taken facing south-east.

The timbers in the frame are a mixture of hand-sawn and machine-cut while the roof is wholly machine-cut timbers. The brick plinth is not visible in the eastern wall or the southern wall in bays 4 and 5, suggesting that the small barn may have been partially rebuilt or raised at some point.

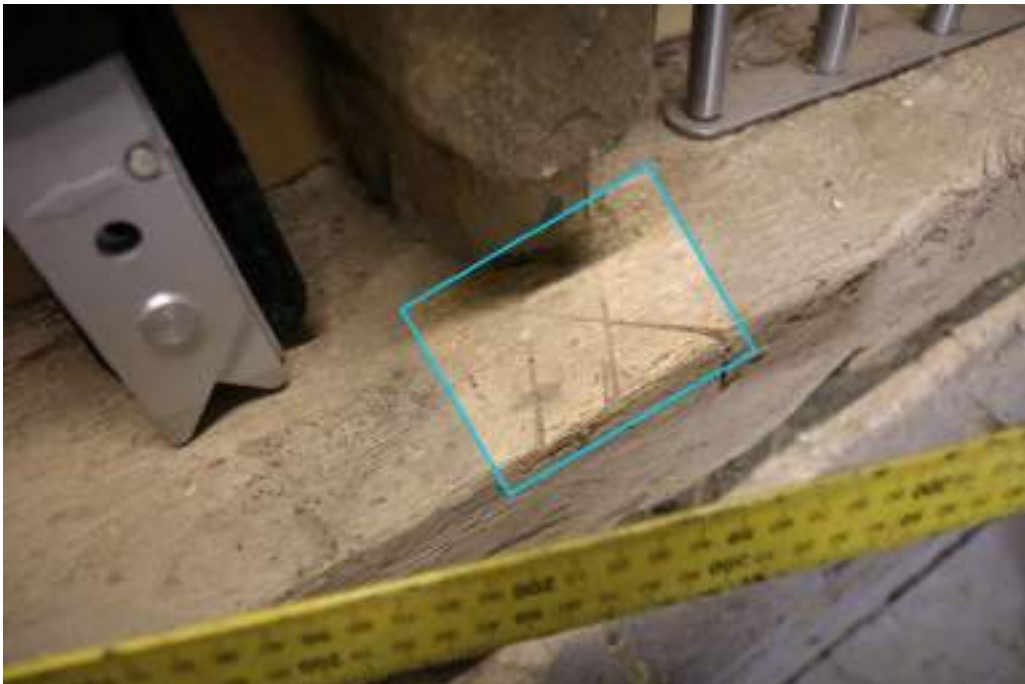
intermediate post (out of sequence so probably evidence of reuse) and the sill-beam has a cubic volume mark as well as a side-halved scarf-joint.

**Photograph 42** Detail of cubic volume mark on sill-beam in small barn. Photograph taken facing north-west.

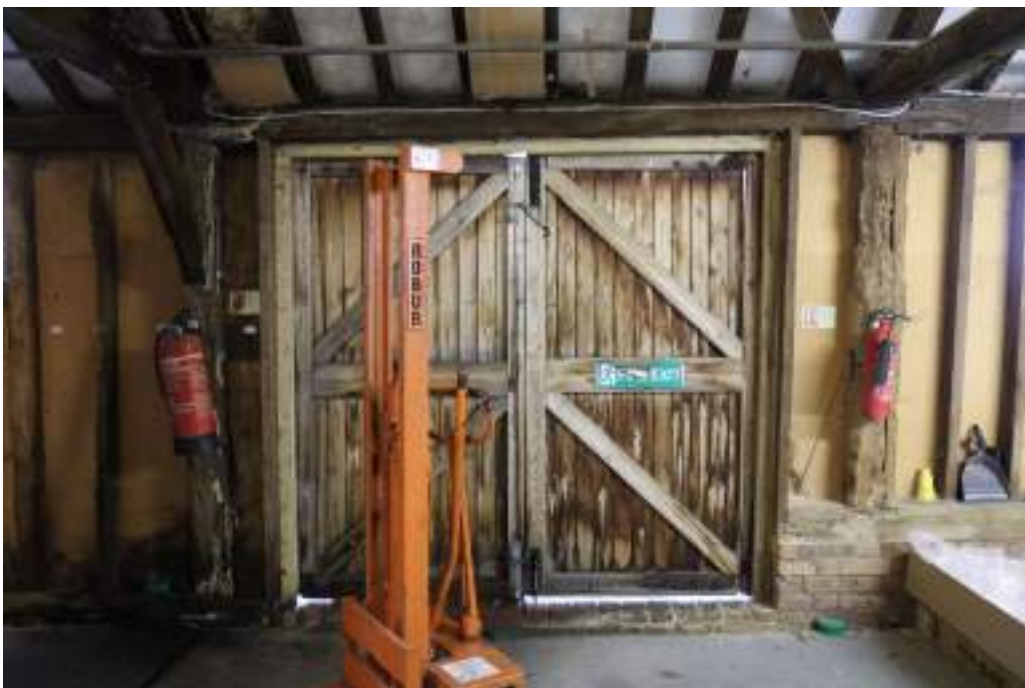
In bay 3, an iron strap covers a presumed scarf-joint on the wall-plate, above the intermediate post between bays 2 and 3 in the northern wall. There is a horizontal brace from the intermediate post to the second stud, it is similar in form to the additional bracing between the centre posts and tie-beams between bays 3-4 and 4-5. The doorway in the southern wall is inserted, as evidenced by the empty mortices in the wall-plate above.

**Photograph 44** Detail of doors in bay 3 of small barn, also showing the differing plinth heights either side. Photograph taken facing south.

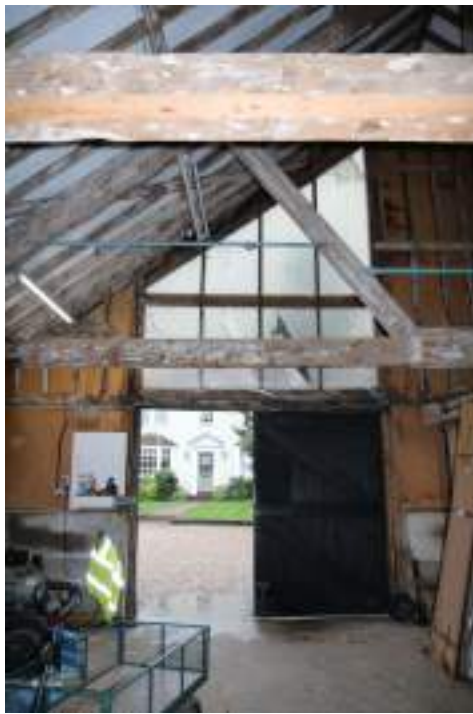
MGWF24\_PhotoGraph\_005

Interior detail shot of door and window in cowshed, bay 1. Photograph taken facing south.

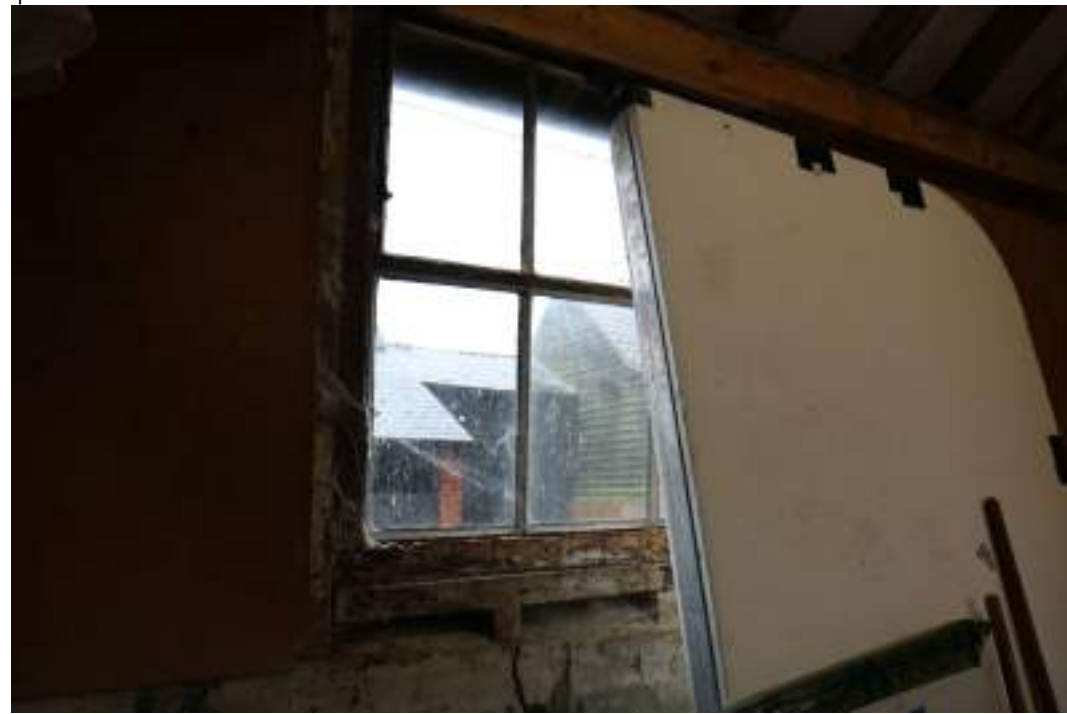
MGWF24\_PhotoGraph\_006

Interior detail shot of metal framed window in cowshed, bay 1. Photograph taken facing east.

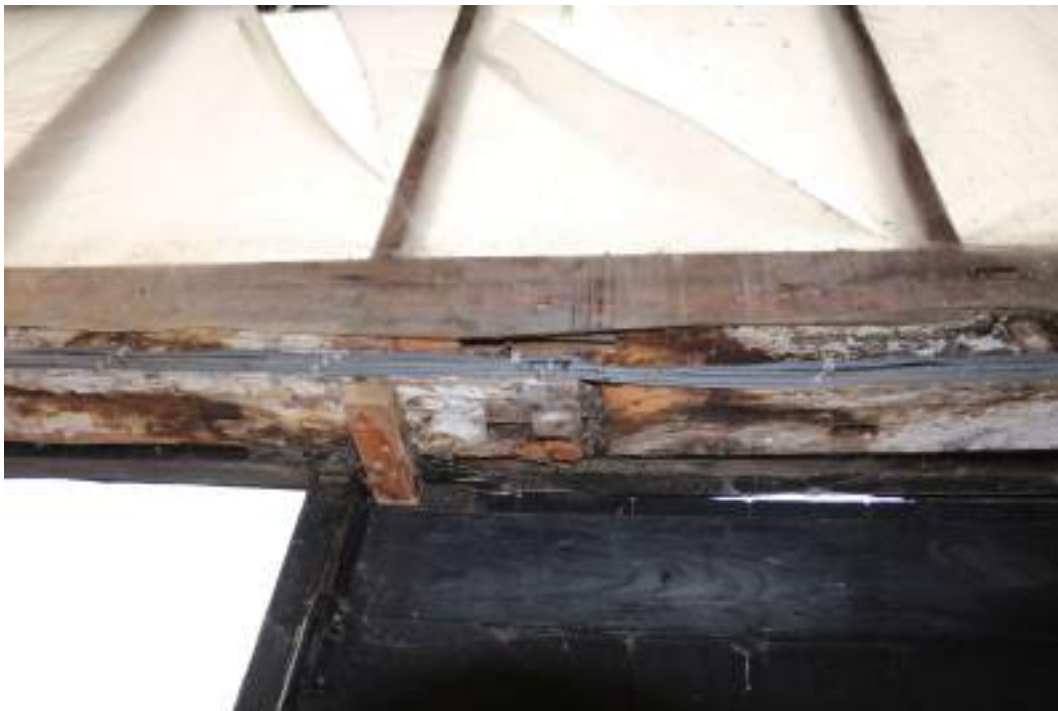
MGWF24\_PhotoGraph\_007

Interior detail shot of side-halved scarf-joint in cowshed, bay 1. Photograph taken facing south.

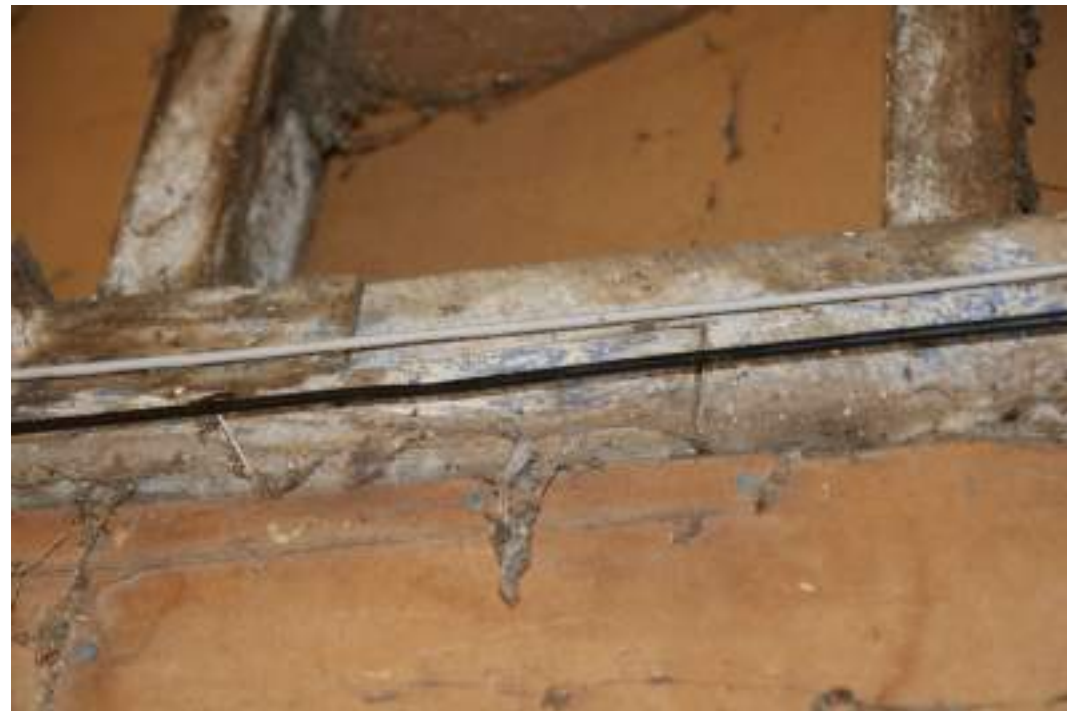
MGWF24\_PhotoGraph\_008

Interior detail shot of side-halved scarf-joint in cowshed, bay 1. Photograph taken facing south.

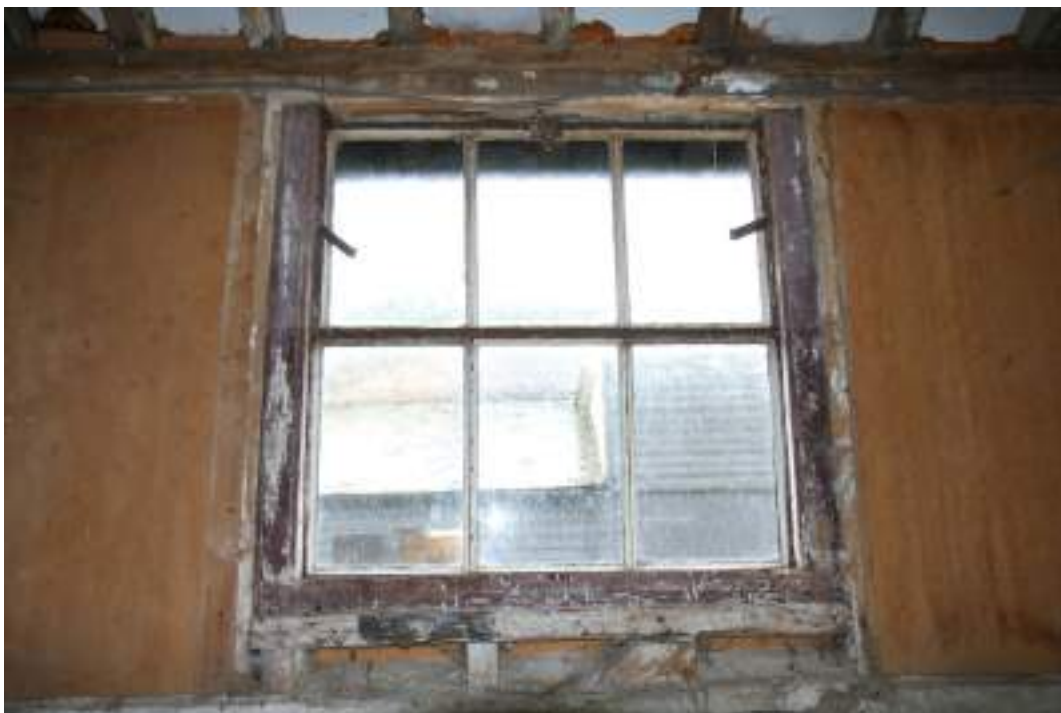
MGWF24\_PhotoGraph\_011  
Interior detail shot of inserted metal framed window in cowshed, bay 3. Photograph taken facing east.

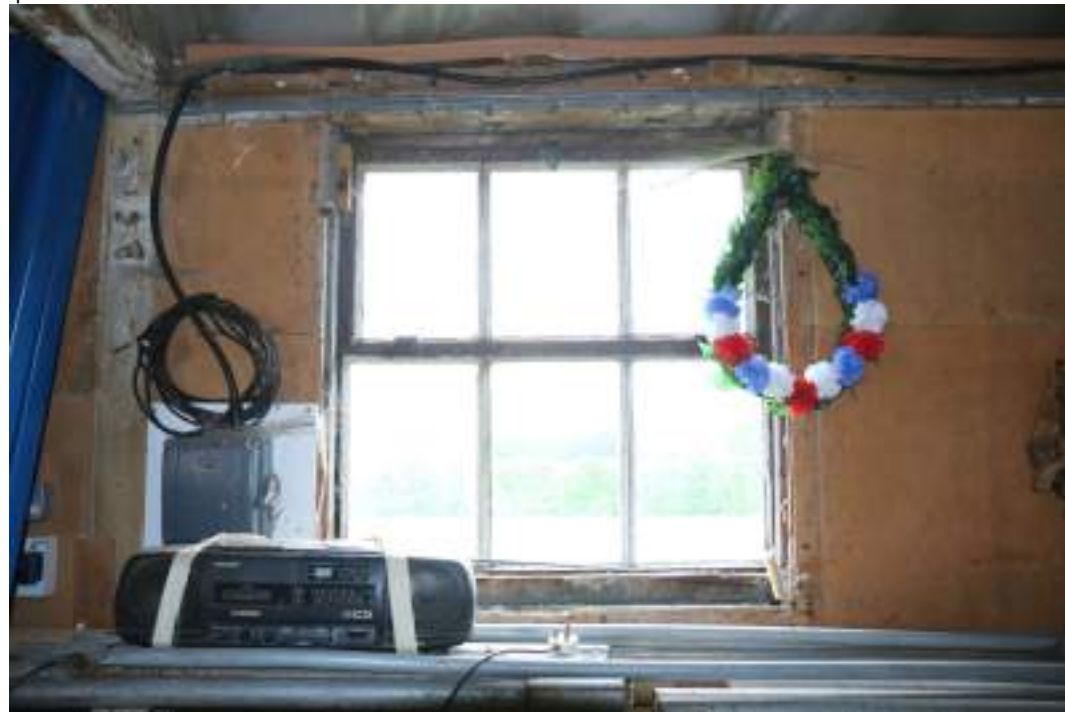
MGWF24\_PhotoGraph\_014  
Interior detail shot of inserted metal framed window in cowshed, bay 3. Photograph taken facing west.

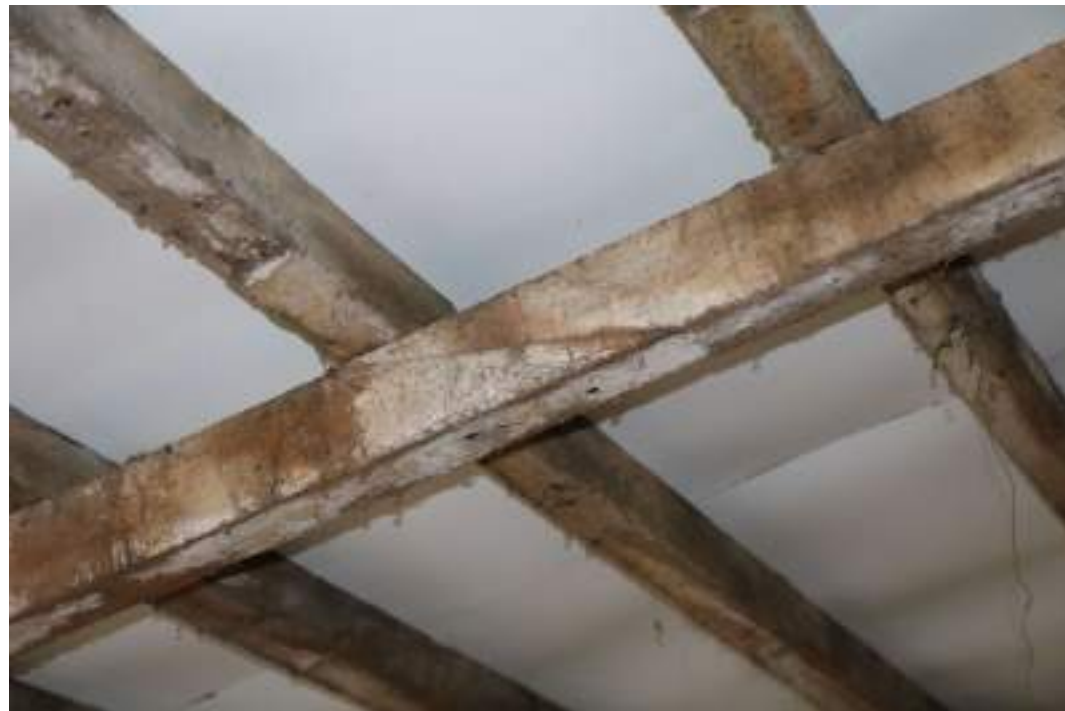
MGWF24\_PhotoGraph\_016  
Interior detail shot of splayed scarf-joint in lower purlin of cowshed, bay 4. Photograph taken facing south-west.

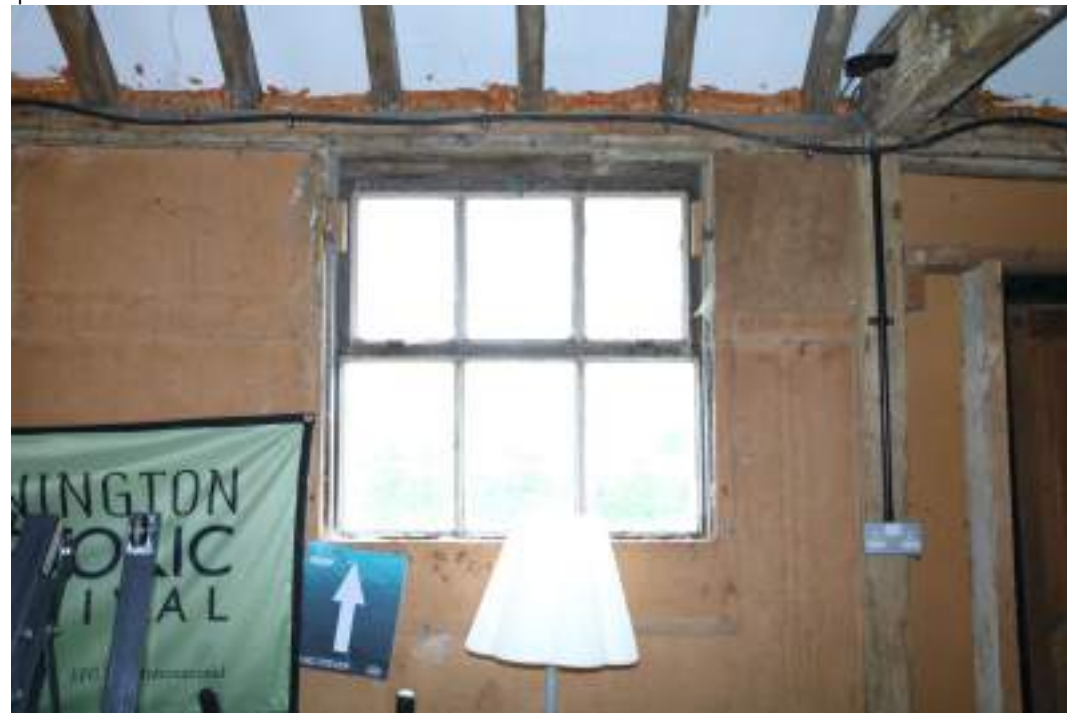
MGWF24\_PhotoGraph\_018  
Interior shot of inserted metal framed window in cowshed, bay 4. Photograph taken facing west.

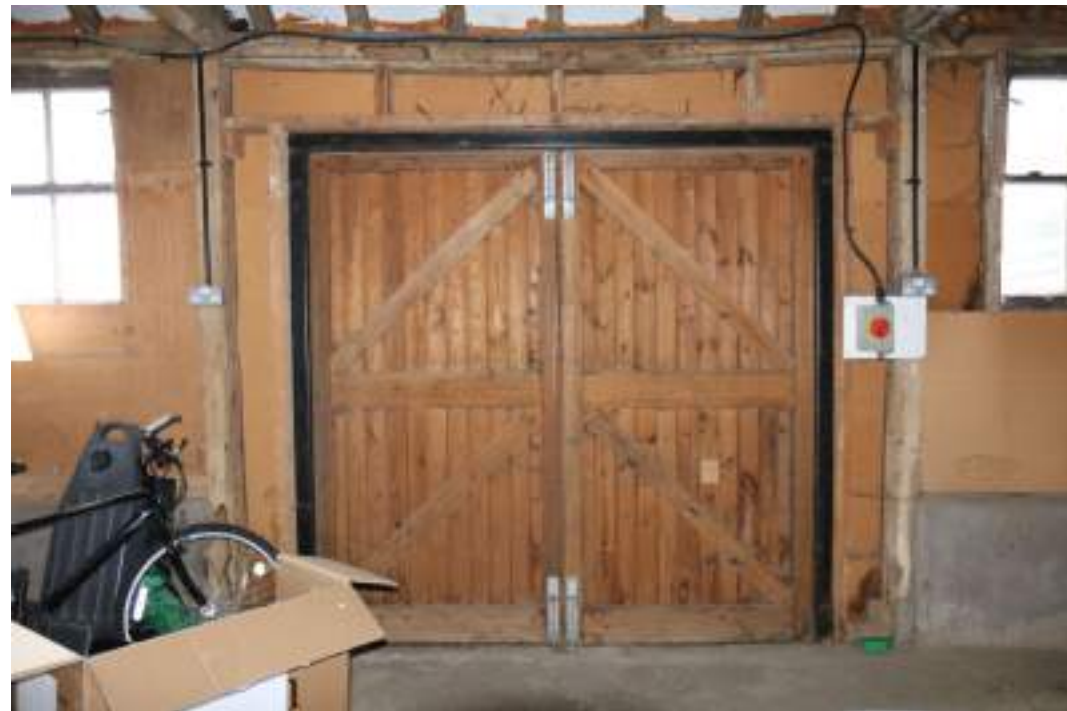
MGWF24\_PhotoGraph\_020  
Interior detail shot of replacement door in cowshed, bay 5. Photograph taken facing west.

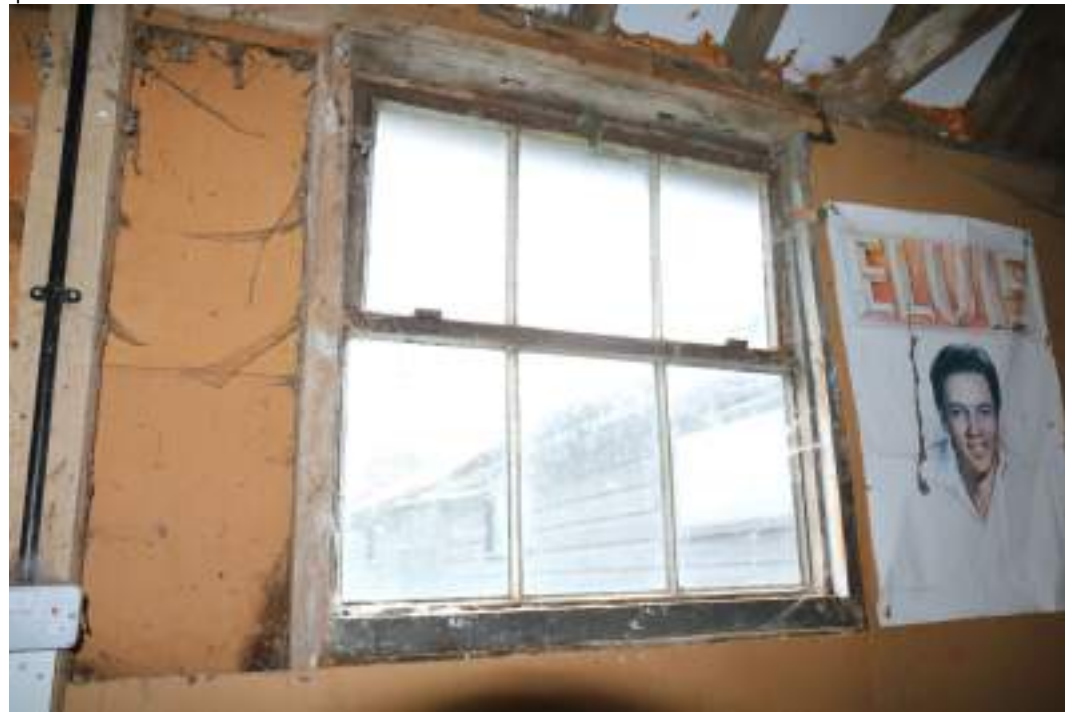
MGWF24\_PhotoGraph\_022  
Interior detail shot of inserted metal framed window in cowshed, bay 6. Photograph taken facing west.

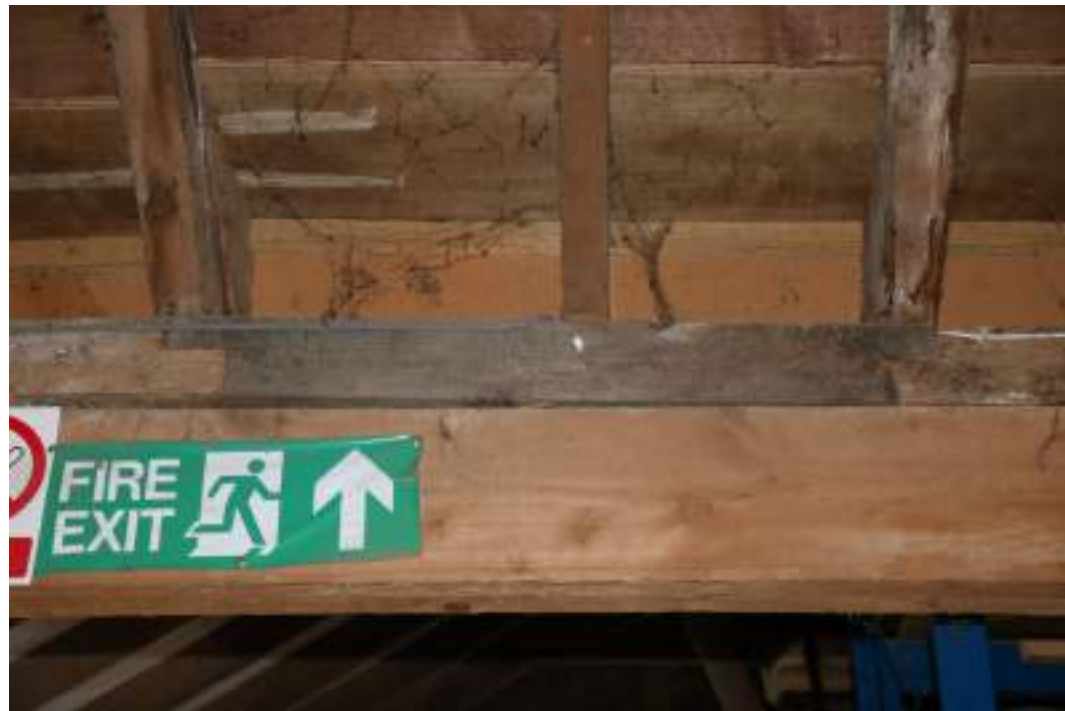
MGWF24\_PhotoGraph\_024  
Interior detail shot of replacement timber and scarf-joints of wall-plate in cowshed, bay 7. Photograph taken facing west.

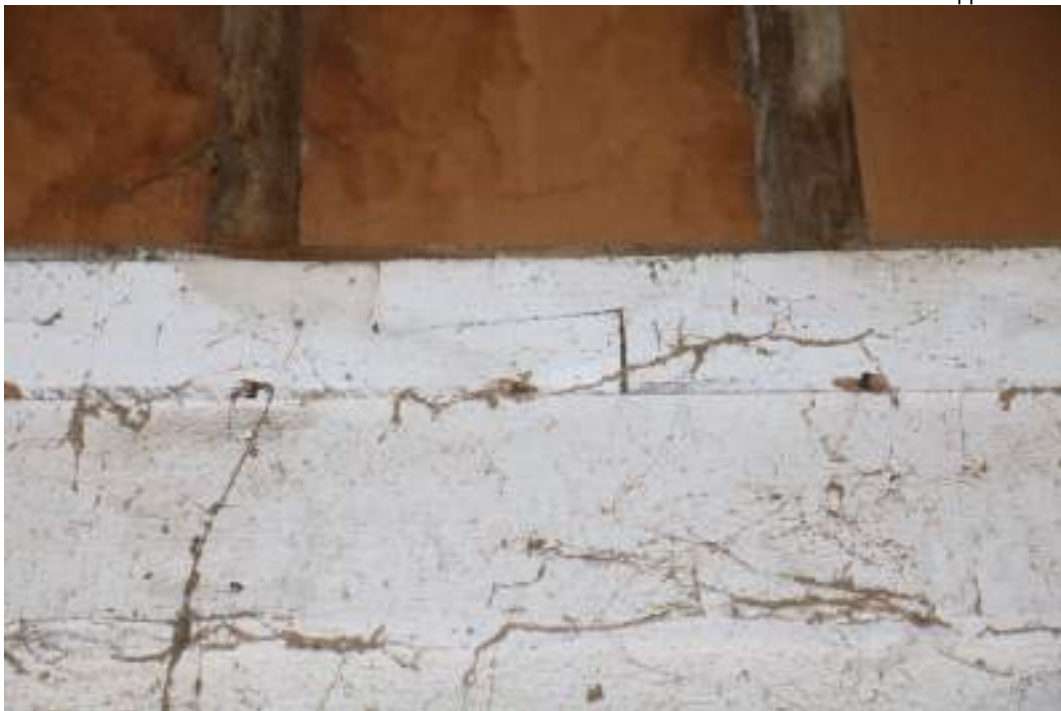
MGWF24\_PhotoGraph\_025

Interior detail shot of scarf-joint in wall-plate of cowshed, bay 7. Photograph taken facing north.

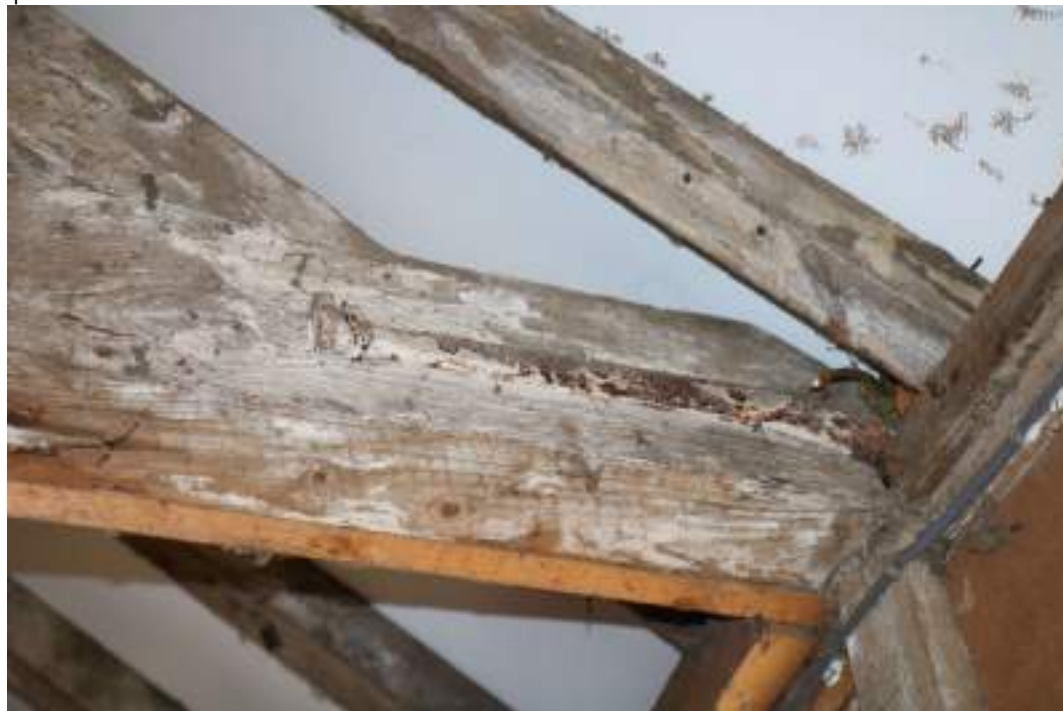
MGWF24\_PhotoGraph\_026

Interior detail shot of iron strap on tie-beam in cowshed. Photograph taken facing north.

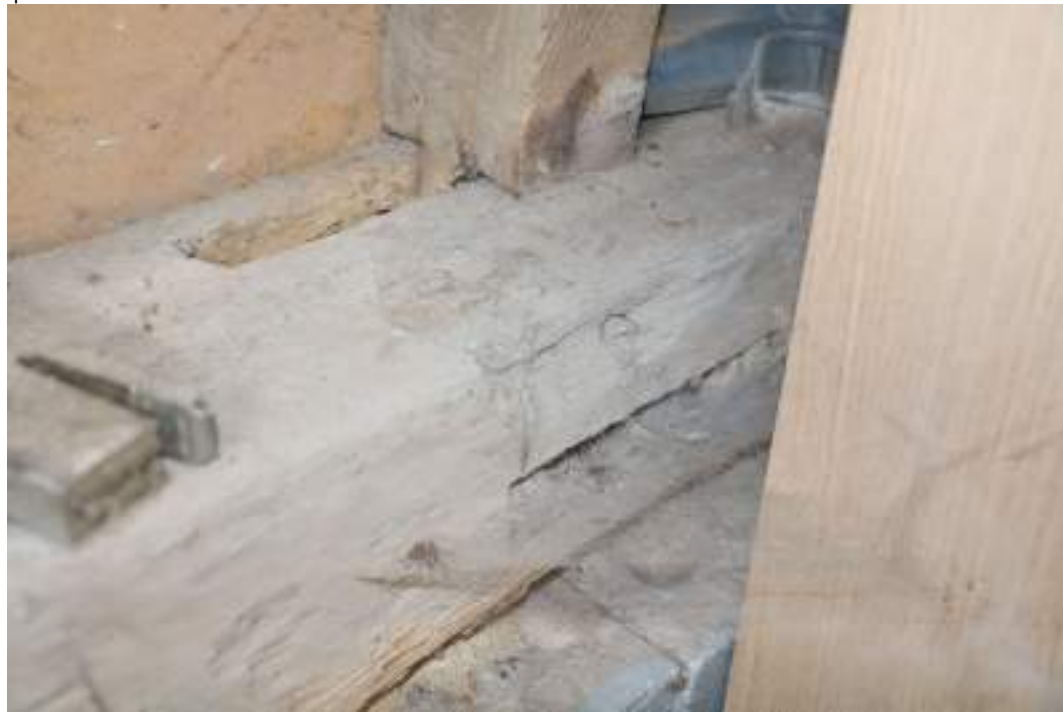
MGWF24\_PhotoGraph\_041

In bay 1, the timber-framed window in the southern wall is a replacement. There is an iron strap on the wall-plate in the south-western corner of the bay. In the western wall, eight of the upper studs, the northern wind-brace, the wall-plate and the sill-beam are all reused timbers (all hand-sawn). Also in the western wall, there is a Baltic timber mark on the intermediate post, a "XII" carpenter's mark on the second stud north of the

Interior detail shot of iron strap in small barn, bay 1. Photograph taken facing south-west.

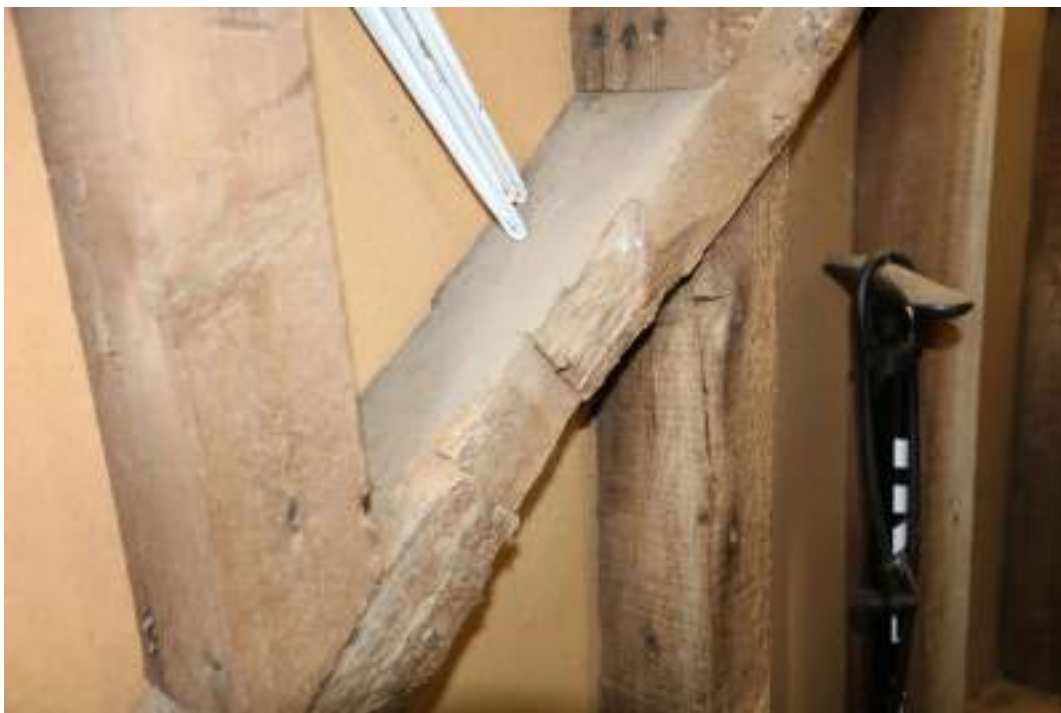
MGWF24\_PhotoGraph\_042

Interior detail shot of reused timber sill-beam in small barn, bay 1. Photograph taken facing north-west.

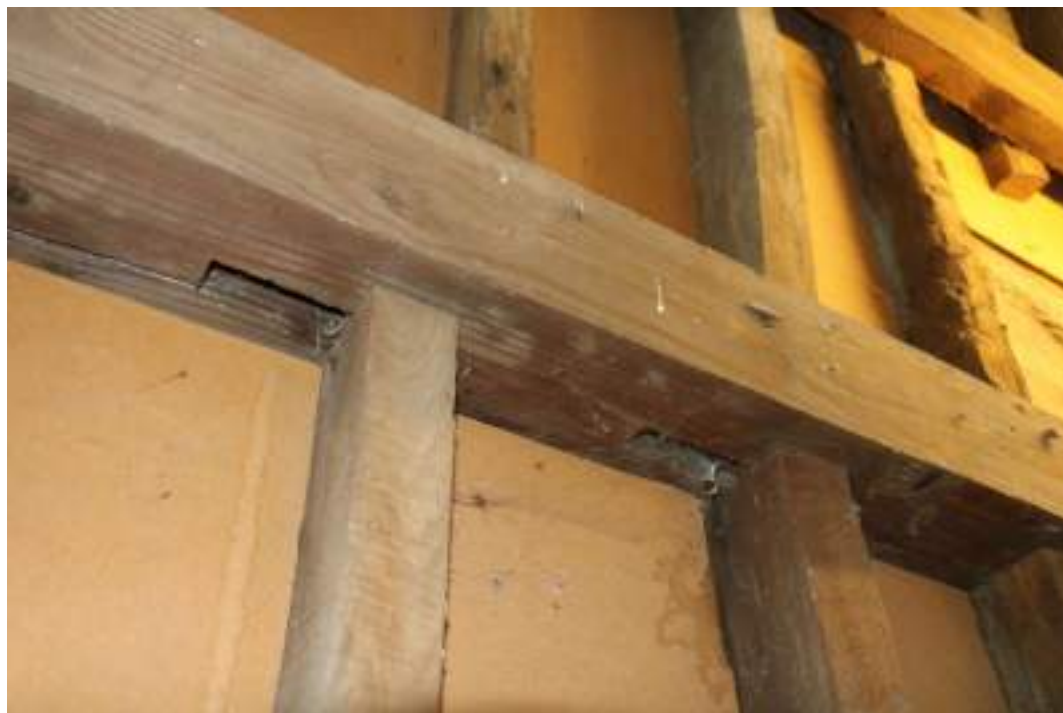
MGWF24\_PhotoGraph\_043

Interior detail shot of reused timber wind-brace in small barn, bay 1. Photograph taken facing north-west.

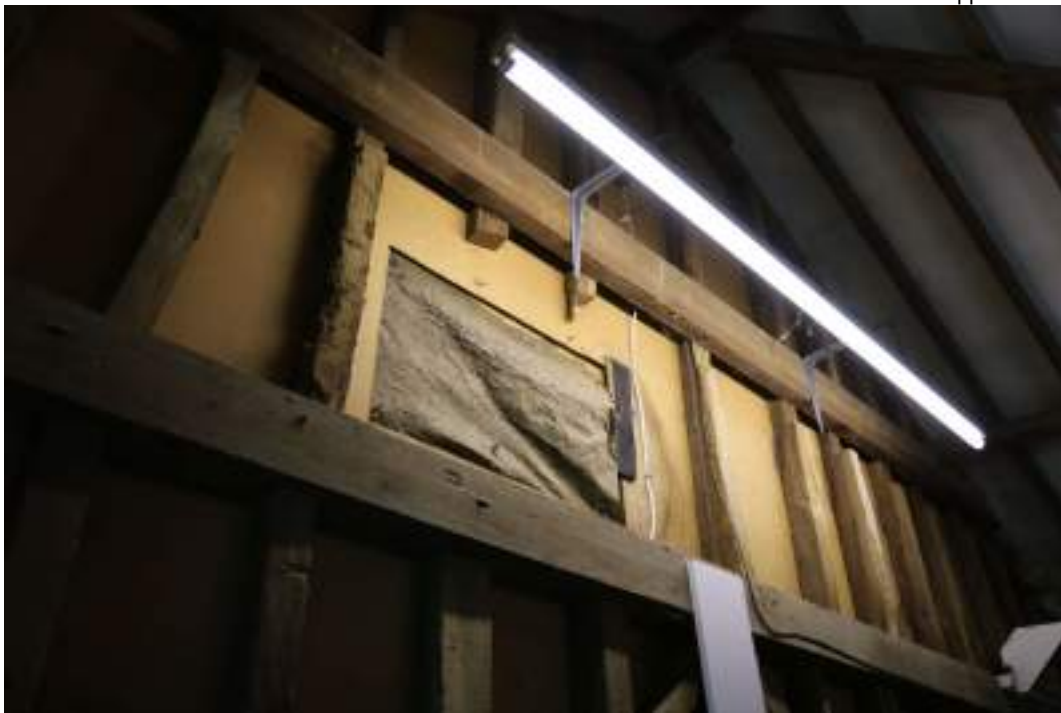
MGWF24\_PhotoGraph\_044

Interior detail shot of reused timber tie-beam in small barn, bay 1. Photograph taken facing north-west.

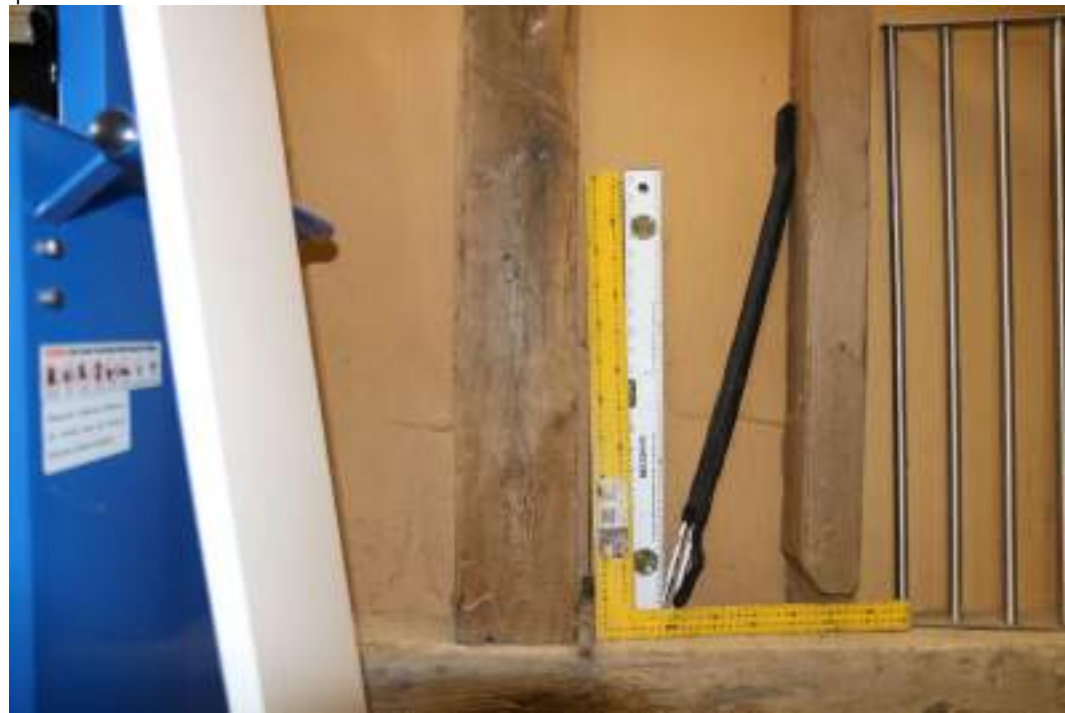
MGWF24\_PhotoGraph\_045

Interior detail shot of reused timber studs in small barn, bay 1. Photograph taken facing north-west.

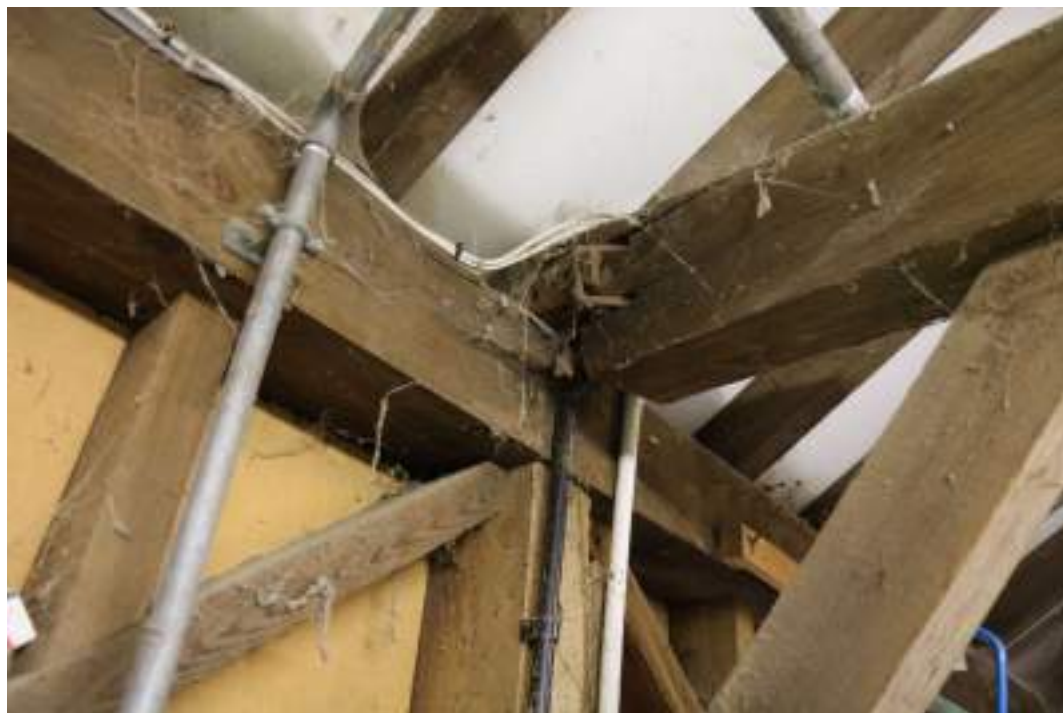
MGWF24\_PhotoGraph\_055

Interior detail shot of reused timber tie-beam between bays 2 and 3 of small barn. Photograph taken facing north-east.

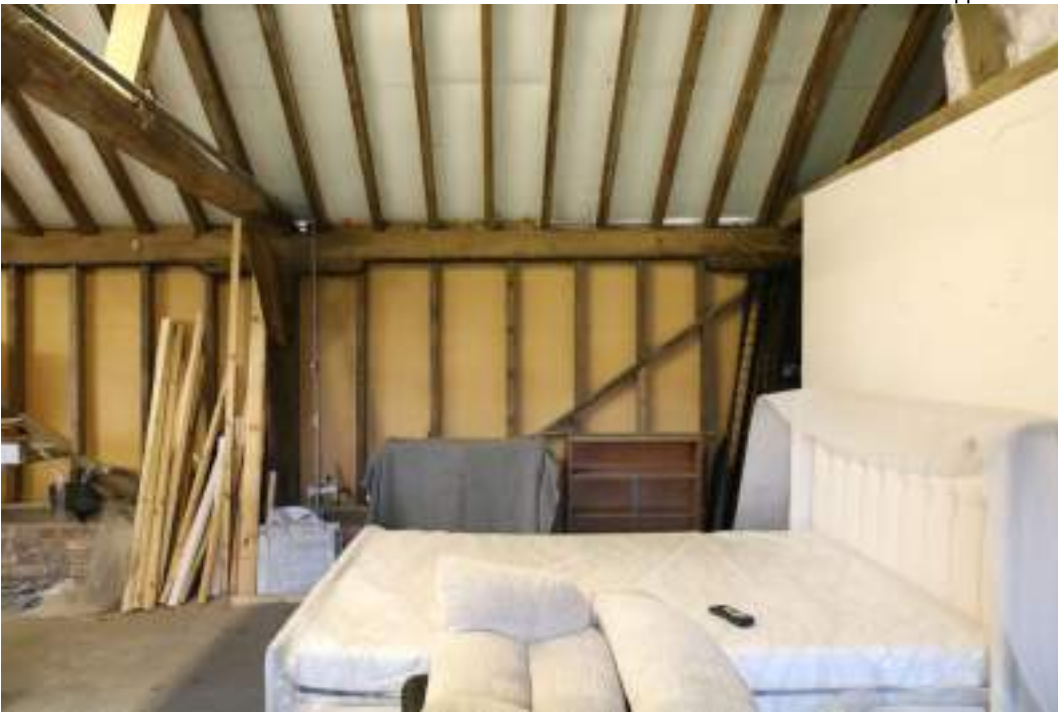
MGWF24\_PhotoGraph\_060

In bay 5, the south-eastern corner-post is a reused timber, as is the sill-beam and a number of studs in the eastern gable wall. The doorway between the small barn and the cowshed is inserted, evidenced by the empty mortices in the wall-plate. The wall-plate in the southern wall has a side-halved scarf-joint. The timber-framed window in the southern wall is a replacement.

Interior detail shot of empty mortices indicating inserted doorway in small barn, bay 3. Photograph taken facing south-east.

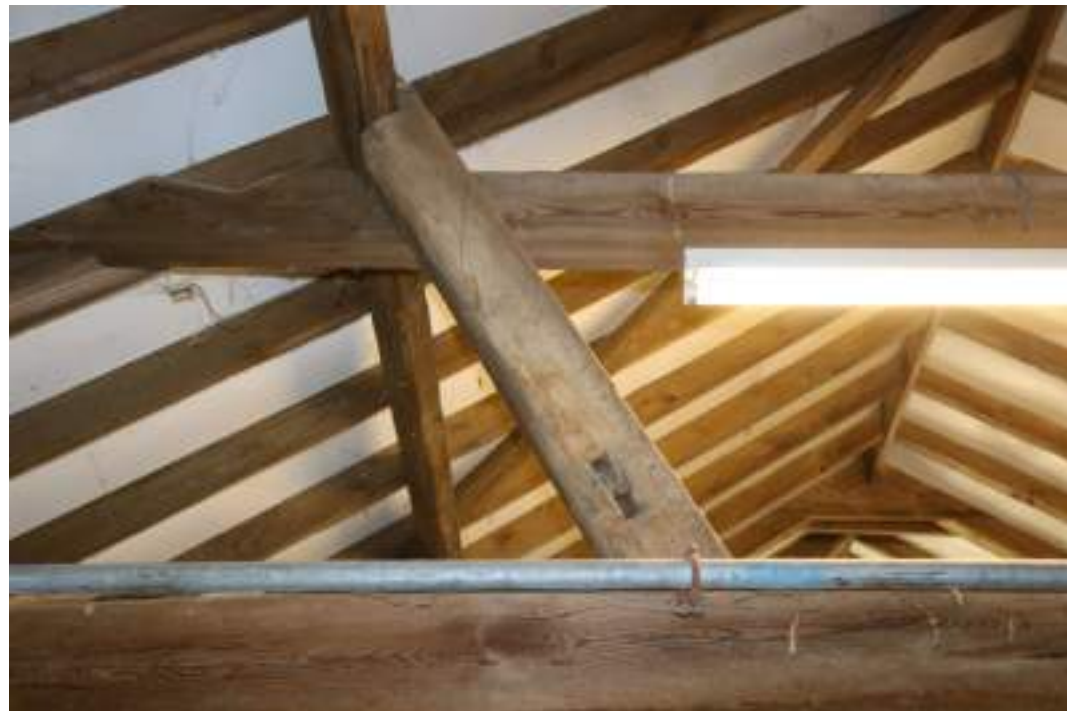
In bay 4, there is a side-halved scarf-joint, with squinted abutments, on the northern wall-plate under the tie-beam between bays 4 and 5. The southern intermediate post between bays 4 and 5 is a re-used timber, as is the southern inclined strut between those bays. The sill-beam also displays signs of reuse and has a replaced section beneath the intermediate post between bays 4 and 5, with a side-halved scarf-joint on its western side, with a simple scarf-joint on the eastern. The timber-framed window is a replacement.

MGWF24\_Phograph\_063  
Interior detail shot of reused timber intermediate post between bays 4 and 5, small barn. Photograph taken facing south-west.

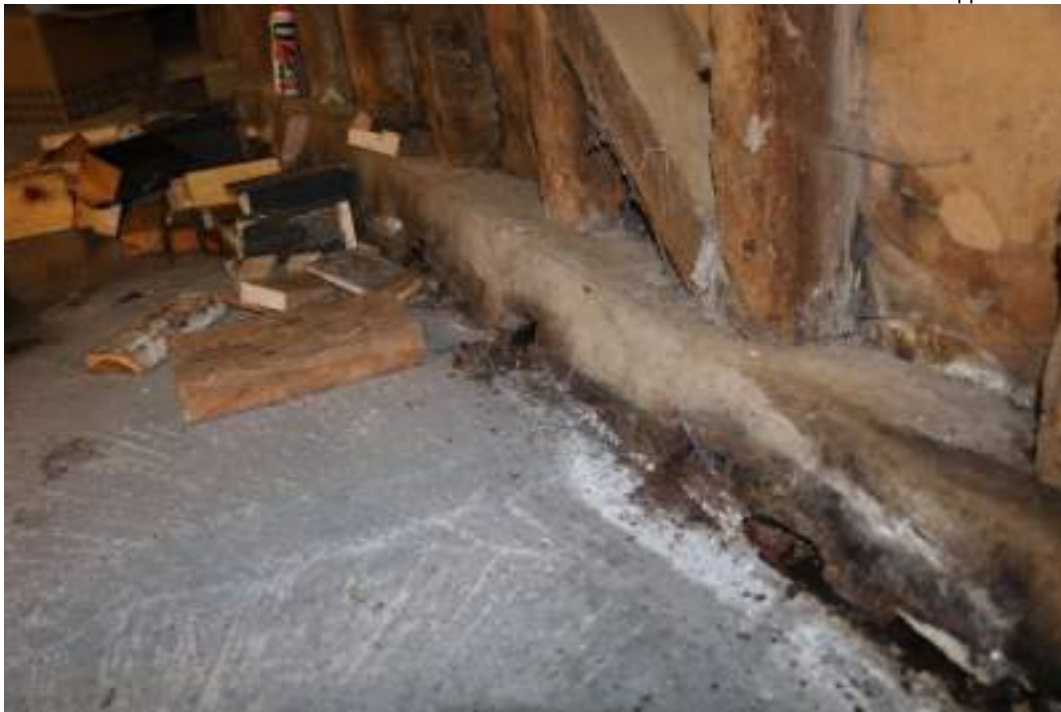
MGWF24\_Phograph\_064  
Interior detail shot of reused timber inclined strut between bays 3 and 4 in small barn. Photograph taken facing west.

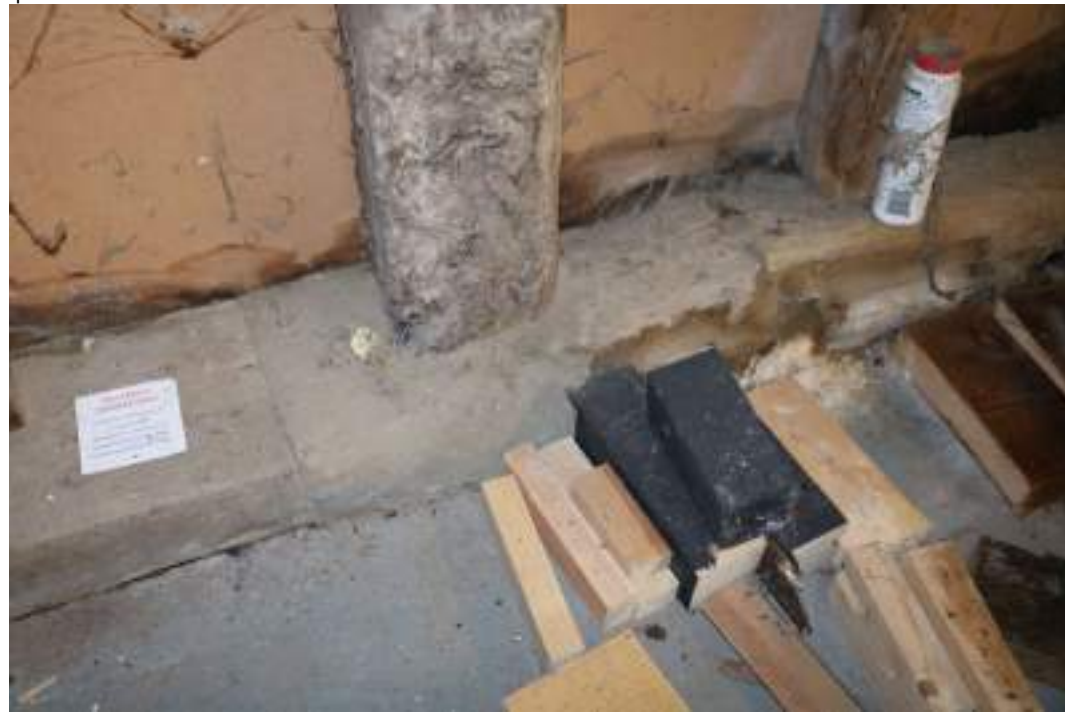
MGWF24\_PhotoGraph\_065

Interior detail shot of reused timber sill-beam in small barn, bay 4. Photograph taken facing south-east.
