**CAT Report 2052  
Issued May 2024**

**Historic building recording at Wells Farm, Ivy Barn  
Lane, Margarett, Essex, CM4 0PU**

**NGR: TL 64802 02431**

**Planning district.: Chelmsford  
Planning ref.: 23/01372/FUL**

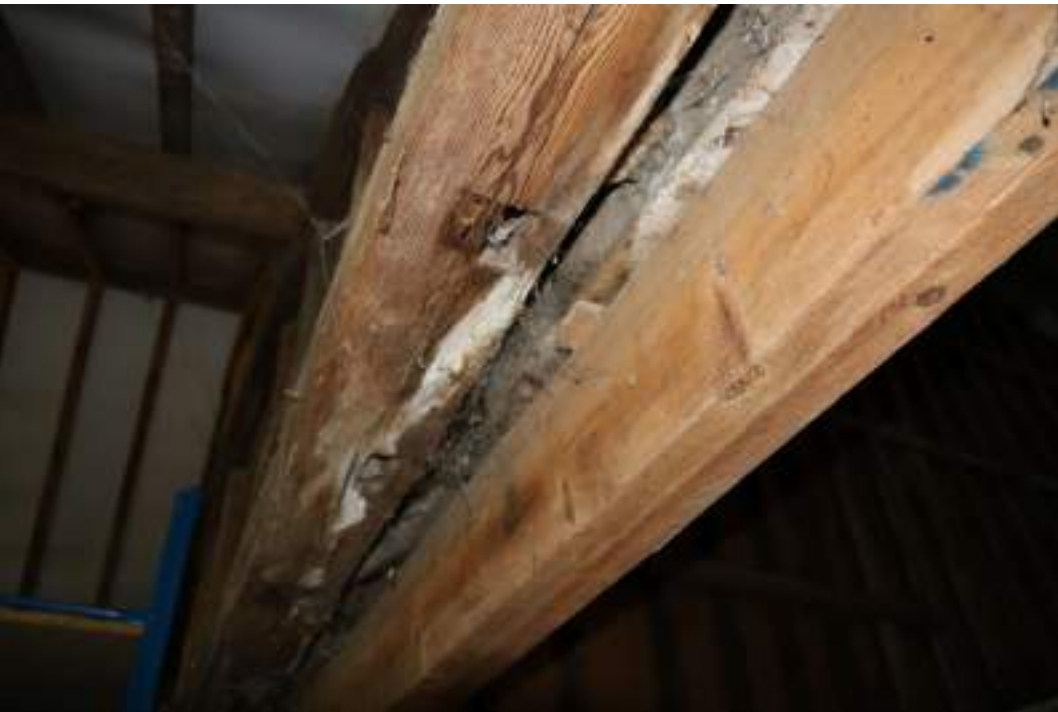
MGWF24\_PhotoGraph\_074

Interior detail shot of inserted entrance/removed wall between small barn and cowshed, Photograph taken facing east.

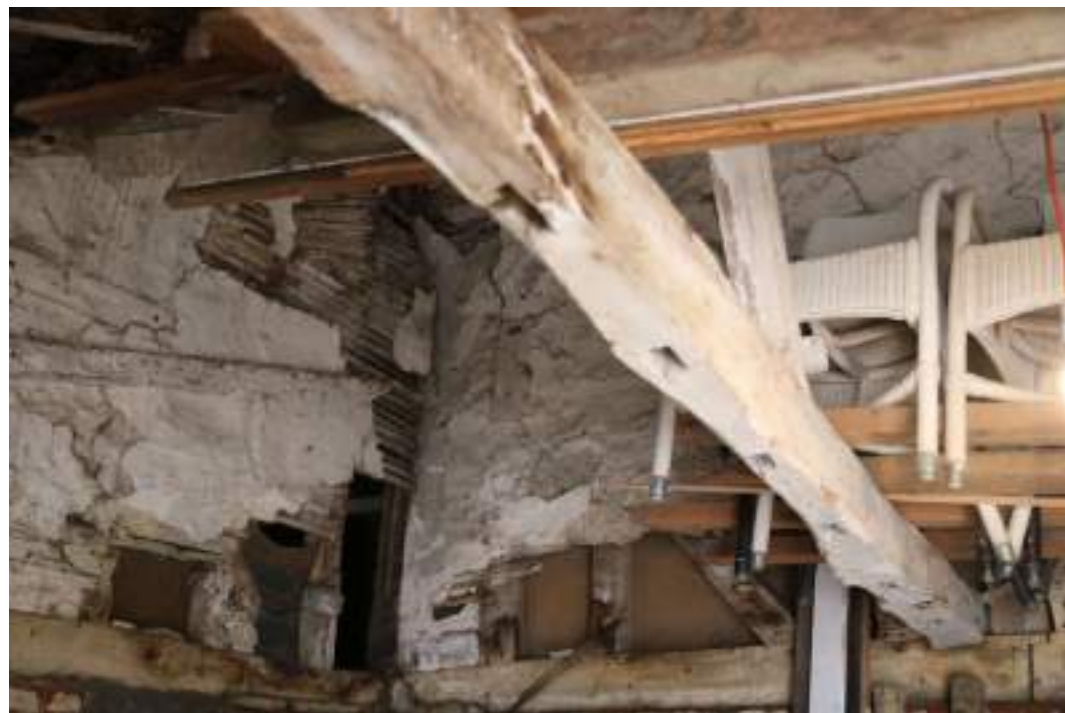
MGWF24\_PhotoGraph\_087

Interior detail shot of side-halved scarf-joint of sill-beam in lean-to 2. Photograph taken facing south.

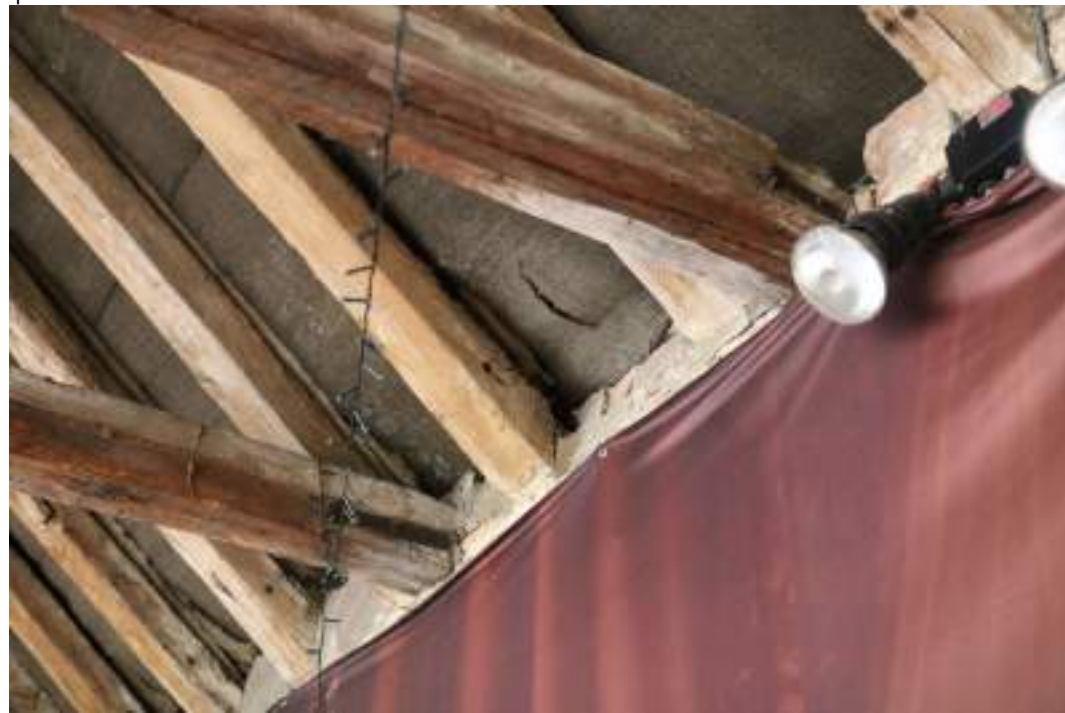
MGWF24\_PhotoGraph\_093

Interior detail shot of empty mortices in southern tie-beam of carport, indicating removal of wall. Photograph taken facing north-east.

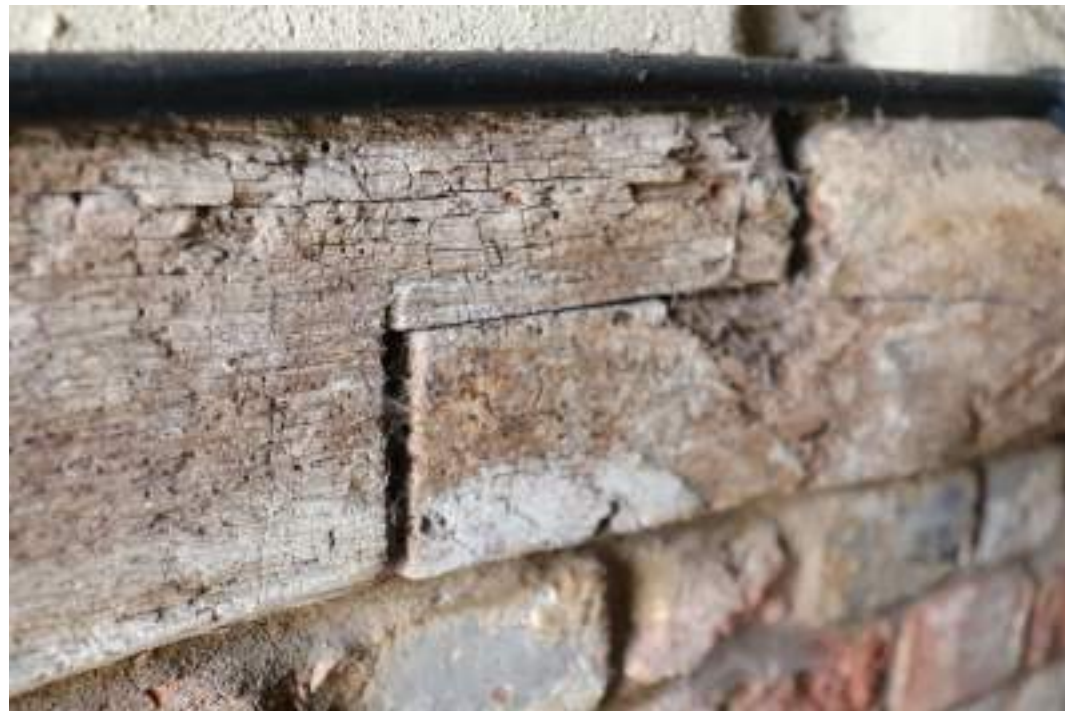
MGWF24\_PhotoGraph\_095

The presence of a Baltic timber mark in the roof of the carport can also be used to help with a construction date. The importing of timber into Britain began in the 17th century but increased dramatically during the 19th century (Vandenabeele et al. 2016). The small number of marks identified in the building suggests the building was raised whilst import levels were still relatively low. The collars in roof of the carport are hand-sawn and have lap-dovetail joints at either end, a technique found in timber-frames in the

Interior detail shot of reused timber tie-beam and Baltic timber mark in carport. Photograph taken facing vertically.

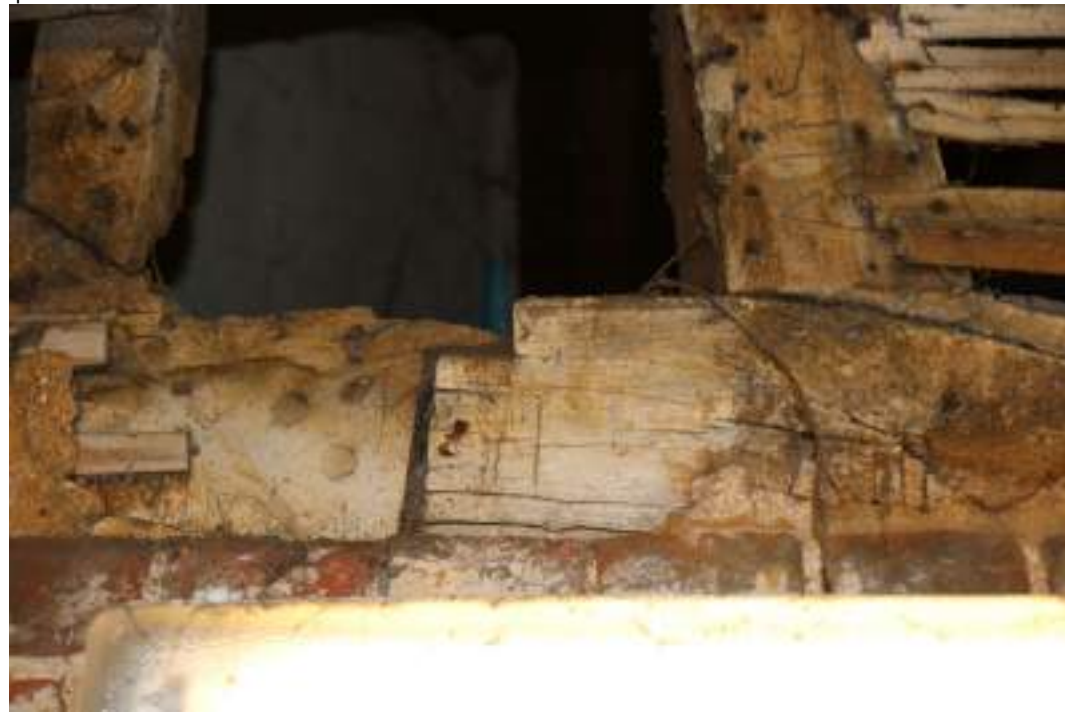
MGWF24\_PhotoGraph\_109

Interior detail shot of lath and plaster wall in lean-to 1. Photograph taken facing north-east.
