CAT Report 2096
Issued October 2024

**Historic building recording at Camp Poultry Farm,
Mill Lane, Hatfield Heath, Essex, CM22 7AA**

August 2024

**Planning district.: Uttlesford
Planning ref.: UTT/23/1688/FUL**

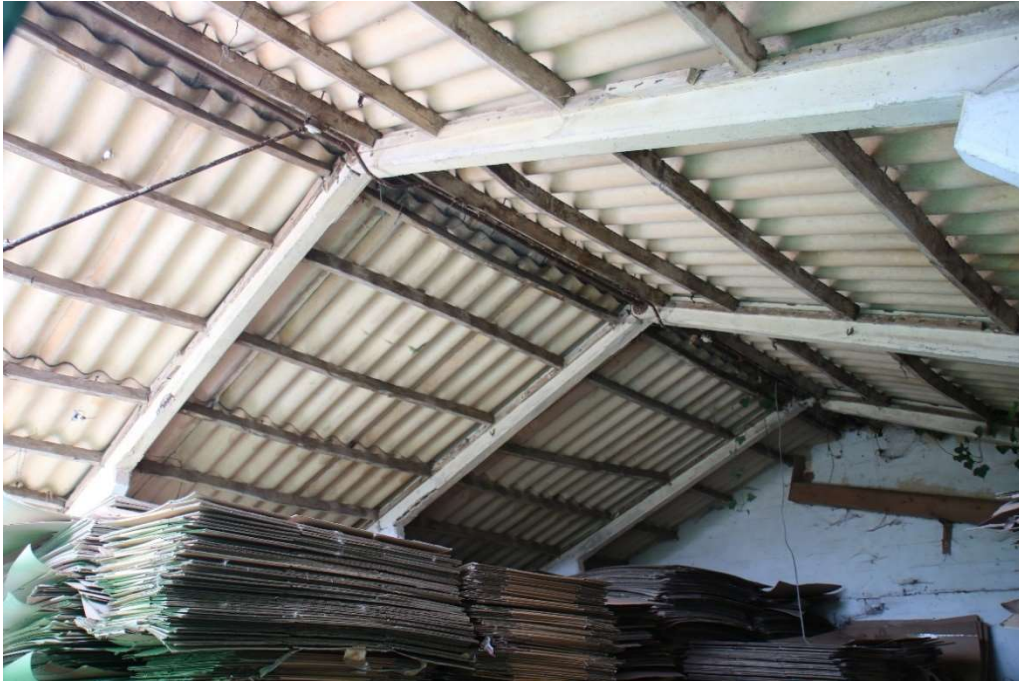
The precast concrete structure of the huts (Photograph 2) comprises posts, with concrete braces, from which rafters rise to meet at the apex of the roof. A secondary pair of timber rafters sit on top of the concrete rafters, which interrupt a number of timber purlins. The trusses of the hut are connected along the ridge line using lengths of gas pipe.

Photograph 2 Roof structure of a MoWP standard hut (building 18). Photograph taken facing north-east.

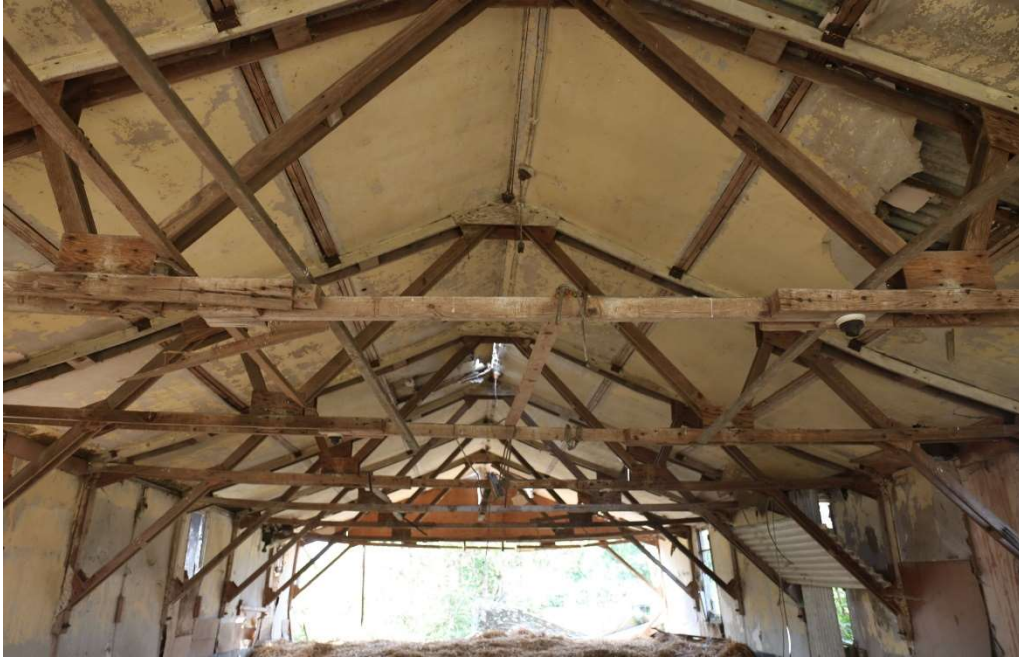
The MoWP hall huts (Photograph 3) are constructed from pre-fabricated timber-frames covered with weatherboarding. These huts also have gabled roofs clad with corrugated asbestos sheets. The roof structure (Photograph 4) of the huts comprises pairs of double rafters rising from the wall-plate and meeting at the apex of the roof. The rafters are supported on a series of diagonal struts, with timber gussets, projecting from the tie-beams, arranged in pattern know as a Fink Truss. Between the tie-beams and posts are a series of straight braces. The wall-framing of the timber huts (Photograph 5) can be divided into panels, which are situated between each pair of posts. Each panel comprises a central stud with a horizontal girt, above the girt are diagonal braces, forming an X-shape either side of the stud, with a central horizontal brace. This style of bracing is also repeated beneath the girt.

Photograph 4 Roof construction of MoWP hall hut (building 7). Photograph taken facing west.

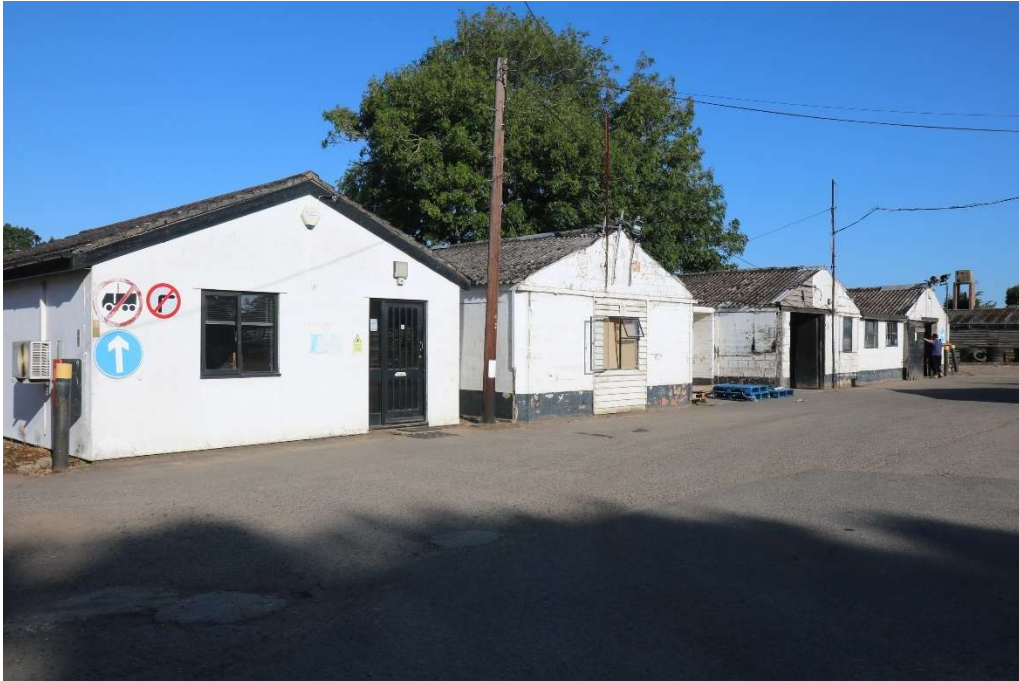
Buildings 2,3 and 4 are MoWP standard huts that have been heavily altered. They are joined together with a series of passages, which are original to the structure. The passages are constructed from brick laid in Stretcher bond (brick dimensions: 225 x 110 x 65mm). The eastern elevation (Photograph 6) of these buildings has been painted white.

Photograph 6 Eastern elevation of building 1, 2, 3 and 4. Photograph taken facing north-west.

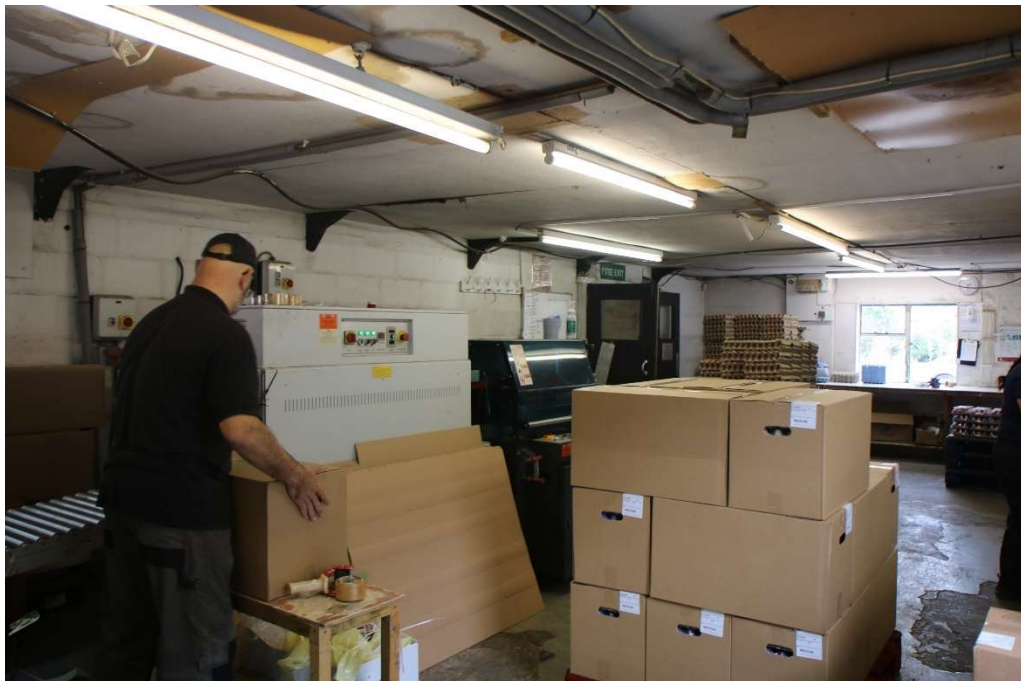
Building 2 (Photograph 10) has an inserted suspended ceiling and a concrete floor. The concrete braces of the roof structure poke through the ceiling and have been painted black. The walls are exposed hollow clay blocks painted white. There are three windows present – in the northern, eastern and southern walls. There are inserted doorways in the northern and southern walls. A small, inserted room is present in the north-west corner of the building. The extension of building 2 has been divided into two smaller rooms, to form a toilet and washroom.

Photograph 10 Interior of building 2. Photograph taken facing north-east.

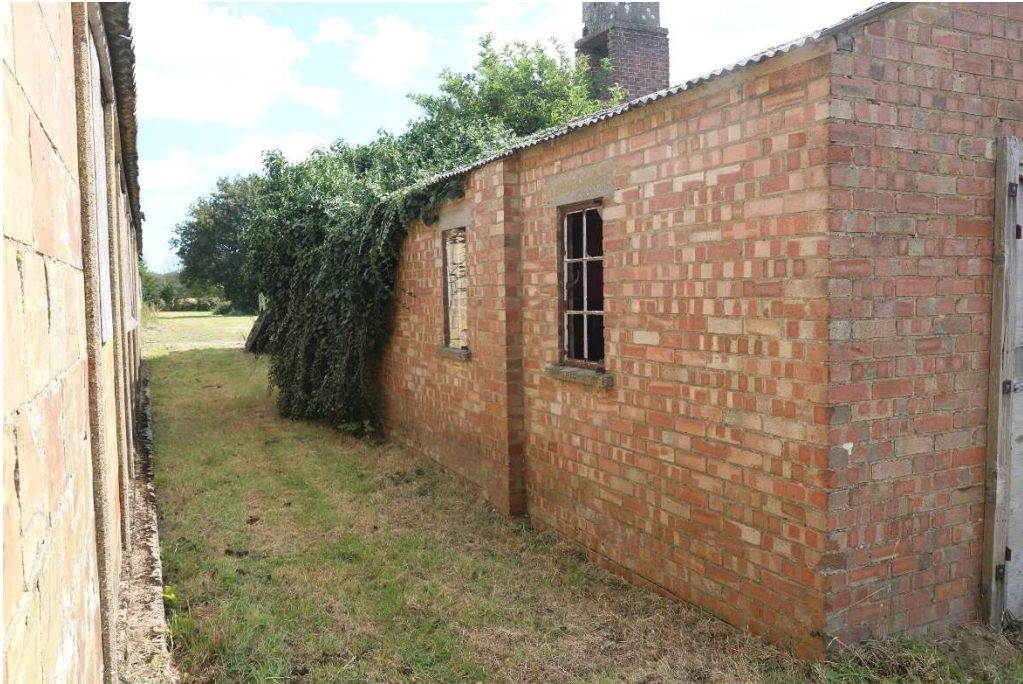
The western elevation (Photograph 15) of building 6 is relatively plain and only has a pair of centrally located double doors. The northern (Photograph 16) and southern elevations are parallels of one another, with two six-light Crittall windows flanking a brick buttress at one end and a further two six-light Crittall windows at the other end. The eastern elevation of building 6 was not accessible at the time of recording.

Photograph 16 Northern elevation of building 6. Photograph taken facing south-east.

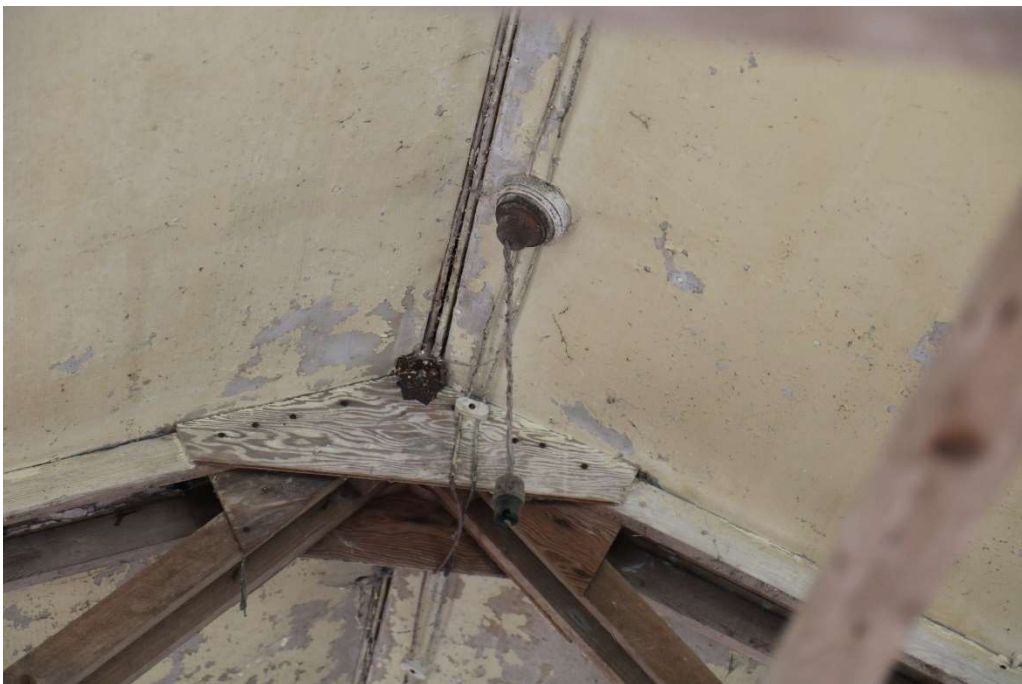
Photograph 19 Detail of light fitting in building 7. Photograph taken facing north-west.

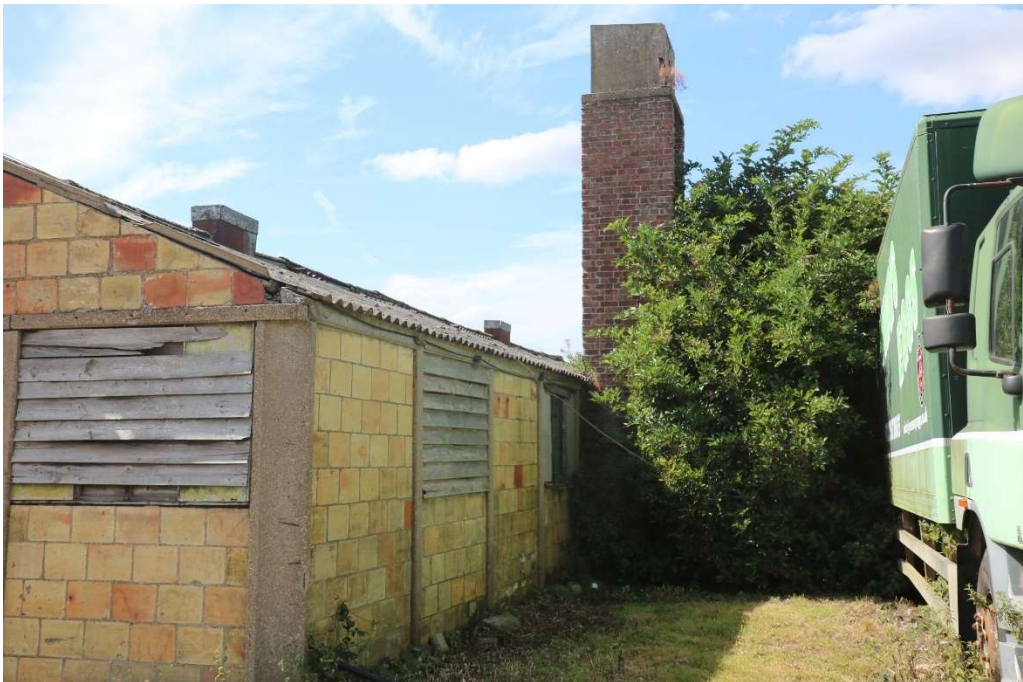
Photograph 22 Northern elevation of building 10. Photograph taken facing south-west.

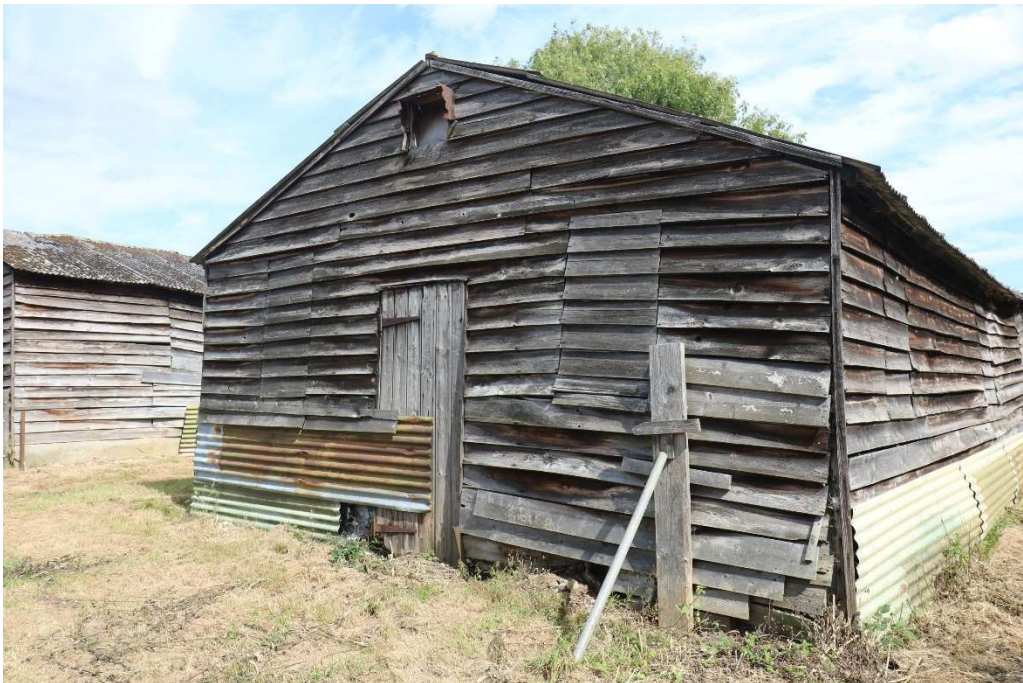
Photograph 25 Western elevation of building 12. Photograph taken facing north-east.

elevation (Photograph 25) has a central timber door, with iron strap hinges, flanked by blocked window openings. Corrugated metal sheets have been added to part of the elevation, preventing the door from opening.

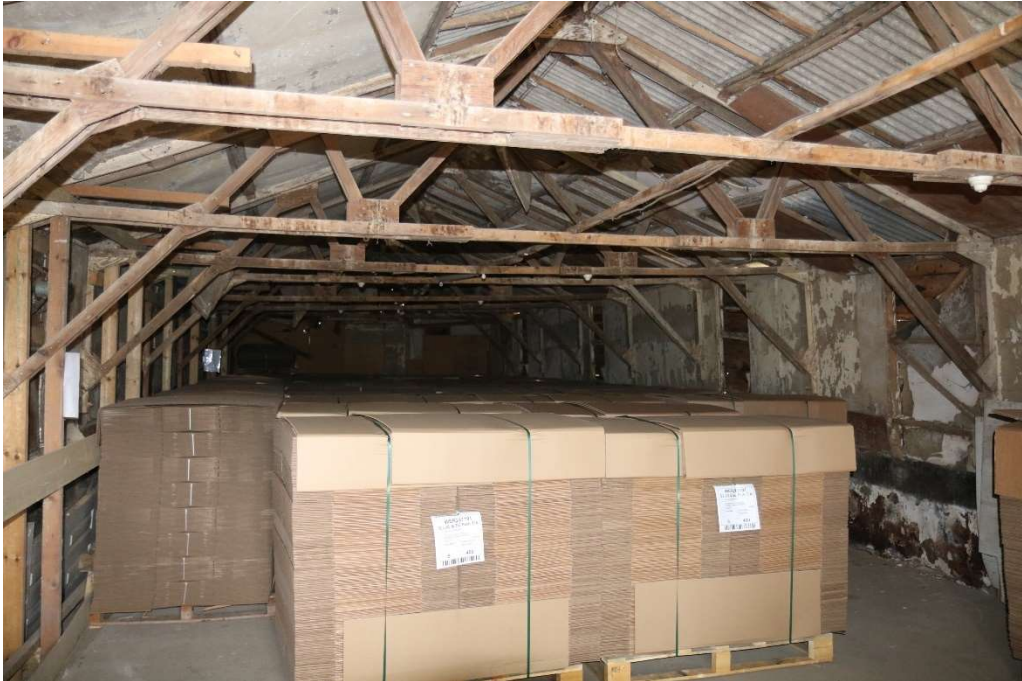
The ceiling and walls of building 14 (Photograph 29) are covered with plasterboard, which has come away in areas. Metal sheets have been added to the lower portion of the wall. The southern wall has had extra timber-framing added. The floor is concrete.

Photograph 29 Interior of building 14. Photograph taken facing north-west.

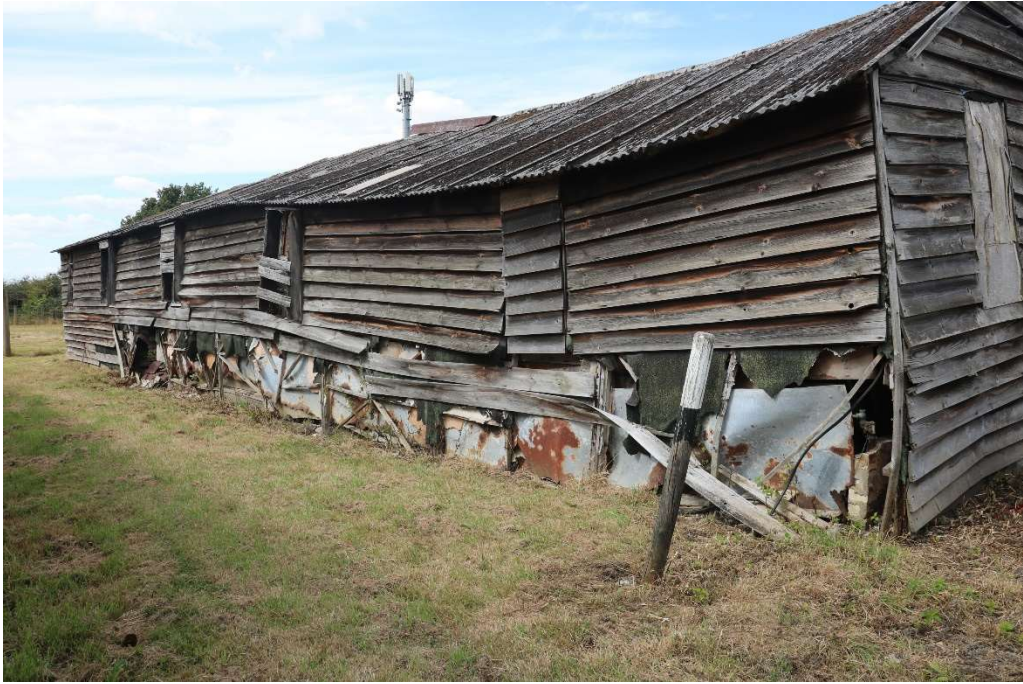
The eastern elevation of building 16 has a central vertically-planked door, with iron strap hinges. Either side of the doorway is a window opening, blocked with plywood. The northern and southern elevations have five window openings, some of which are blocked while others still have the frames and glass. A large quantity of weatherboard has come away from the southern elevation, exposing the frame beneath (Photograph 16). The western elevation has a central door, flanked by two windows, both of which have been covered.

Photograph 32 Southern elevation of building 16. Photograph taken facing north-west.

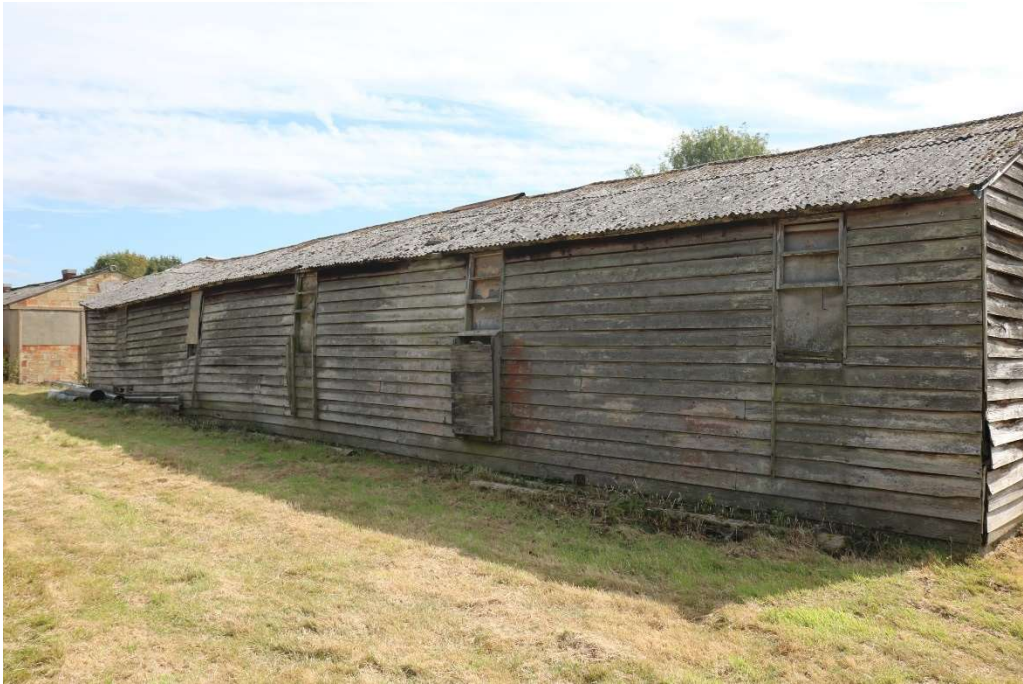
A single timber door is present in the centre of the eastern elevation of building 17. A window, blocked with weather board, is located to the south of the doorway. Along both the northern (Photograph 34) and southern elevations are five window openings, all

which have been blocked – some from the interior and others from the exterior. The windows blocked from the inside still have their timber-frames along with the remains of external vertical sliding-shutters. The western elevation of building 17 has two blocked windows, either side of a single, partially blocked, doorway.

Photograph 34 Northern elevation of building 17. Photograph taken facing south-east.

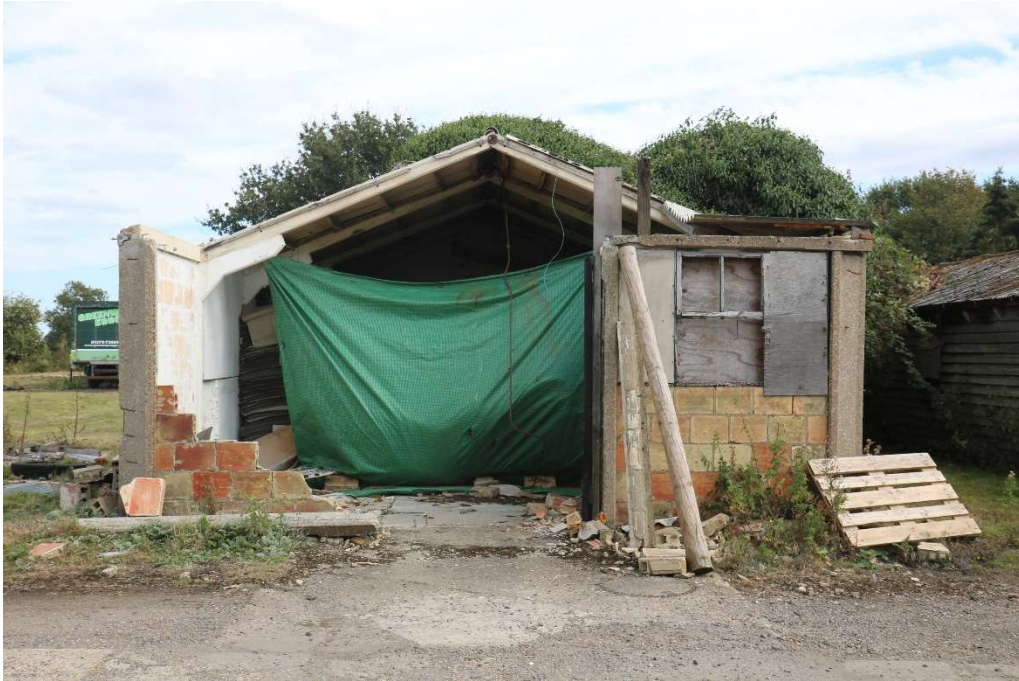
The western elevation (Photograph 36) of building 18 is quite dilapidated, with only one full panel remaining, which has a single timber-framed window with no surviving glass. The southern elevation was mostly obscured by vegetation at the time of recording. An original doorway is present in the eastern elevation, along with an inserted door and a blocked opening. A number of the panels in the northern elevation have windows blocked by either timber or breeze blocks.

Photograph 36 Western elevation of building 18. Photograph taken facing east.

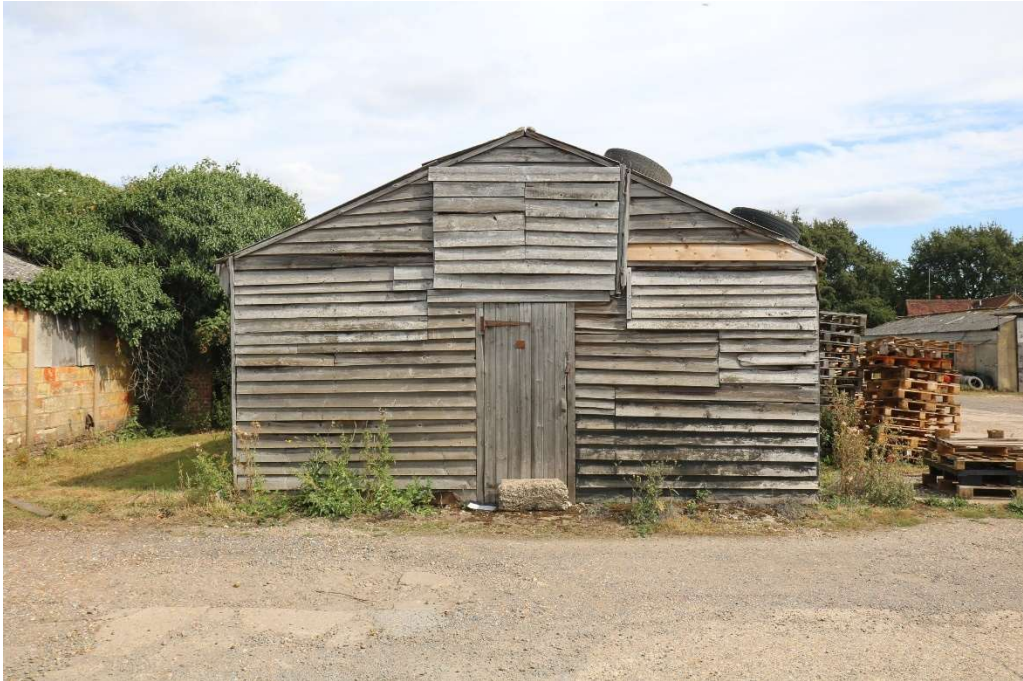
Photograph 37 Western elevation of building 19. Photograph taken facing east.
