**Historic building recording of an outbuilding at
Bennett's Farm, Weald Road, South Weald,
Brentwood: November 2022**

**CAT project ref.: 2022/10g
ECC code: SOWBF22**

**Historic building recording of an outbuilding at
Bennett's Farm, Weald Road, South Weald,
Brentwood**

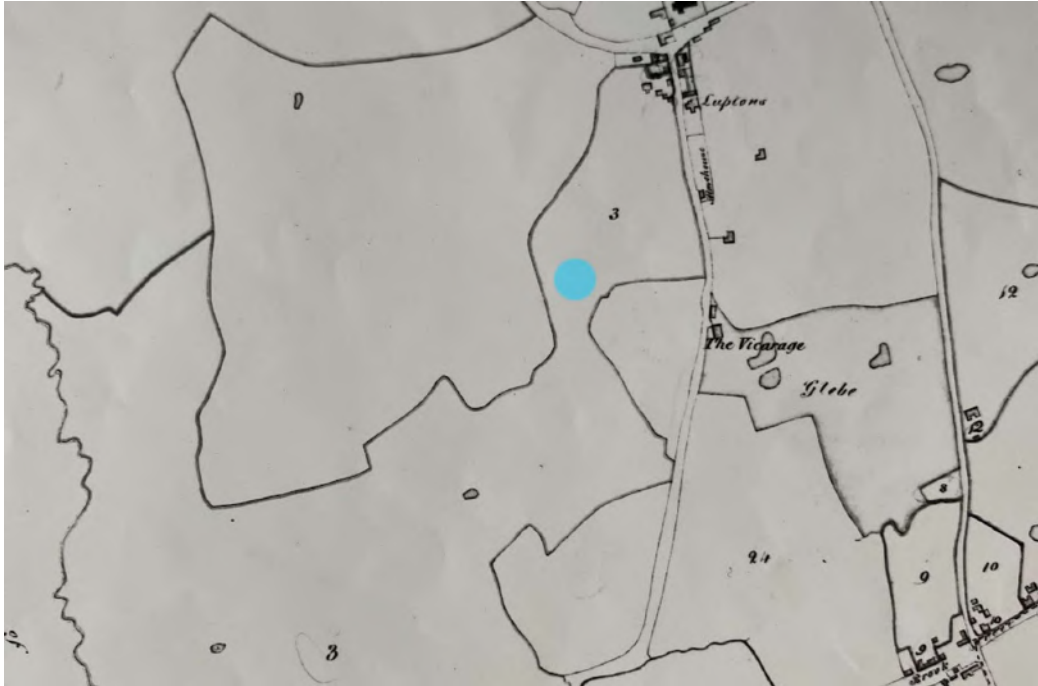
Map 3 Extract from the 1838 Tithe Apportionment map with the approximate location of the outbuilding highlighted in blue.

The tithe apportionment map of 1838 (Map 3) shows the area in more detail, as well as the division of land around Bennett's Farm. There do not appear to be any structures on this map around Bennett's Farm, which probably straddles the boundary between parcels 3 (Weald Meadow) and 24 (Bushy Pasture). There is no structure visible on the tithe map.

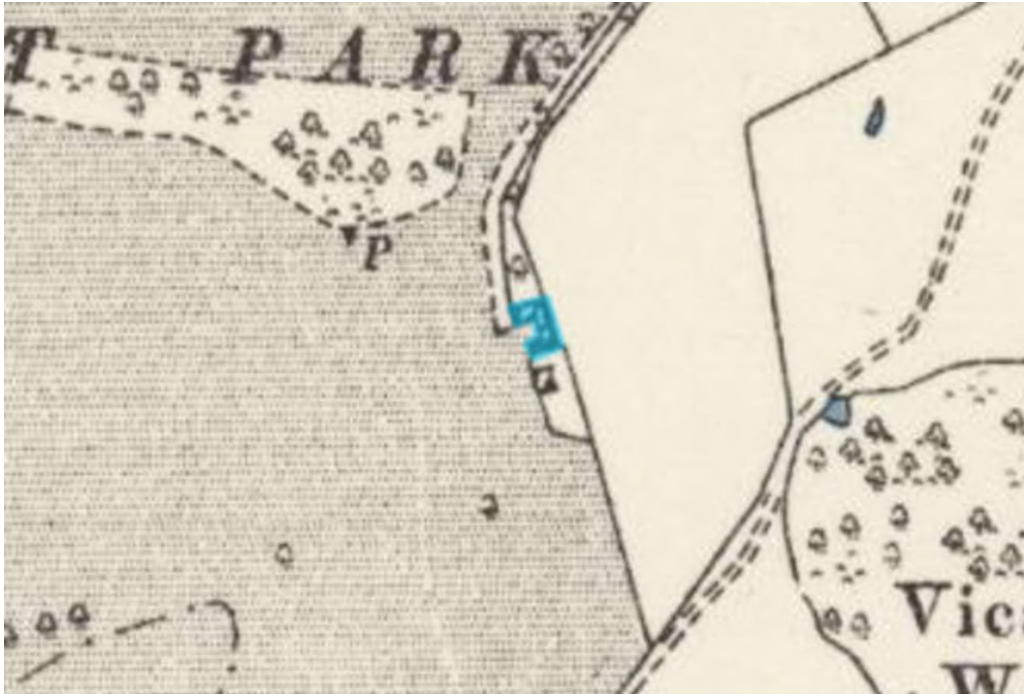
Map 5 Extract from the 1898 Ordnance Survey map showing the outbuilding highlighted in blue.

The 1898 edition of the Ordnance Survey map shows Bennett's Farm within a small plot of land, separating it from the parkland immediately to the west (Map 5). The building was still accessed from the north by a trackway. Between 1881 and 1898 the farmhouse was built just to the south of the U-shaped building.

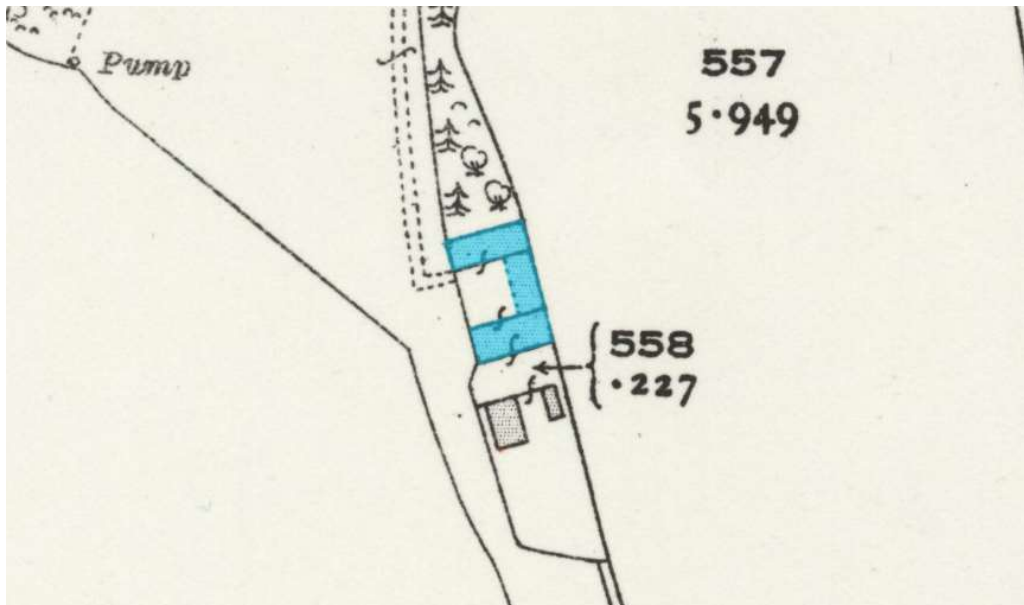
Map 6 Extract from the 1921 Ordnance Survey map showing the location of the outbuilding highlighted in blue.

The 1921 OS map clearly shows the buildings of Bennett's Farm (Map 6). The U-shaped building was still present at this time, as well as the farmhouse to the south and an additional small building just to the east of the farmhouse. The 1947 edition

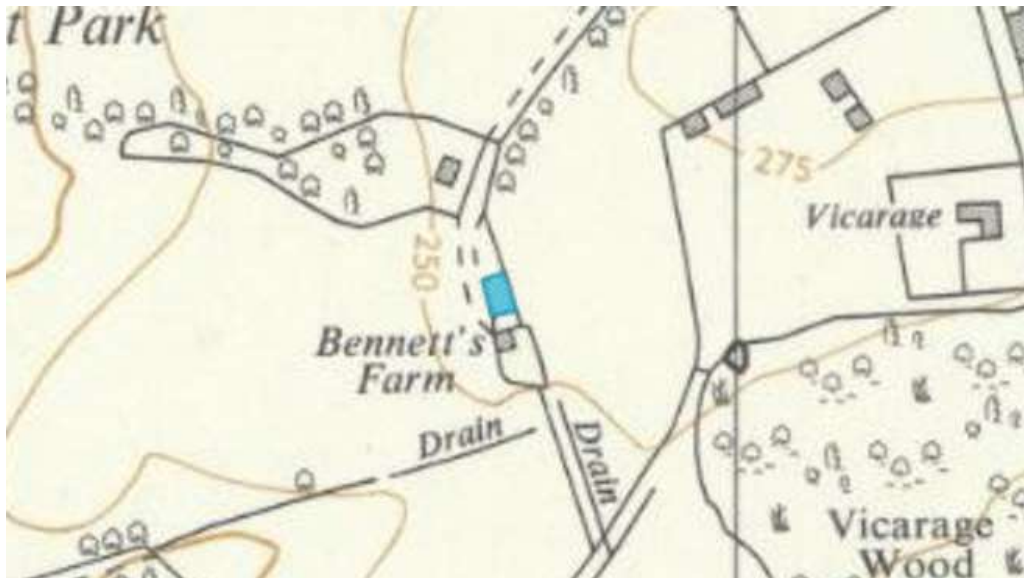
Map 8 Extract from the 1967 Ordnance Survey map showing the location of the outbuilding highlighted in blue.

The 1967 OS map labels the buildings as Bennett's Farm. By this time the U-shaped building has been altered – the northern wing of the building appears to have been demolished and the central yard infilled to make a rectangular building. The farmhouse remains to the south, but the additional small building immediately to the east of the farmhouse is not marked on the map, so has likely been demolished. A new building is marked on the map just to the north of Bennett's Farm, presumably a barn or shed. Since 1967, this building has been removed and a large barn has been added to the farmyard, to the west of the building that is the focus of this report.

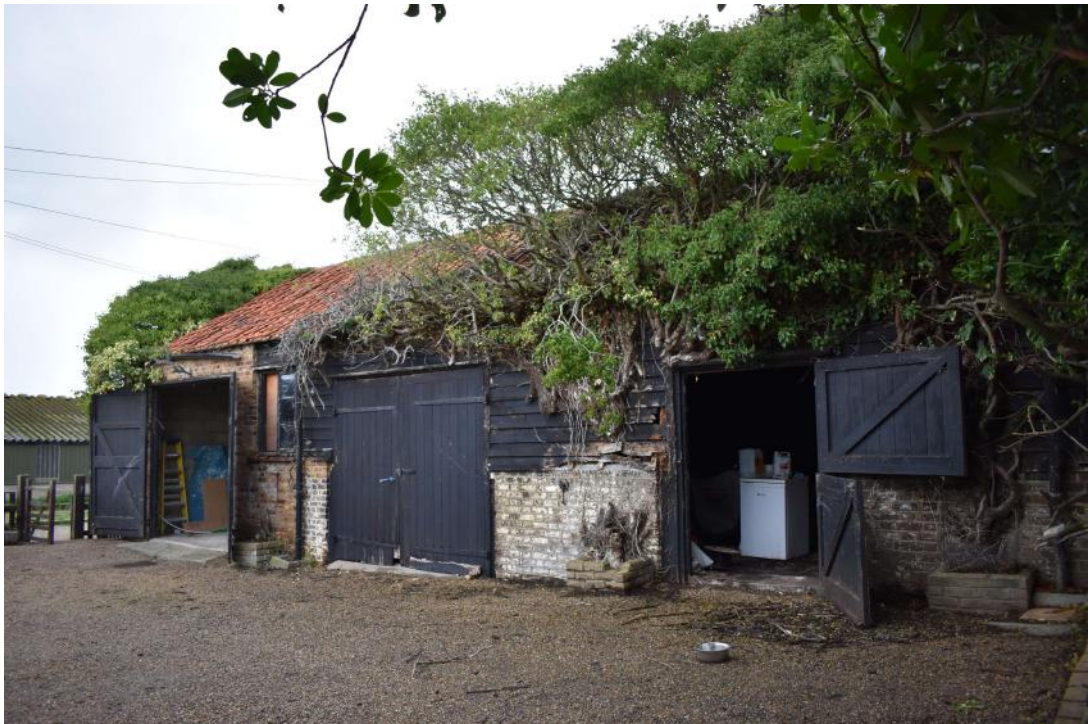
Photograph 1 South-east elevation. Photograph taken facing north north-west.

The south-east elevation is a combination of brick and black weatherboard. The south-western end of this elevation is a later extension, constructed of red brick laid in English-bond (brick dimensions: 225 x 110 x 65mm). The rest of the elevation is clad in black weatherboard with a brick plinth. Two sets of double doors and a single stable door are present on this elevation, and whilst the openings are original, the doors themselves are modern replacements. There is also a single window on this elevation, which would have been a six-light vertical awning window, but half has been removed and boarded up.

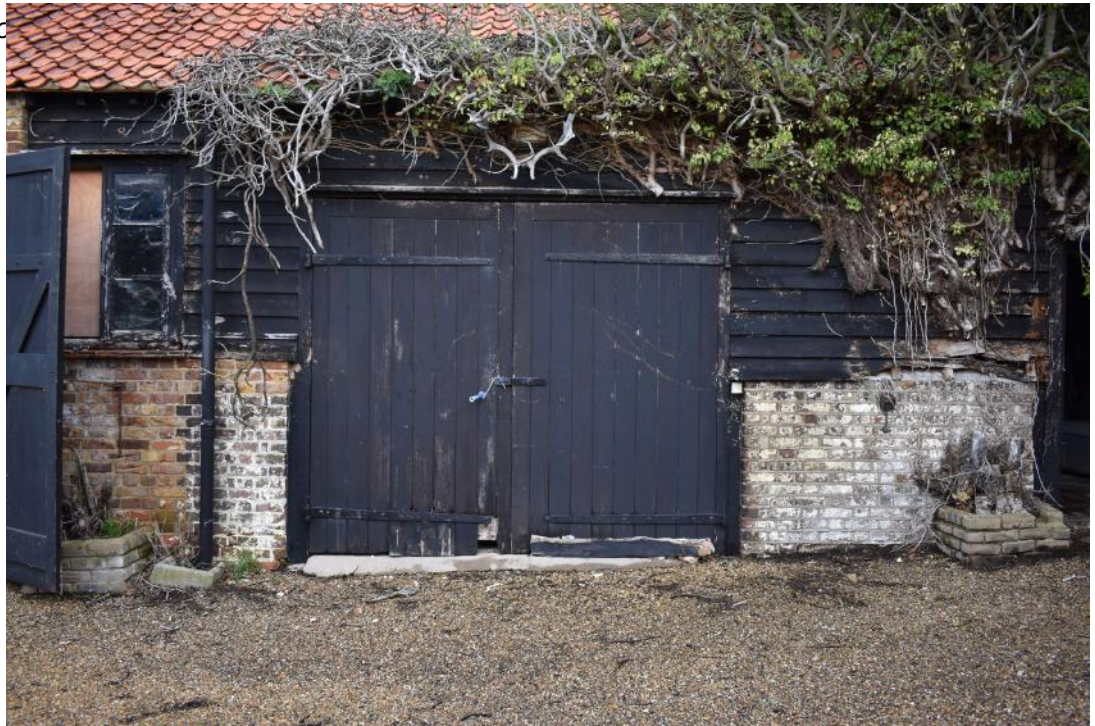
Photograph 2 Detail of double-doors on south-east elevation. Photograph taken facing north-west.

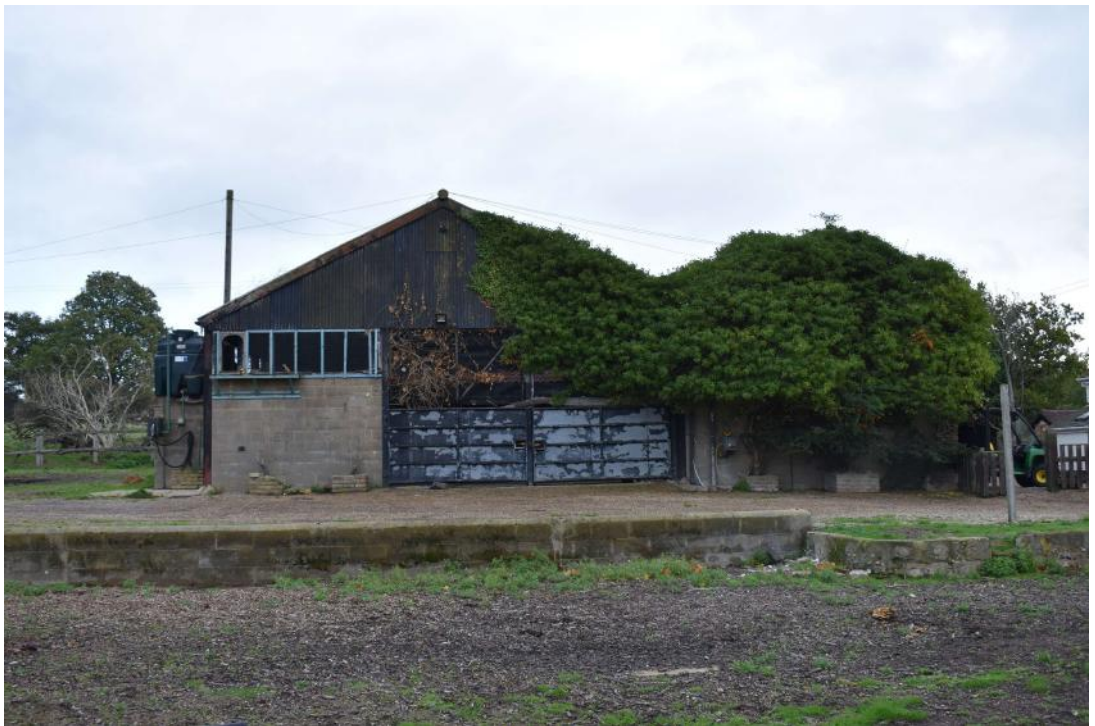
Photograph 3 South-west elevation. Photograph taken facing north-east.

The south-west elevation is dominated by a large set of modern double doors. There is a set of mesh-covered openings to the north-west of the doors along with a modern peacock door and ledge. This elevation is constructed of breeze blocks.

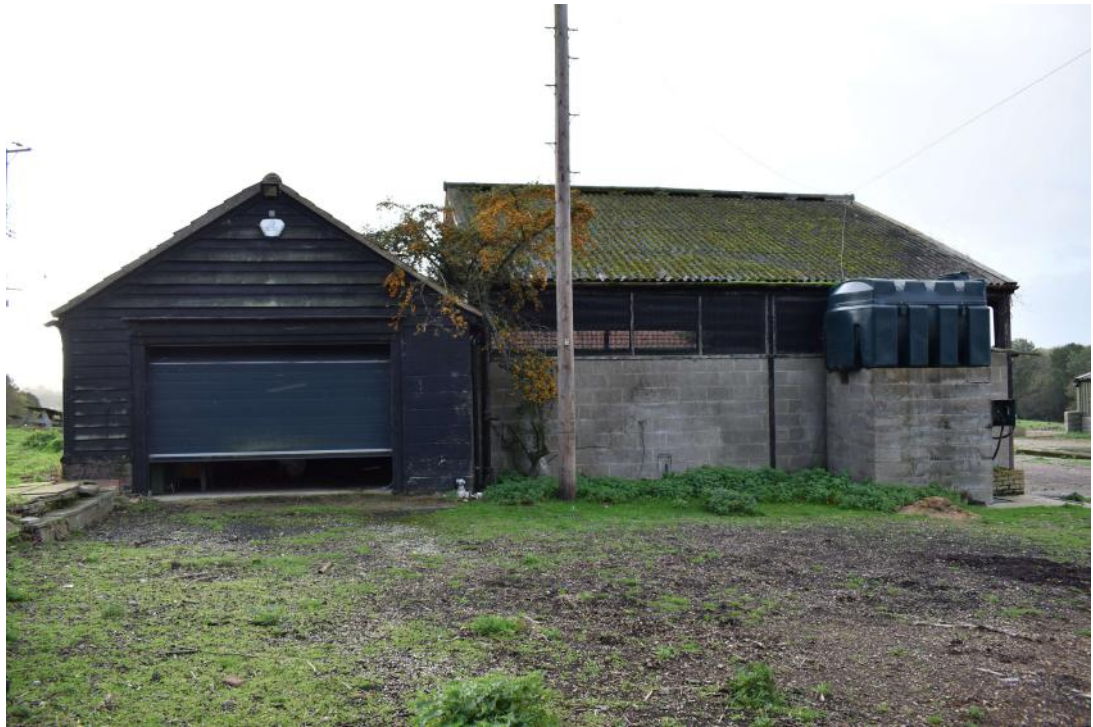
Photograph 4 North-west elevation. Photograph taken facing south-east.

The north-east end of the north-west elevation is clad in black weatherboard, around a modern Garage door, while the rest of the elevation is breeze blocks. A small amount of the brick plinth also survives on this elevation. There are also a number of mesh-covered openings at the top of the elevation.

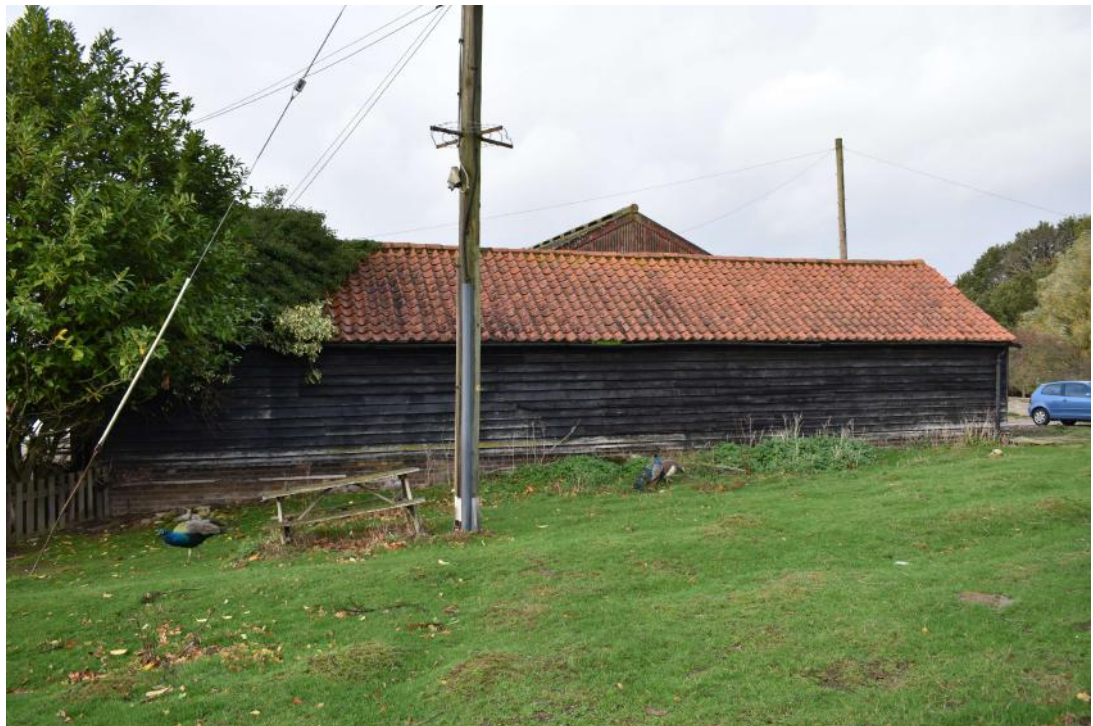
Photograph 5 North-east elevation. Photograph taken facing west.

The north-east elevation is featureless and clad in black weatherboard.

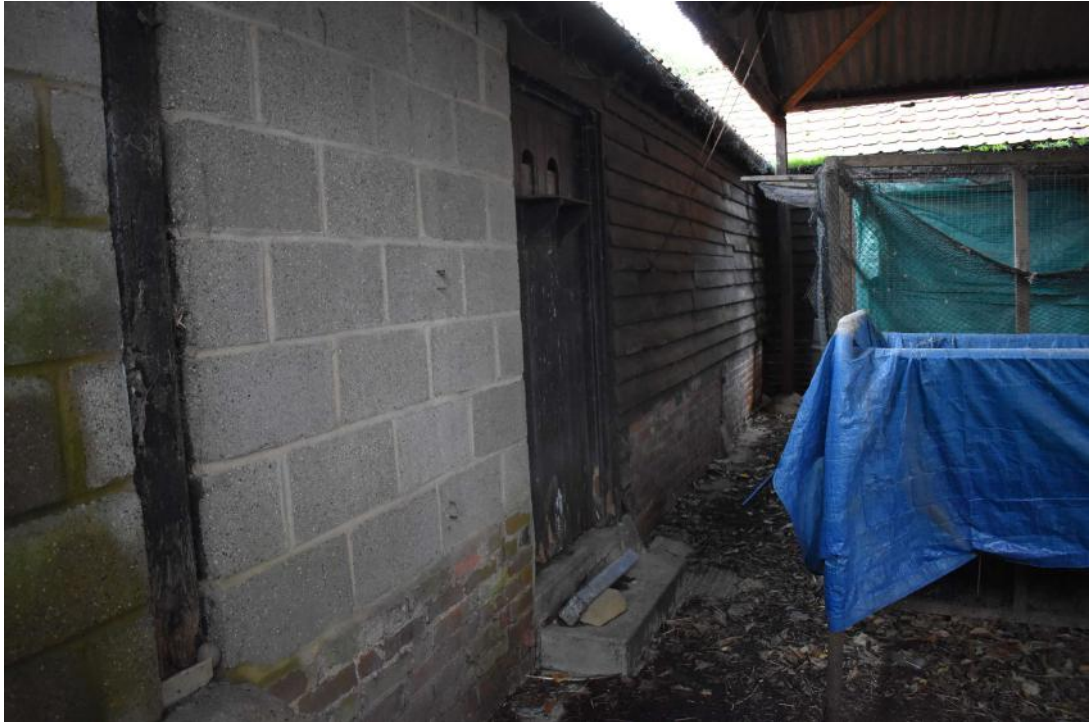
Photograph 6 Internal elevation in Store 5. Photograph taken facing south-east.

Within Store 5, the north-west and south-west elevations of the L-shaped building are visible. The north-west elevation is partially clad in black weatherboard below which the brick plinth is visible. A small door (probably avian related) is present in the weatherboarding. The rest of the elevation is breeze blocks.

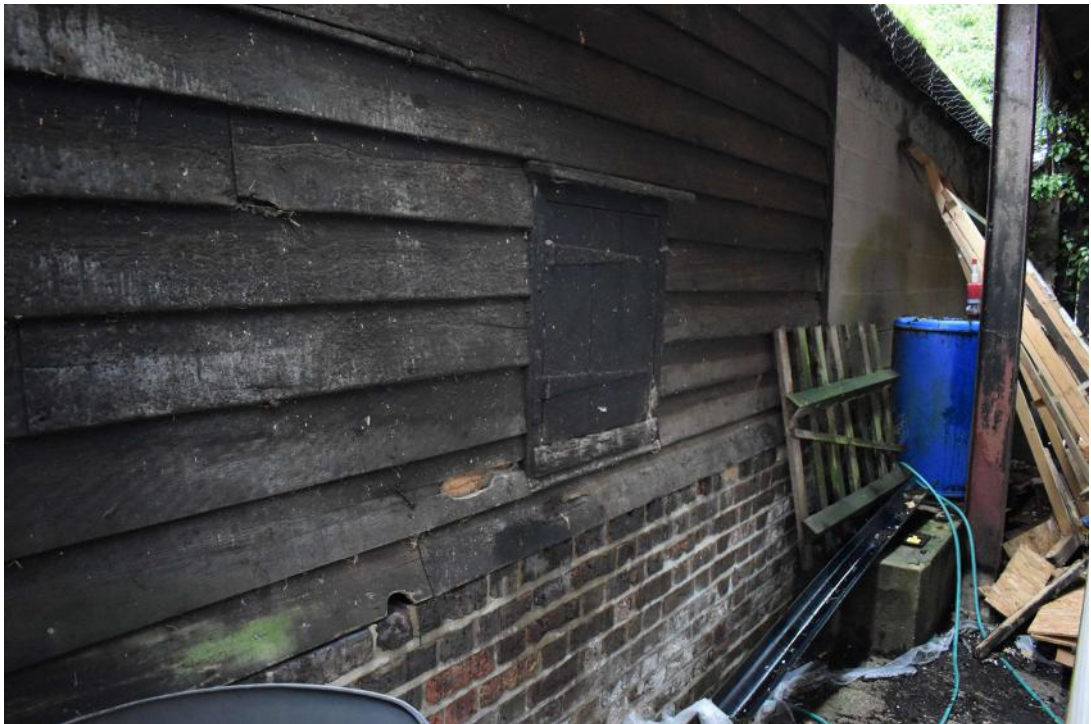
Photograph 7 Internal elevation in Store 5. Photograph taken facing south-west.

The brick plinth is visible the full length of the south-west elevation. Above this is a combination of black weatherboarding and breeze blocks. Two original timber posts are visible, both of which have modern concrete supports. A possible third may be

located behind some weatherboarding (see Fig 7). There is a single inserted door with a concrete step.

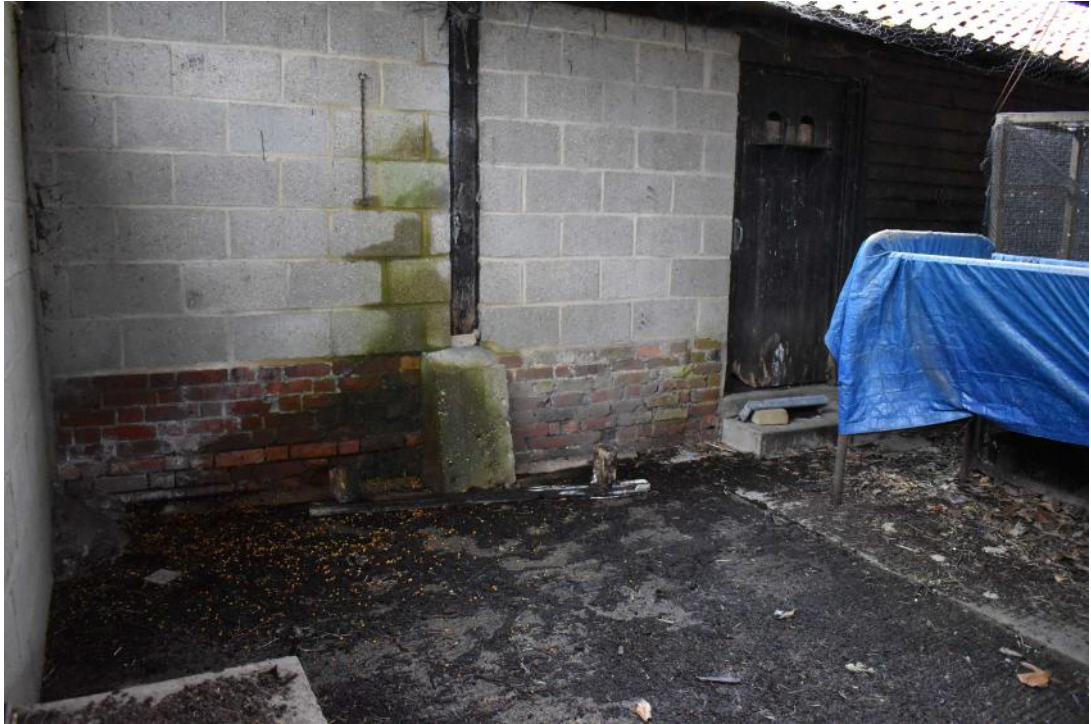
Photograph 8 Detail of original post and brick plinth in Store 5. Photograph taken facing south-east.

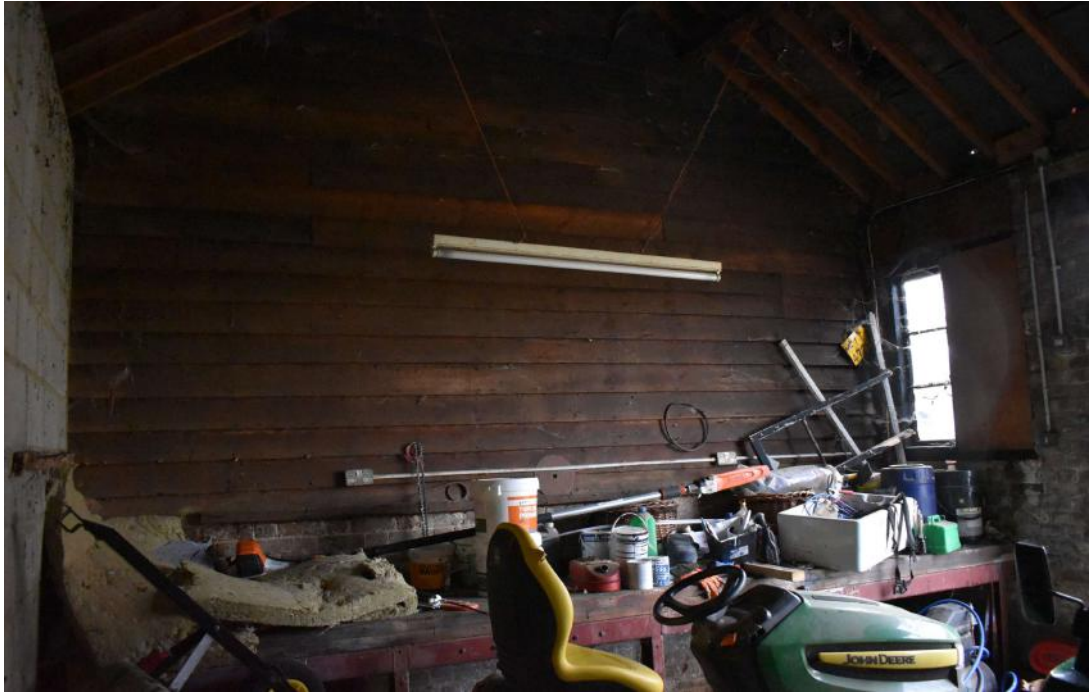
Photograph 9 Interior of Store 1. Photograph taken facing south-east.

Store 1 is located in the south-west wing of the L-shape building and is a later extension. The north-east wall of Store 1 is the original south-west elevation of the historic farm building, it is clad in brown weatherboard and has a red brick plinth. The north-west and south-west walls of Store 1 are breeze block and the south-east wall is dominated by a set of double doors and a single window.

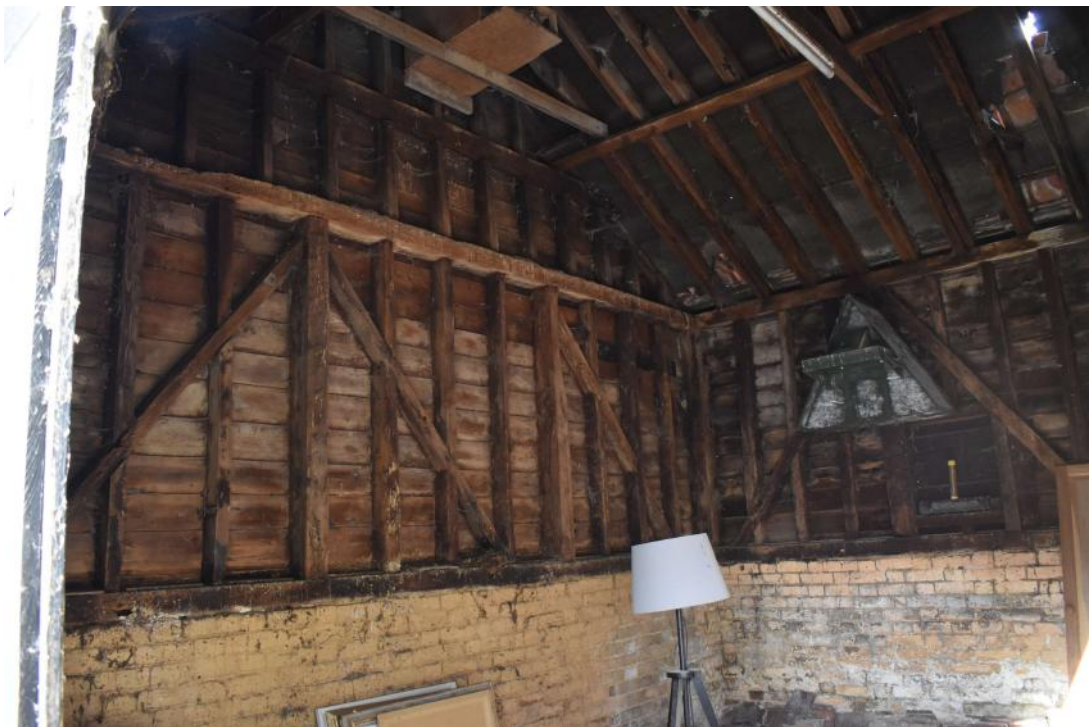
Photograph 10 Interior of Store 2. Photograph taken facing north-west.

The north-west and south-west walls of Store 2 are largely featureless, bar a small vertical-planked door located in the north-west wall. The north-east wall is almost entirely dominated by a set of double doors.

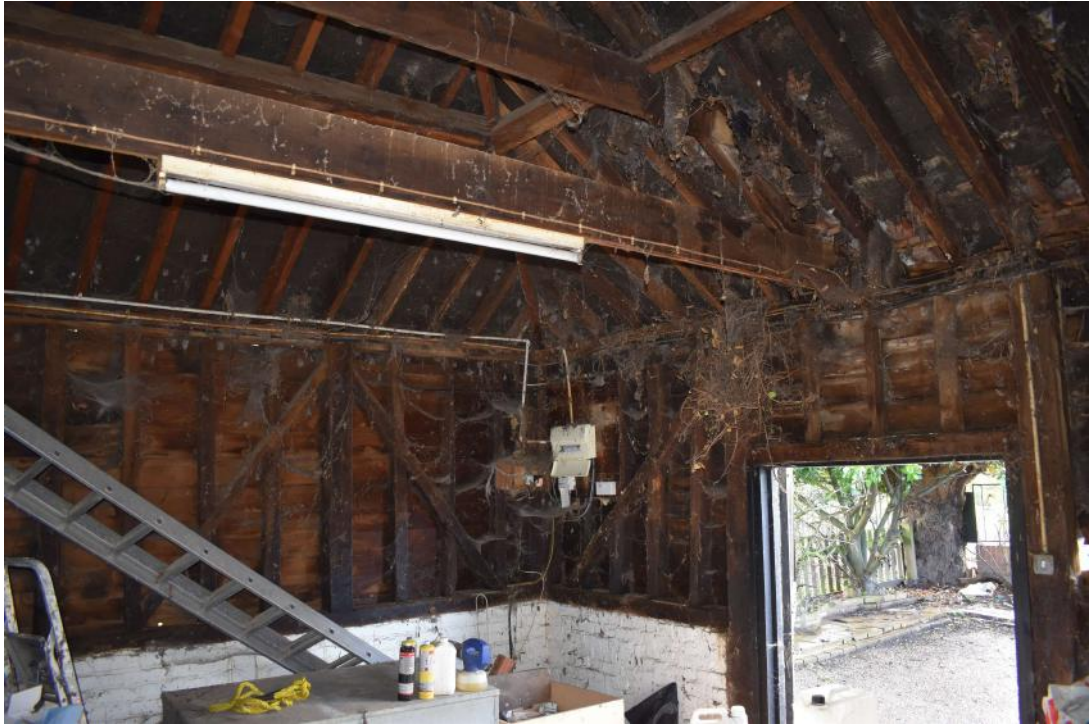
Photograph 11 Interior of Store 3. Photograph taken facing south-east.

Store 3 has a further two doors, one in the north-west wall which leads to Store 4 and an external door in the south-east wall. The timber-frame in this room has the most reused timbers, including posts, braces and the sill-beam. Two side-halved scarf joints

were also identified, one in the wall-plate on the north-west wall and one in the sill-beam of the north-east wall.

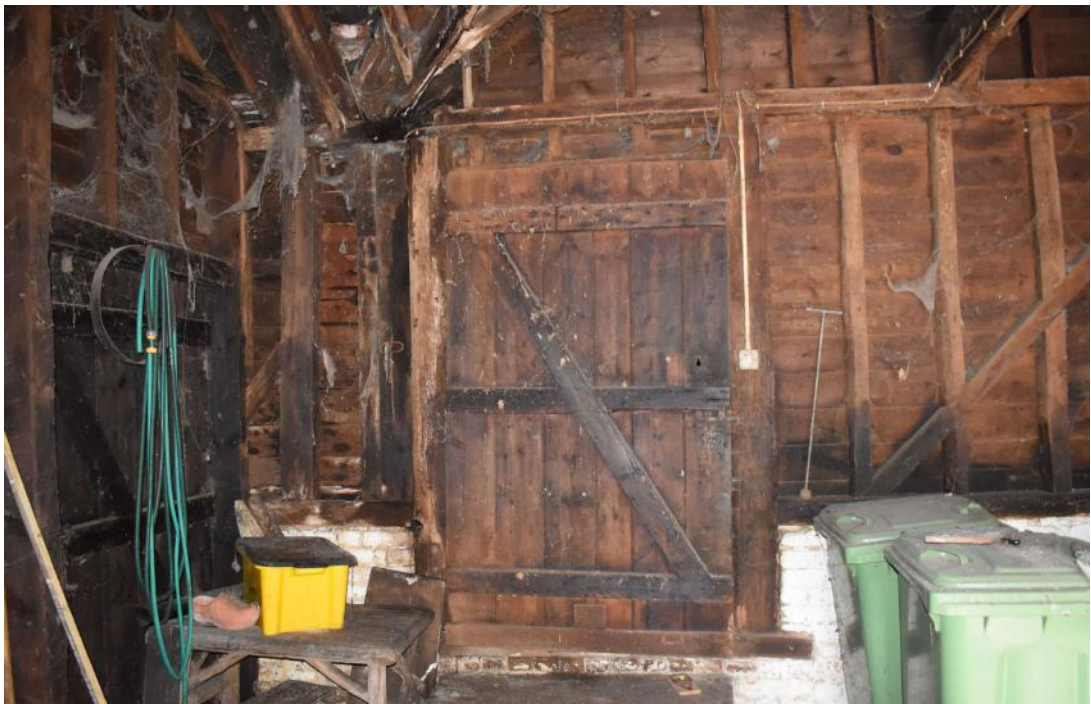
Photograph 12 Detail of interior door between Store 3 and 4. Photograph taken facing north-west.

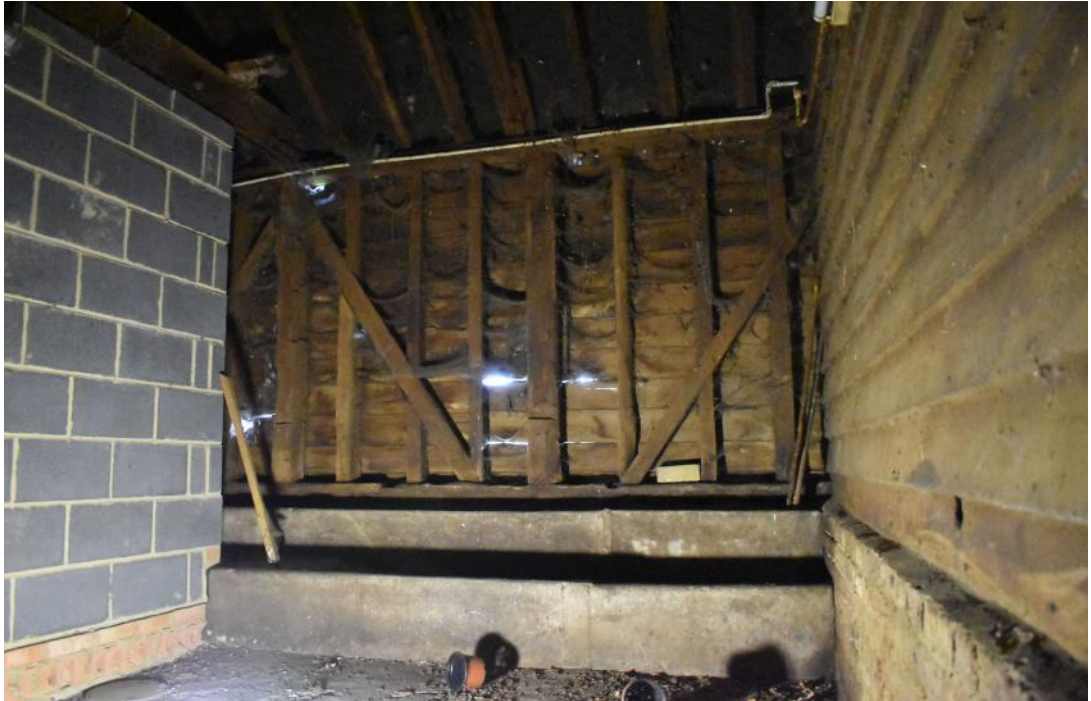
Photograph 13 Interior of Store 4. Photograph taken facing north-east.

The modern Garage has been constructed within the footprint of Store 4 and therefore obscured much of detail of the north-west and south-west walls. The timber-frame of the south-west wall was of a different style to the rest of the building and the plinth was slightly shorter, evidence the wall is inserted. On the north-east wall many of the timbers show signs of reuse and two side-halved scarf joints are present in the sill-beam. A modern feeding trough, now filled with concrete, occupies the gap between the Garage wall and the north-east wall of Store 4.

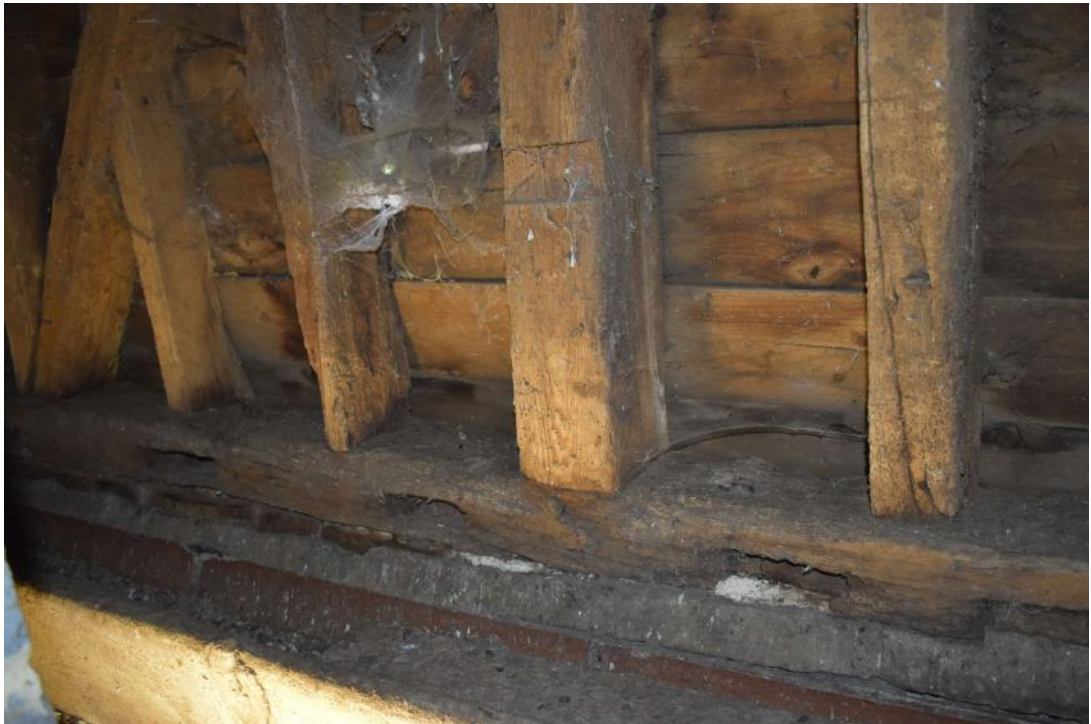
Photograph 14 Detail of reused timber for sill-beam in Store 4. Photograph taken facing north-east.

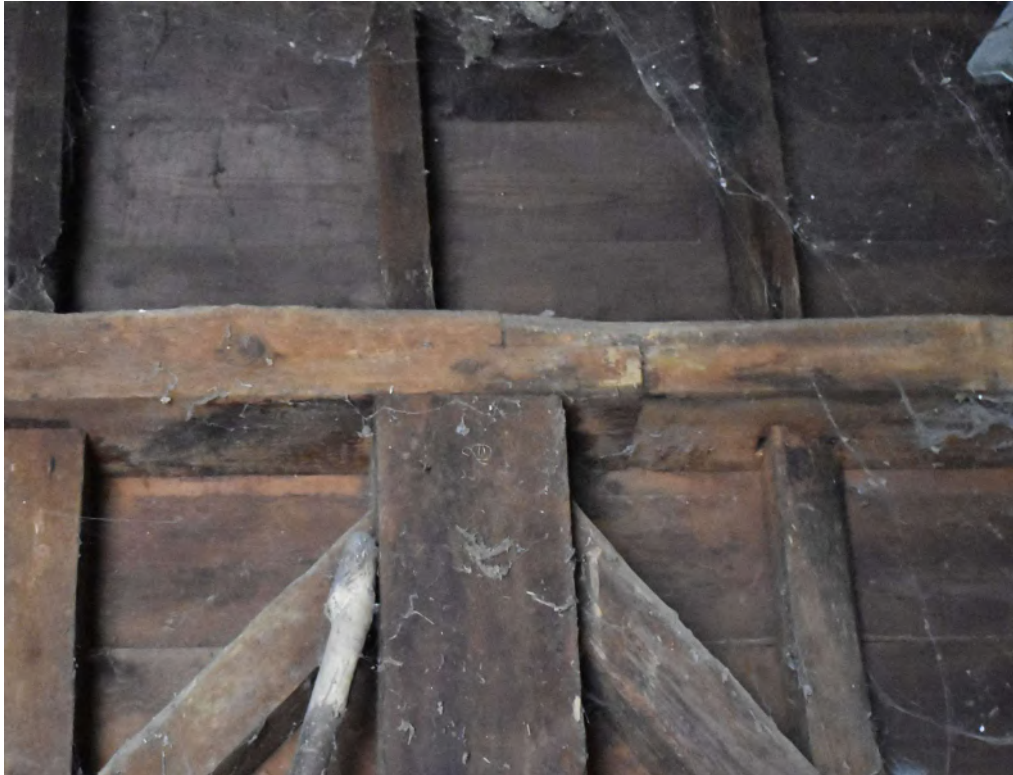
Photograph 15 Detail of scarf joint in wall plate of Store 3. Photograph taken facing north-west.

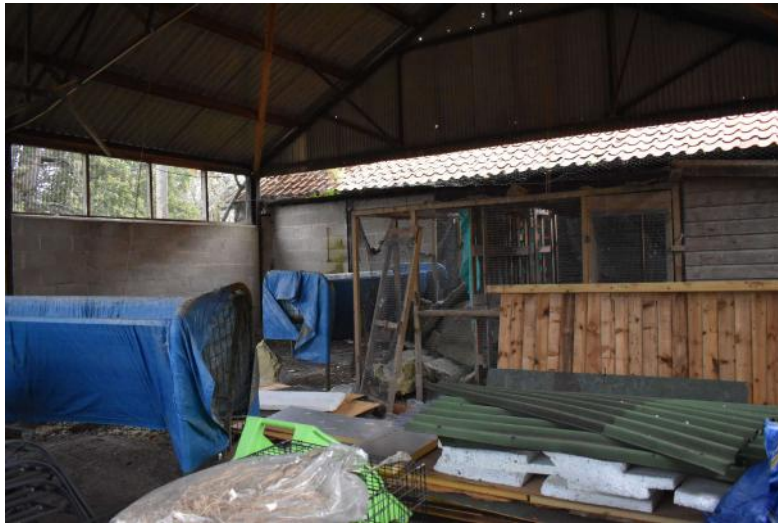
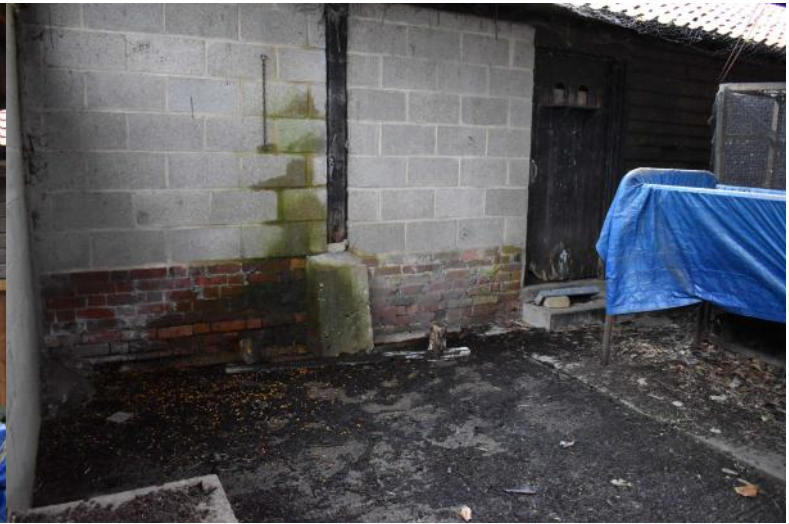
SOWBF22_PhotoGraph_021Interior of store 5. Photograph taken facin... SOWBF22_PhotoGraph_022Detail of internal elevation and brick plinth...

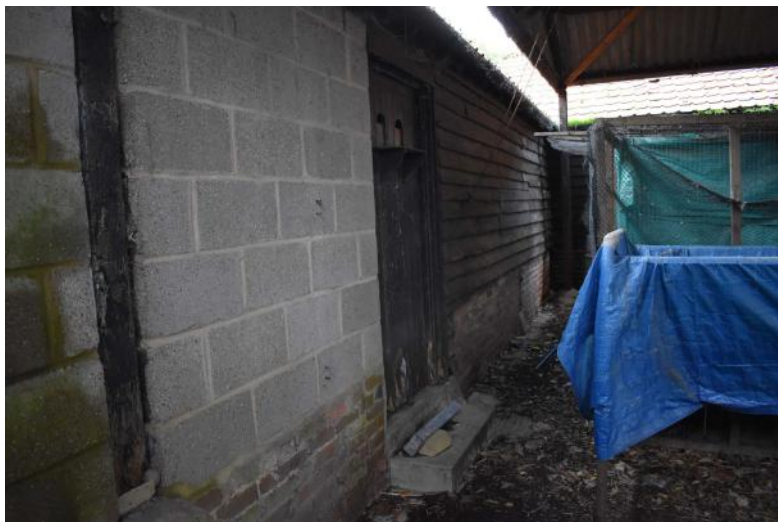
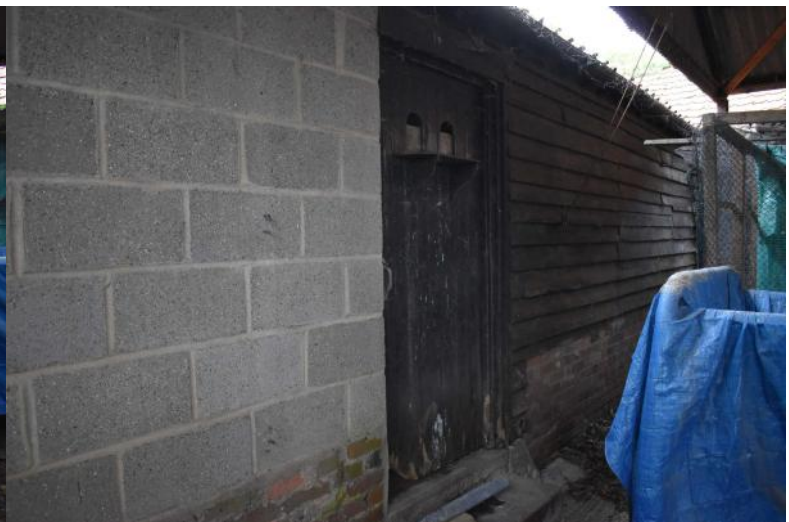
SOWBF22_PhotoGraph_023Internal elevation in store 5. Photograph t... SOWBF22_PhotoGraph_024Detail of door in internal elevation in store...

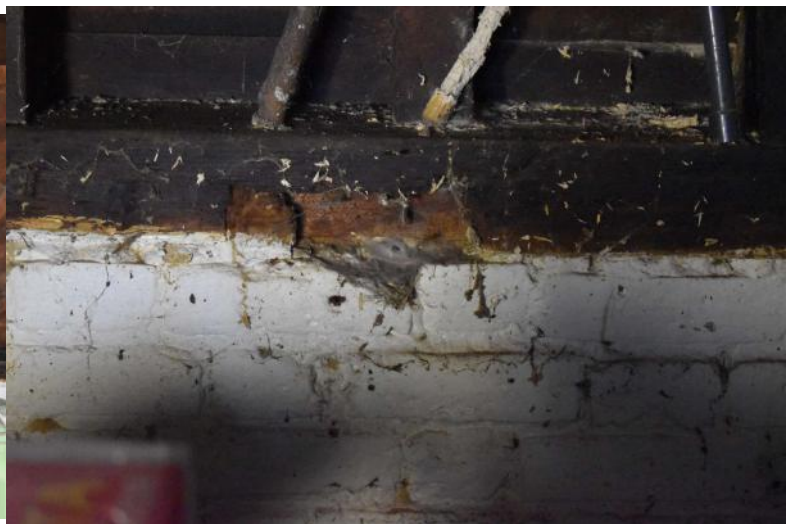
SOWBF22_PhotoGraph_043Detail of interior door between store 3 and... SOWBF22_PhotoGraph_044Detail of reused timber in store 3. Photogr...

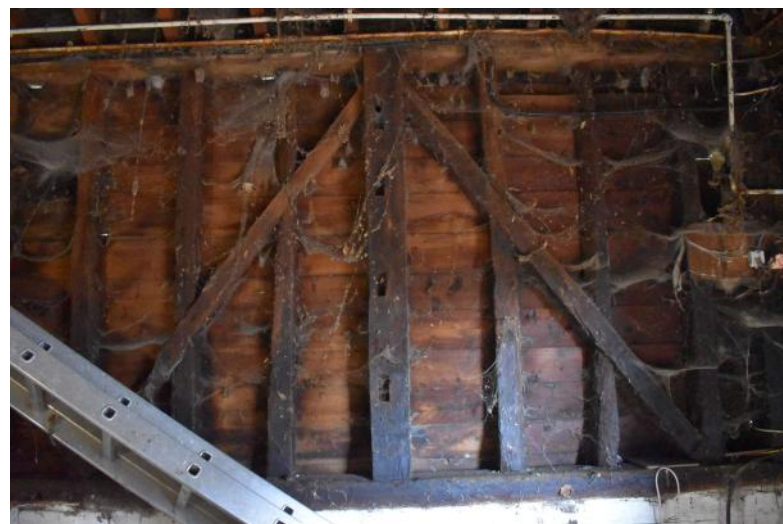
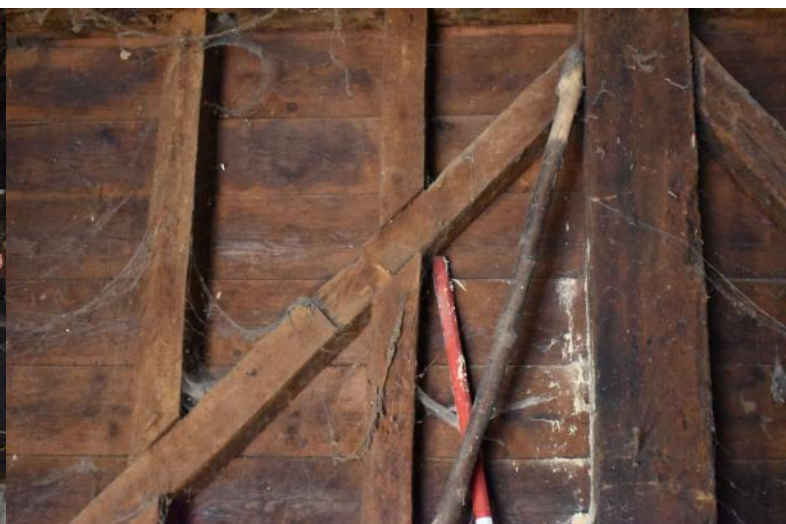
SOWBF22_PhotoGraph_045Detail of reused timber post in store 3. Ph... SOWBF22_PhotoGraph_046Detail of reused timber in store 3. Photogr...

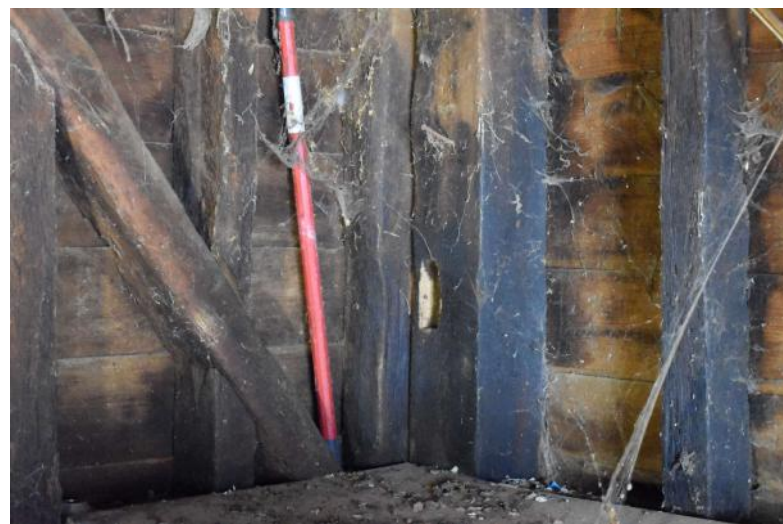
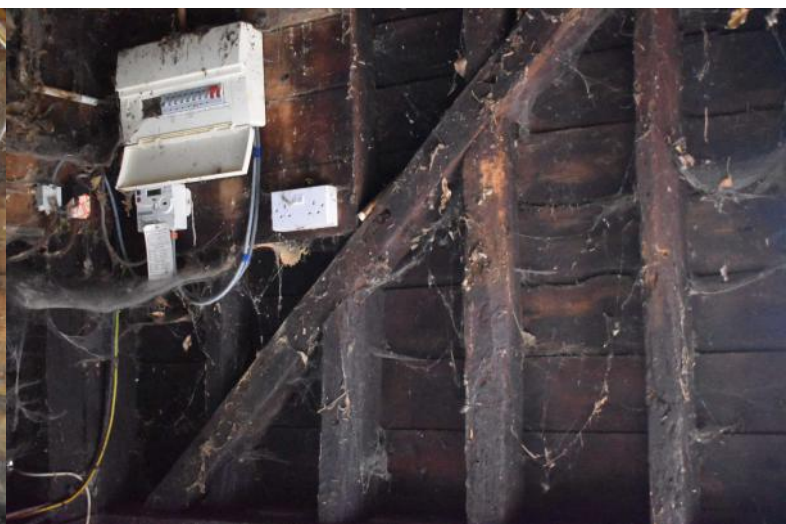
SOWBF22_PhotoGraph_047Detail of reused timber in store 3. Photogr... SOWBF22_PhotoGraph_048Detail of reused timber in store 3. Photogr...

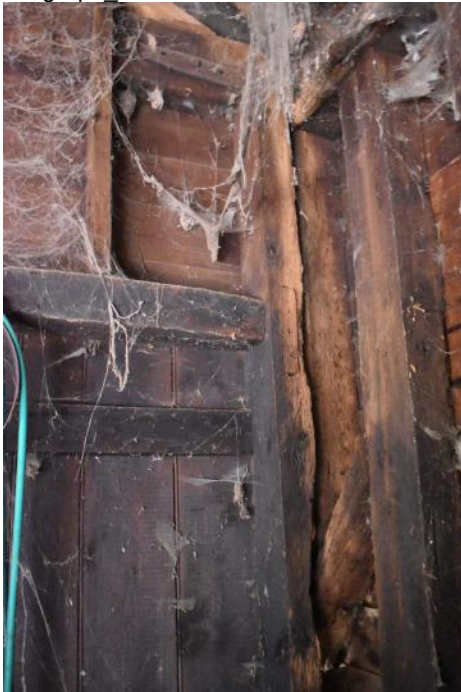
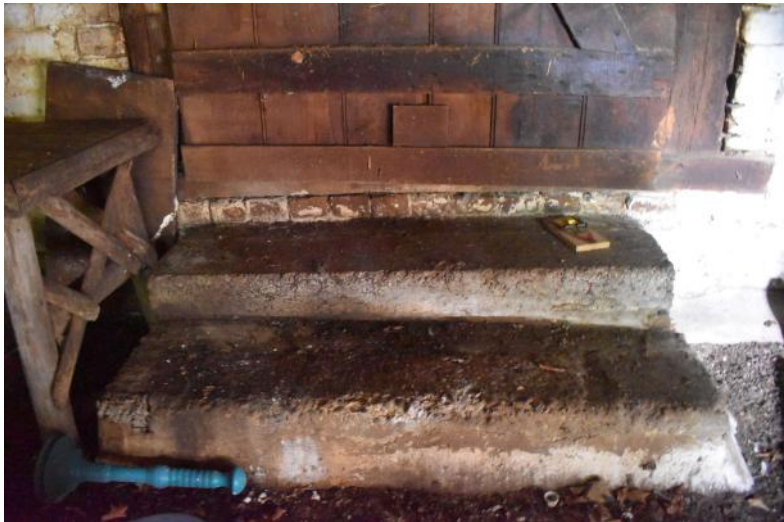
SOWBF22_PhotoGraph_051Detail of reused timber in door frame of ... SOWBF22_PhotoGraph_052Detail of steps and row of headers in door...

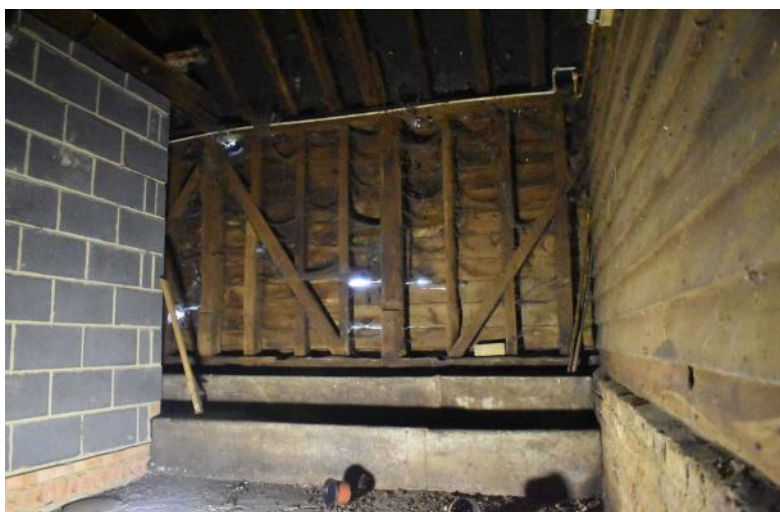
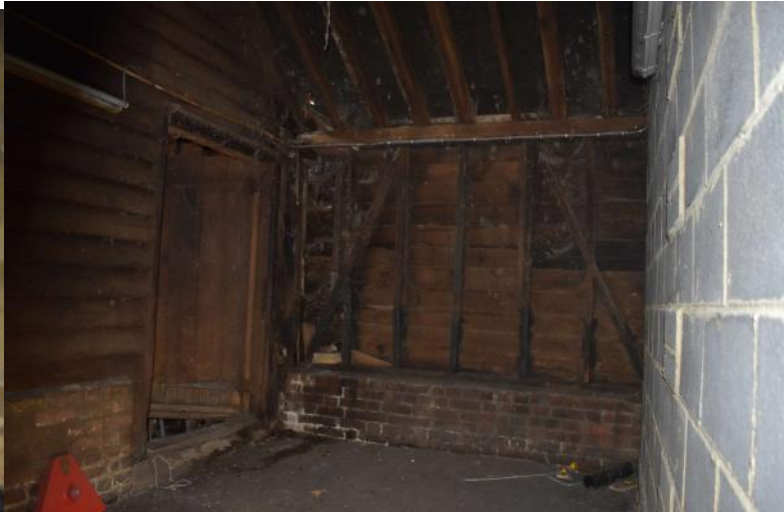
SOWBF22_PhotoGraph_053Interior of store 4. Photograph taken facin... SOWBF22_PhotoGraph_054Interior of store 4. Photograph taken facin...

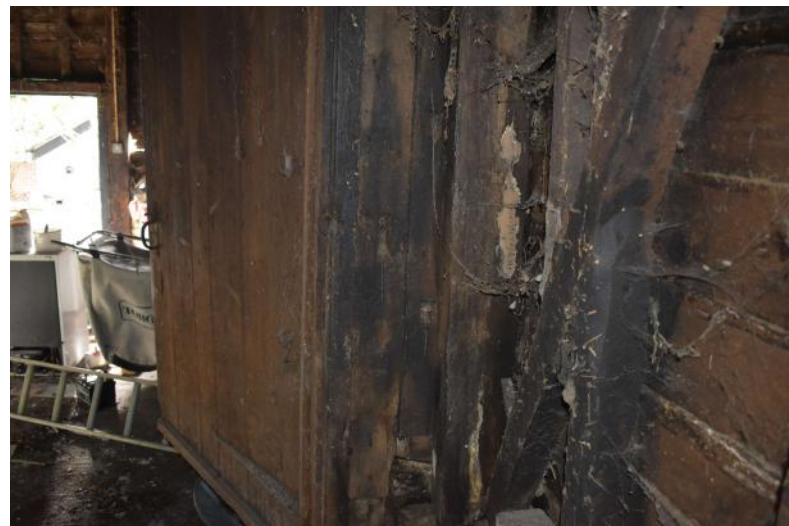
SOWBF22_PhotoGraph_055Detail of reused timber in door frame betw... SOWBF22_PhotoGraph_056Detail of doorway between stores 3 and 4...

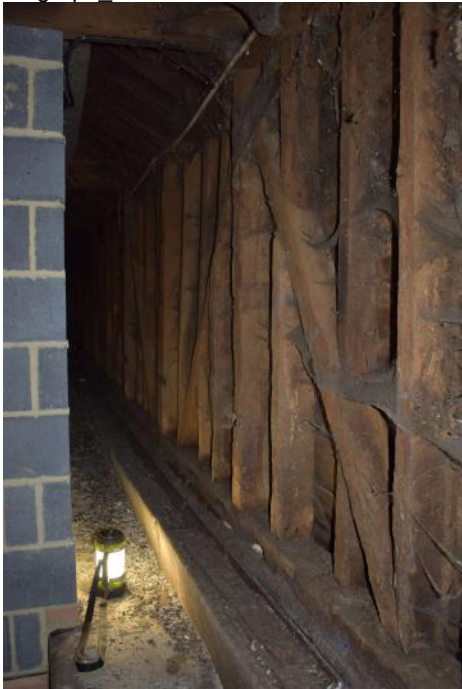
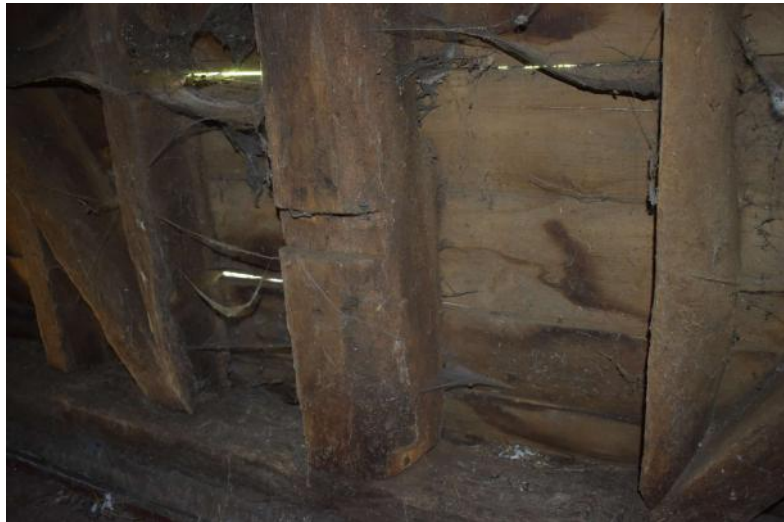
SOWBF22_PhotoGraph_057Detail of timber frame in store 4. Photogra... SOWBF22_PhotoGraph_058Detail of notch in post in store 4. Photogra...
