**Historic building recording of an outbuilding at
Bennett's Farm, Weald Road, South Weald,
Brentwood: November 2022**

**CAT project ref.: 2022/10g
ECC code: SOWBF22**

**Historic building recording of an outbuilding at
Bennett's Farm, Weald Road, South Weald,
Brentwood**

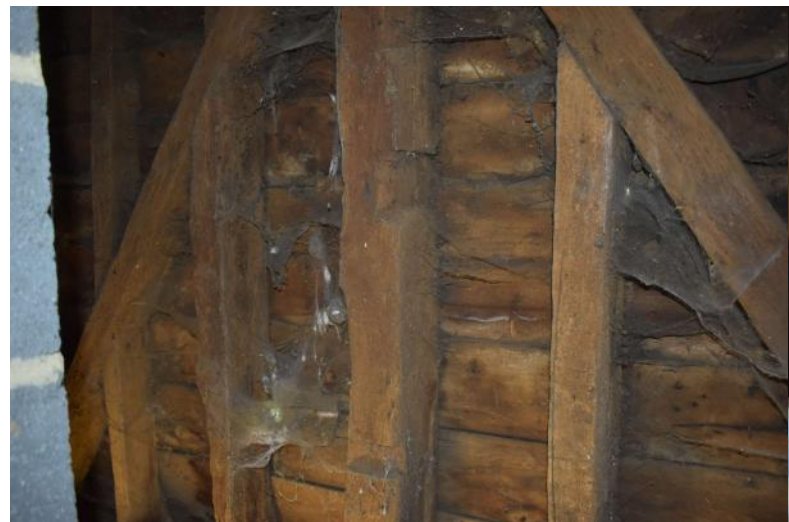
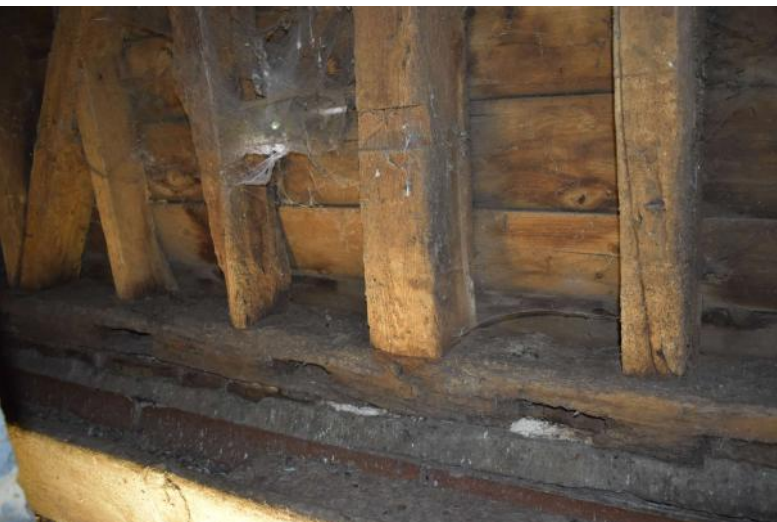
SOWBF22_PhotoGraph_059Detail of reused timber post in store 4. Ph... SOWBF22_PhotoGraph_060Detail of reused timber for sill-beam in stor...

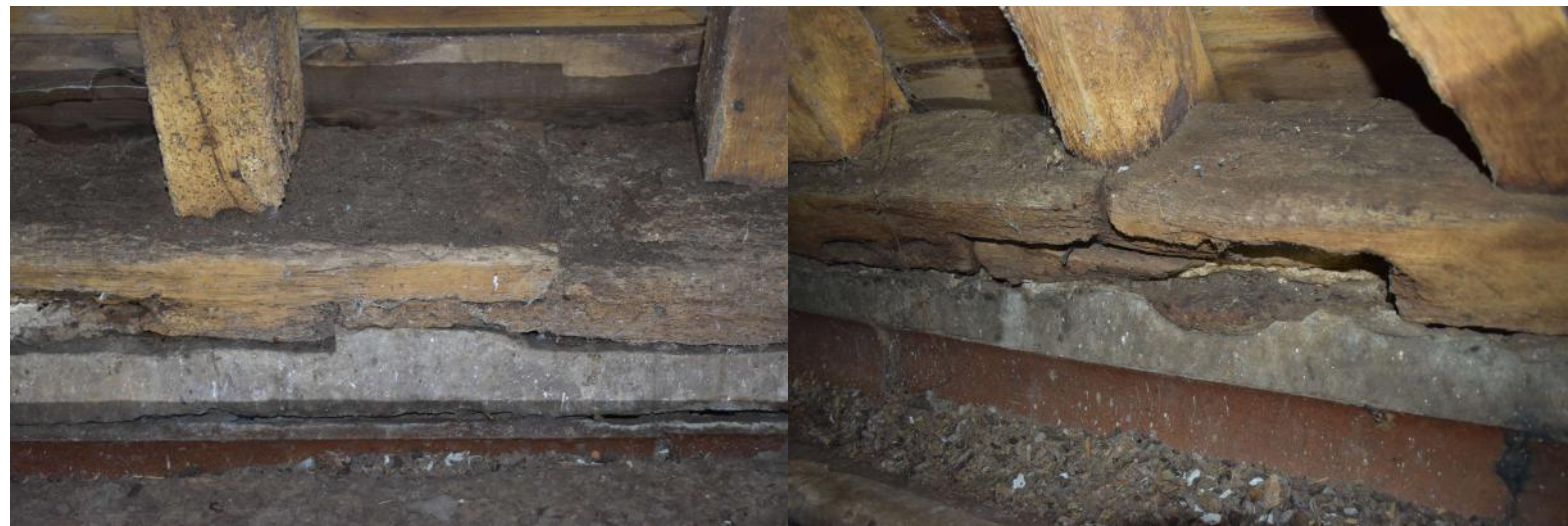
SOWBF22_PhotoGraph_061Detail of scarf joint in sill-beam in store 4. ... SOWBF22_PhotoGraph_062Detail of scarf joint in sill-beam in store 4. ...

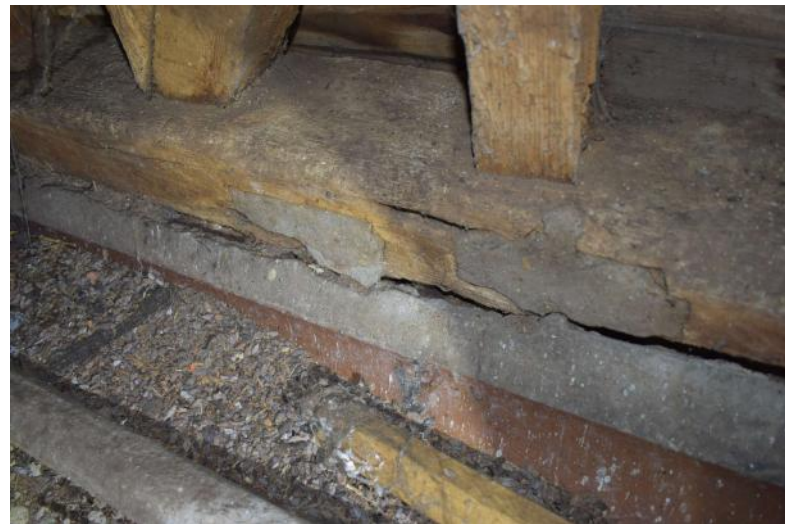
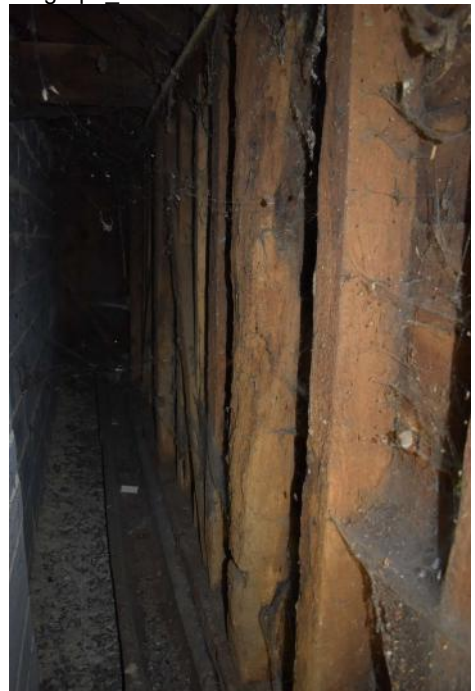
SOWBF22_PhotoGraph_063Detail of cement-filled mortices on sill-bea... SOWBF22_PhotoGraph_064Detail of timber frame in store 4. Photogra...

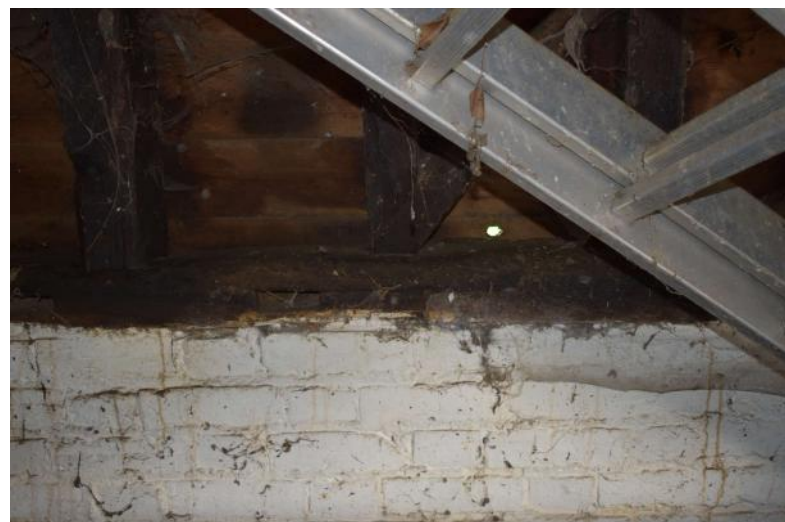
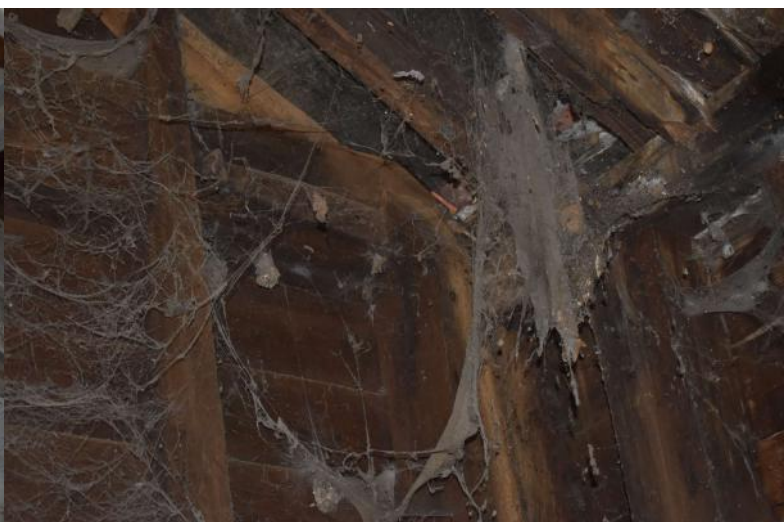
SOWBF22_PhotoGraph_065Detail of scarf joint in sill-beam in store 3. ... SOWBF22_PhotoGraph_066Detail of metal strap in tie-beam between ...
