**A survey of Rayne Foundry,
The Street, Rayne, Braintree, Essex
May 2008**

**report prepared by
Chris Lister**

CAT Report 475
August 2008

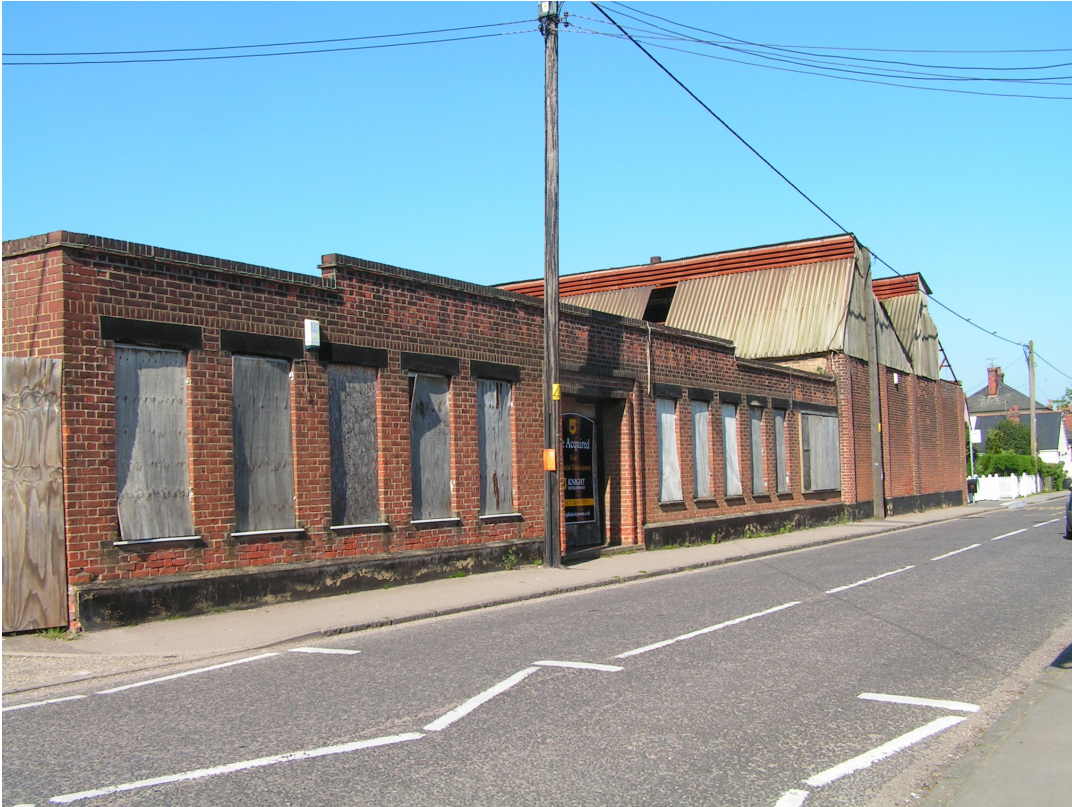
A1.1 Rayne Foundry frontage showing main offices, view north-east, from The Street.

A single-storey, linear office range of red-brick fronted The Street. The staff canteen was at the west end of this range with four offices between this and the main entrance. To the east of the main entrance were four more offices. Behind this range of offices, separated by a narrow corridor, were the office kitchen and washroom facilities, and two store rooms. The corridor led down three steps into the foundry proper. To the west of this doorway lay the entrances to the foundry washrooms, female to the immediate west and male at the far western end. The female washroom was painted pink with one shower cubicle, a WC and a washbasin; the male washroom had three shower cubicles, a bank of seven washbasins, two WCs and a urinal. Through this to the west was a locker room.

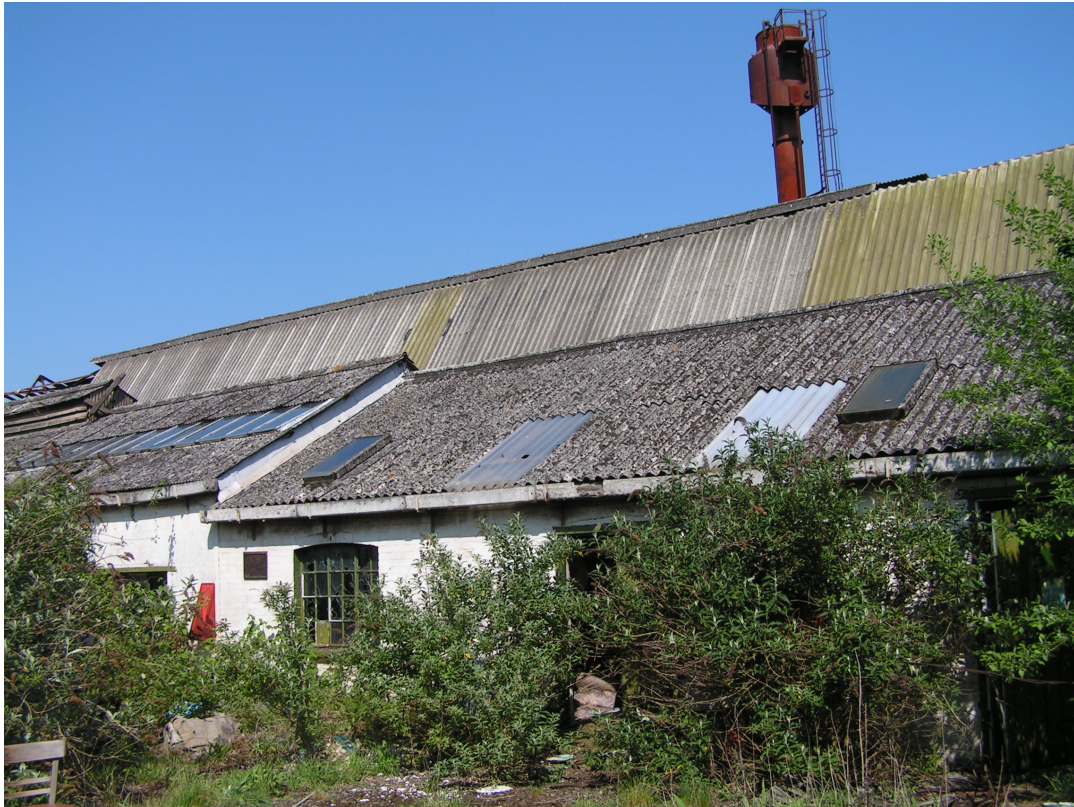
A1.3 Exterior of the pattern shop with main foundry in the background, view north-east.

This was a rectangular single-storey red-brick building on the west side of the foundry complex, approximately 20.9m long by 7.35m wide, and painted white inside and out. Entry (at the south-west corner) was through wooden double doors that opened outwards at the south-west corner, with three further points of egress, ie a single wooden door in the exterior wall in the north-west corner that opened outwards, a double iron door opening into Building 3 in the north wall, and a single iron door in the east wall that opened inwards. This last door led to the casting floor

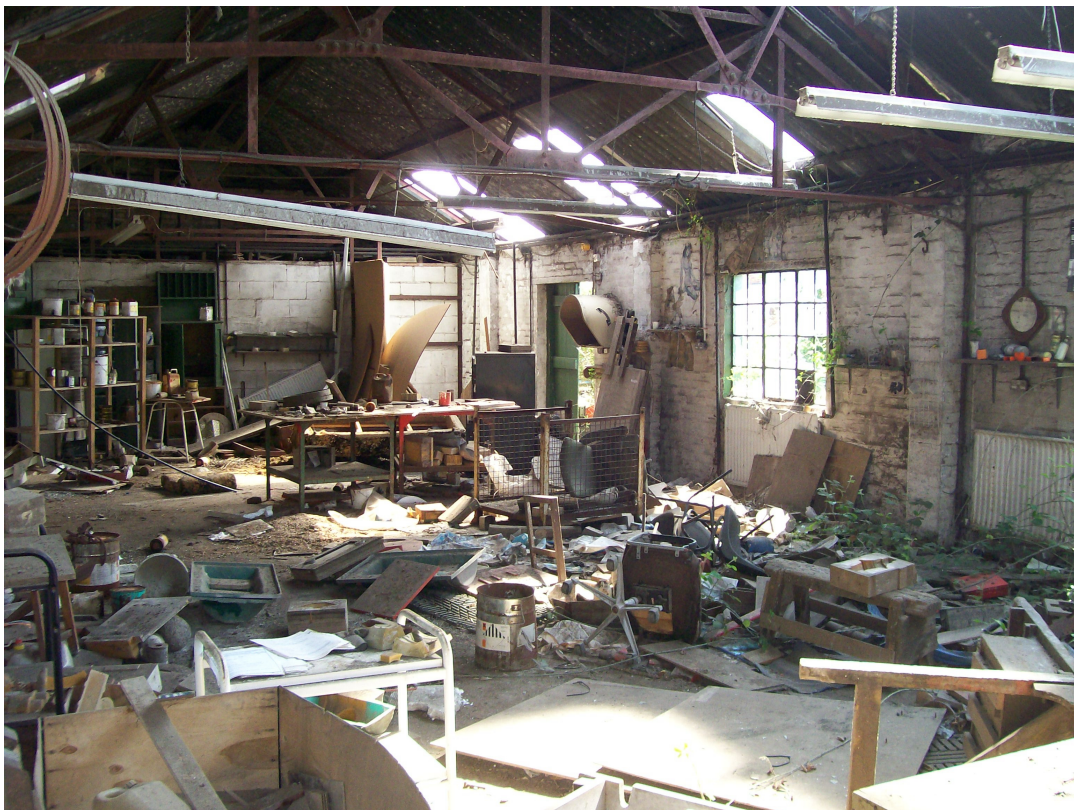
A1.4 Interior of the pattern shop, view south-west.

of the main foundry. Three sets of iron-framed windows were situated in the west wall, in-between the two doors. The roof was of corrugated asbestos sheeting, supported by iron trusses (Plate A2.156). Four raised skylights were in the roof at the south end, two on either side of the ridgeline. In between these skylights, translucent plastic was substituted for two of the asbestos panels. Immediately to the north of the southernmost window, the exterior walls rose by approximately five courses of brick and continued at this level through the rear wall of the pattern shop into Building 3. An unbroken line of skylights extended along the centre of the west side of the roof. At the south end of the pattern shop was a modern wall constructed of breezeblocks. This stood slightly lower than the external walls and separated a WC and a small, flat-roofed kitchen from the pattern shop. A single wooden door that opened outwards in the western external wall accessed these areas as well as a door in the south wall that opened inwards from the goods in area. The north wall of the pattern shop was of poured concrete panels that completely filled the area from the ground to the apex of the roof. It is clear that Building 2 did not originally extend as far north as this but was enlarged at some point. Attached to the south wall of the pattern shop were several lockers and shelves that held adhesives and fittings used by the pattern-makers. A few benches remained, along with half-finished patterns, random tools and equipment, but no *in situ* machinery was present.

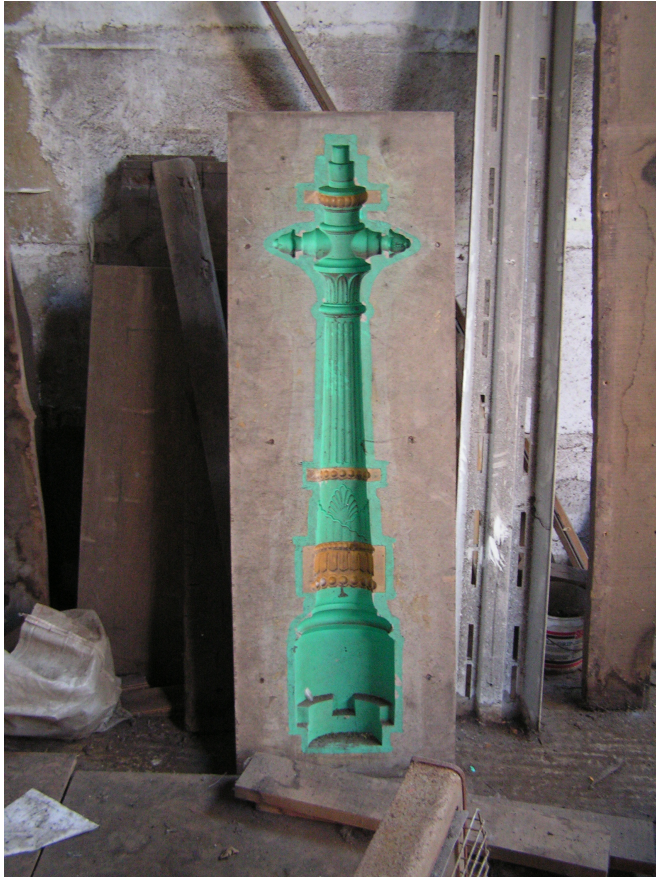
A1.5 Wooden pattern for bollard requiring a core, Building 3.

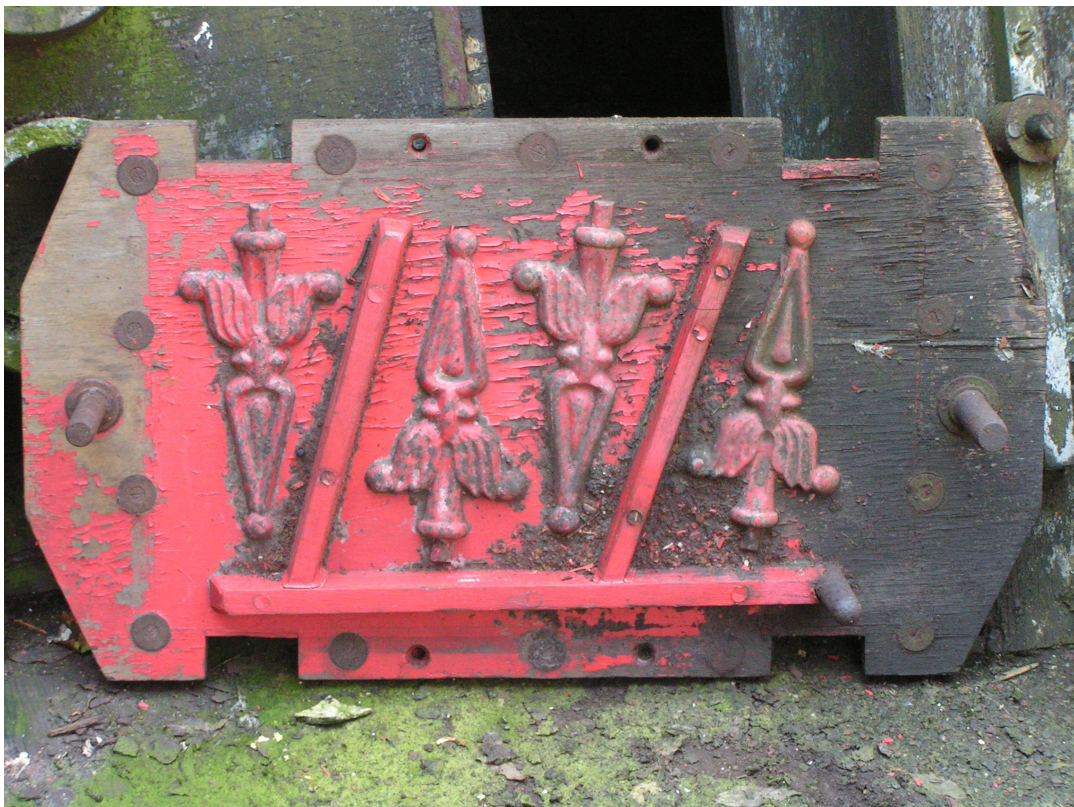
A1.6 Wooden pattern for ornamental railings, pattern loft.

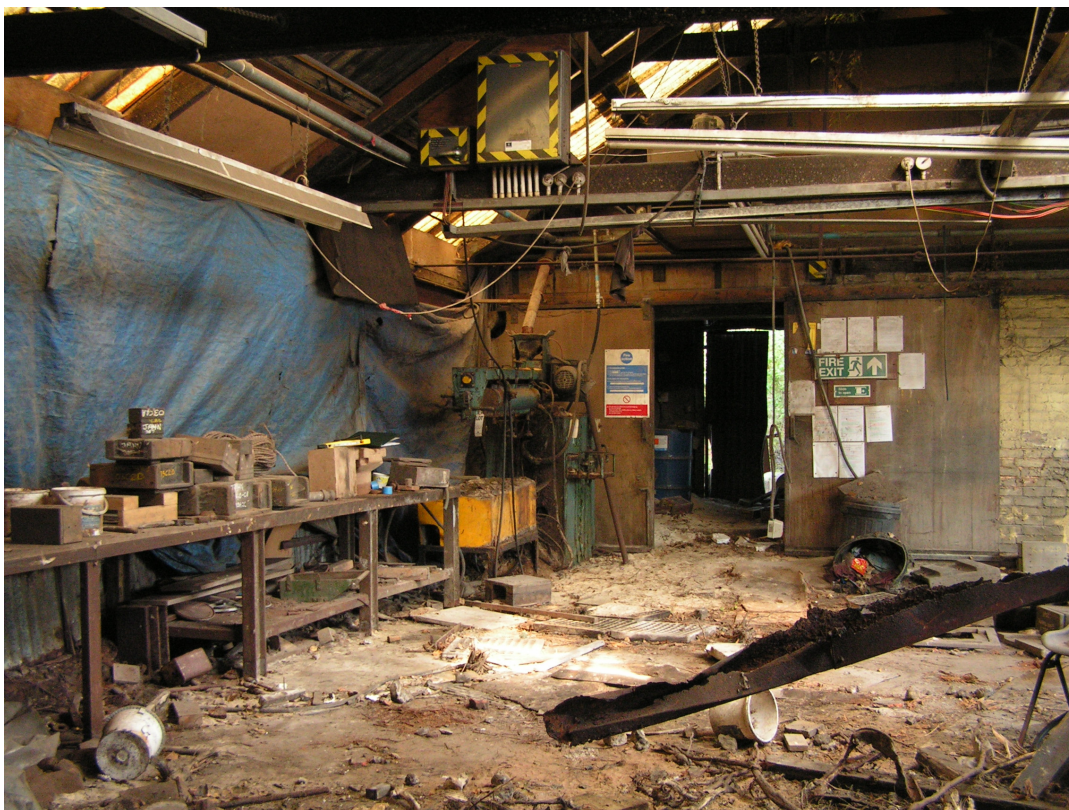
A1.7 Core shed, sand and spermalene mixing machine, view north-west.

In the north-west corner of the core shed was a machine for mixing sand and spermalene (a hardening agent), and a bench with patterns, rammers and other materials for making cores. To the east of the shed was a rack of cores waiting to be baked in the large Gibbons Brothers gas-fired oven that was centrally positioned along the east wall of the shed (Plate A1.9). This replaced an oil-fired oven that reportedly once stood in the south-west corner of the shed and had been fuelled by the oil tank in the area to the west.

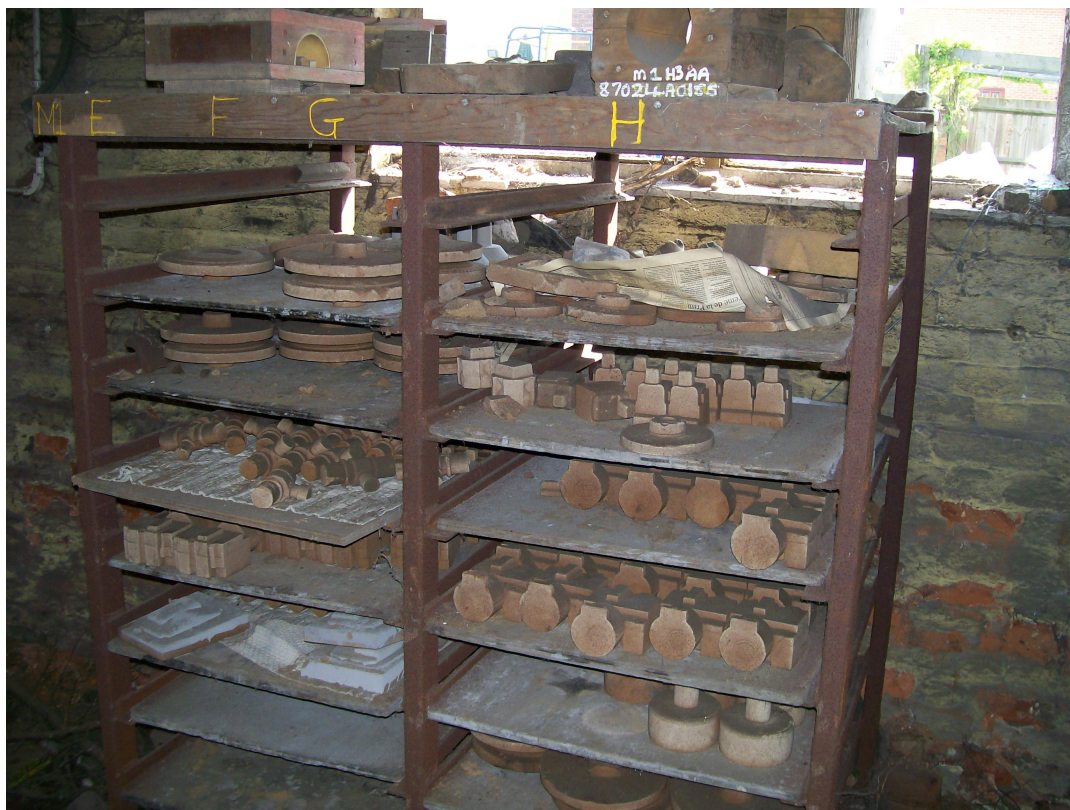
A1.8 Cores waiting to be baked in the core oven, view north-east.

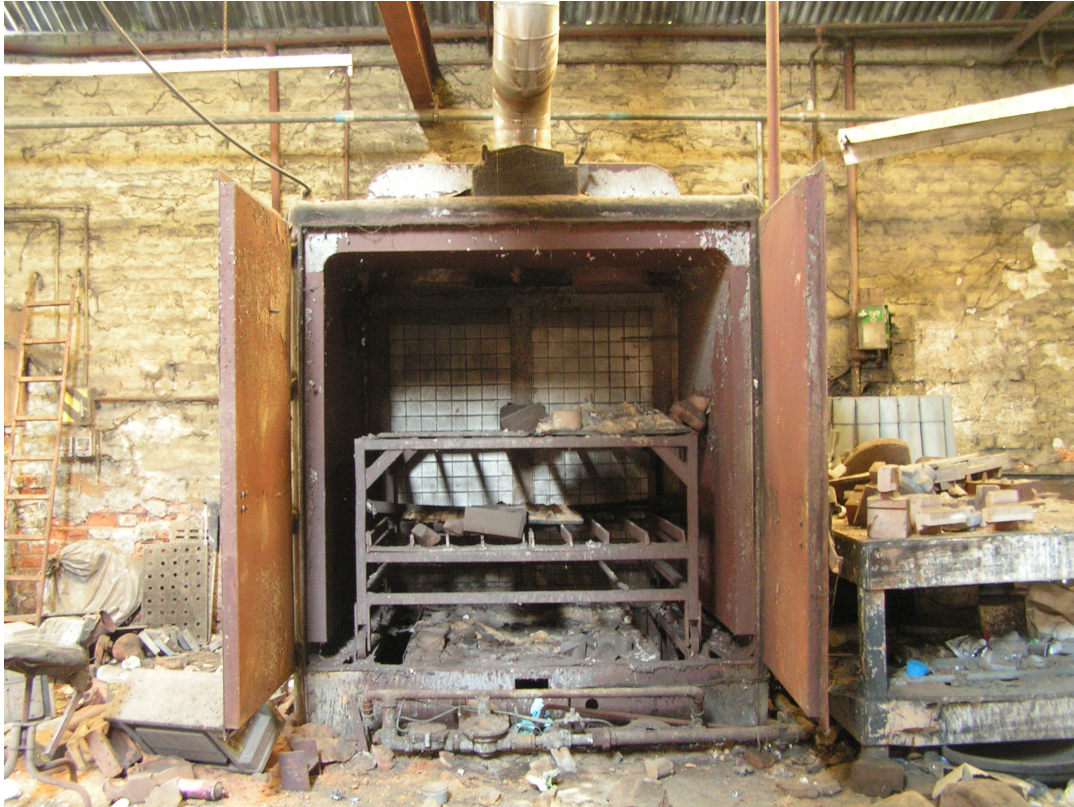
A1.9 Core baking oven, view east.

Sand from the hopper in the core shed was originally mixed by hand with spermalene, a task that was later mechanised. Eventually a sand and resin/acid mix replaced the sand/spermalene mix. This mix was poured into a pattern to form a core, then rammed hard and removed. Any imperfections that might be passed onto the casting were removed by hand and then the cores were baked in the core oven. This was a large gas-fired industrial oven, 1.9m wide by 1.45m deep by 2.1m high, manufactured by Gibbons Brothers Ltd of Dudley. It was installed at Rayne Foundry in the late 1980s, replacing an older oil-fired model.

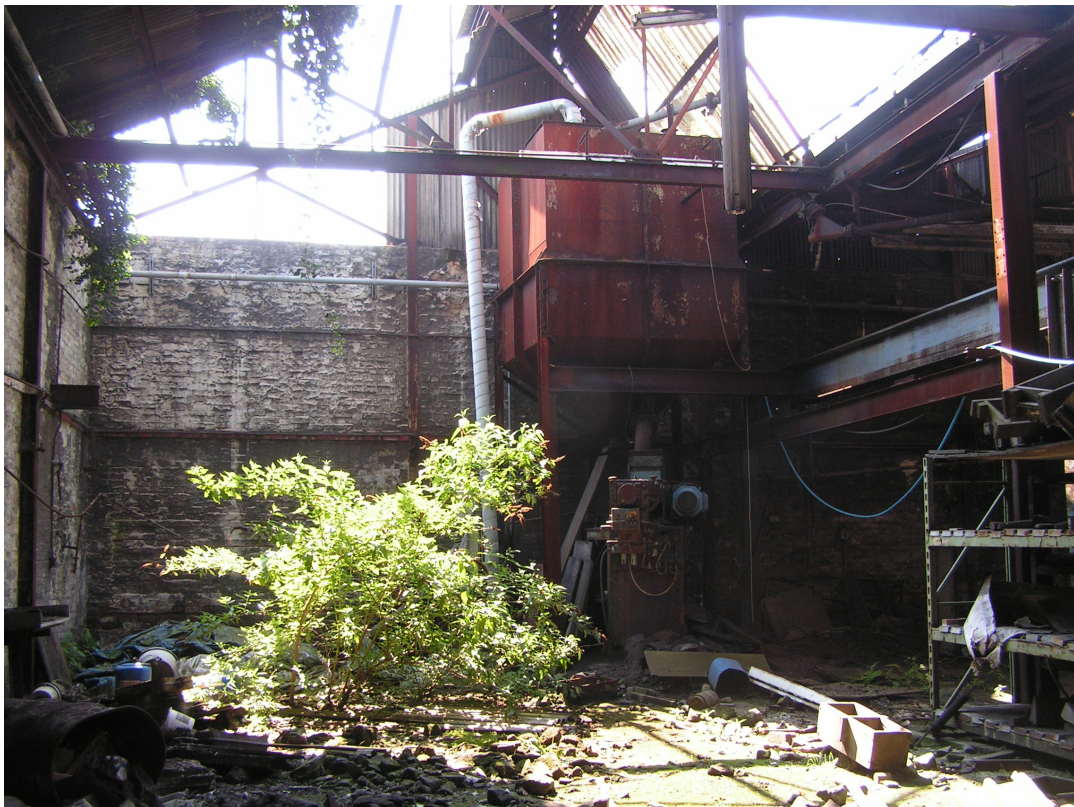
A1.10 The moulding floor with the moulding sand hopper to the right, view south-west.

Through the open east end of the aluminium foundry was the **moulding floor** where the final moulds for the castings were manufactured (Plates A2.40-44). This was one of the older surviving parts of the early foundry, with the east and south walls (approximately 4.7m high) constructed of red brick. The wall to the east of the moulding floor is depicted on the Ordnance Survey map of 1881, as part of a rectangular building aligned roughly north to south. The south wall of this building was separated from The Street by a small structure. By the time of the second edition Ordnance Survey map of 1895, this small building had been removed and the southern wall of the moulding floor extended to The Street frontage. When the foundry was expanded, the west and north walls were removed and replaced by evenly-spaced steel stanchions. A line of evenly-spaced steel stanchions extended north to south down the centre of the moulding floor supporting the double pile roof. This was an unevenly pitched construction of corrugated asbestos sheeting to the east with translucent corrugated plastic panels to the west, a 'saw' design typical of many industrial structures (Plates A2.1, A2.7). The apexes of these had a raised ridgeline with louvred sides for ventilation. At the south end of the moulding floor stood a sand hopper, on the east side of the dividing steel stanchions, whilst, on the west side, large tanks of acid for mixing with the moulding sand once stood.

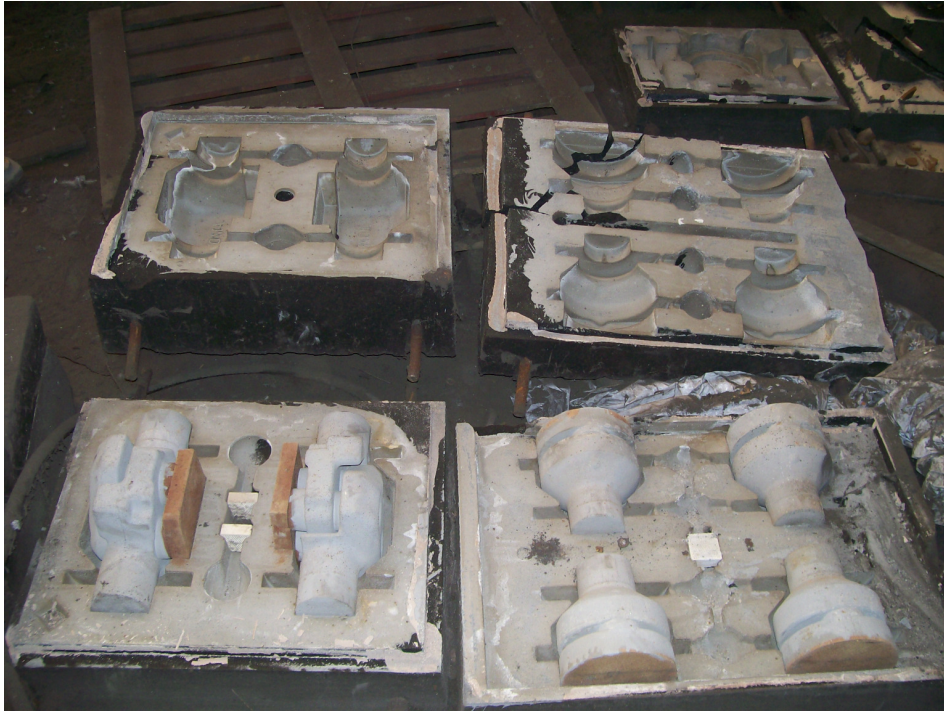
A1.11 Cores placed in moulds ready for casting.

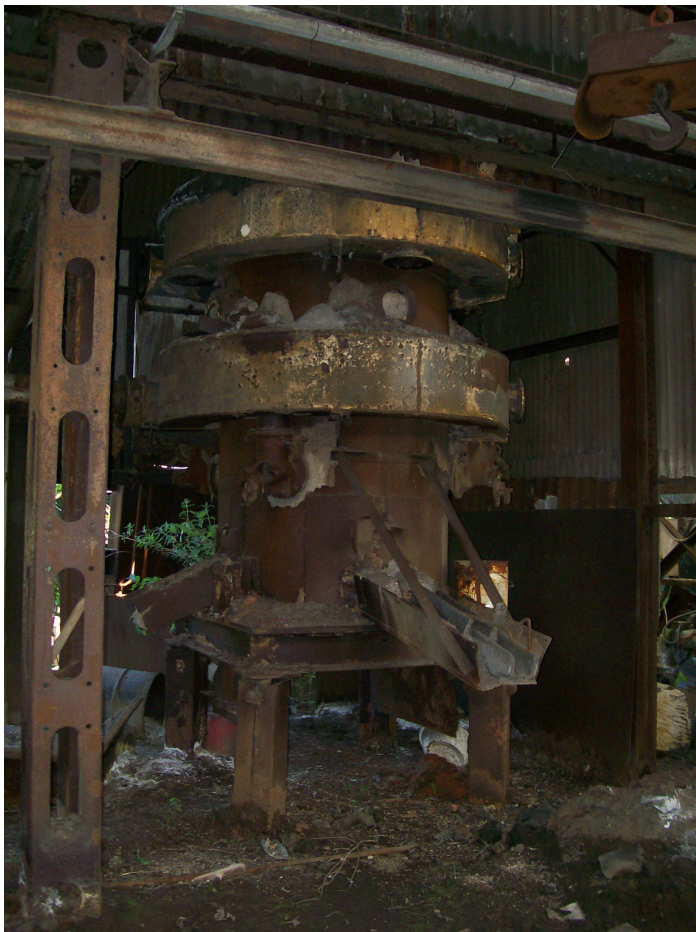
A1.12 Roper cupola furnace, view south-west.

Rayne Foundry's Roper cupola furnace was moved twice in its history, spending 30 years in its final location. The cupola furnace was a coke-fired furnace charged by an external automatic feed system from a raised platform. A ratio of pig iron to scrap was used, depending on the nature of the casting. Limestone was added to the mix to purify the metal. Air was fed into the furnace from an electrically powered fan. It averaged 2-3 tonnes of coke for a day's firing, usually being fired up at 11 am for a 2 pm pour. The 20m-tall chimney was shrouded in a water jacket to remove fumes and grit.

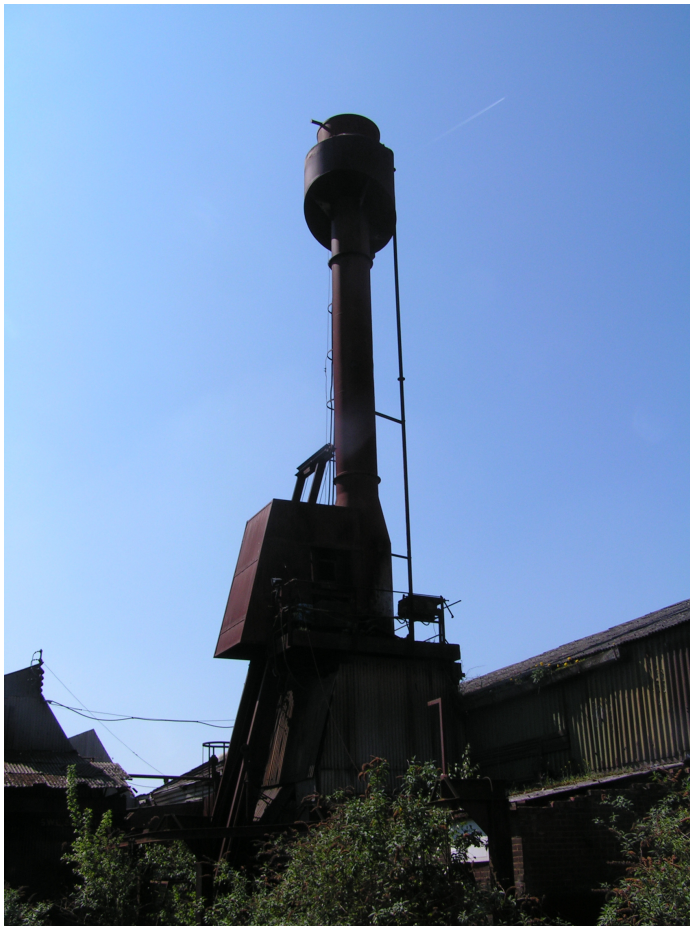
A1.13 Roper cupola chimney, view south-west.

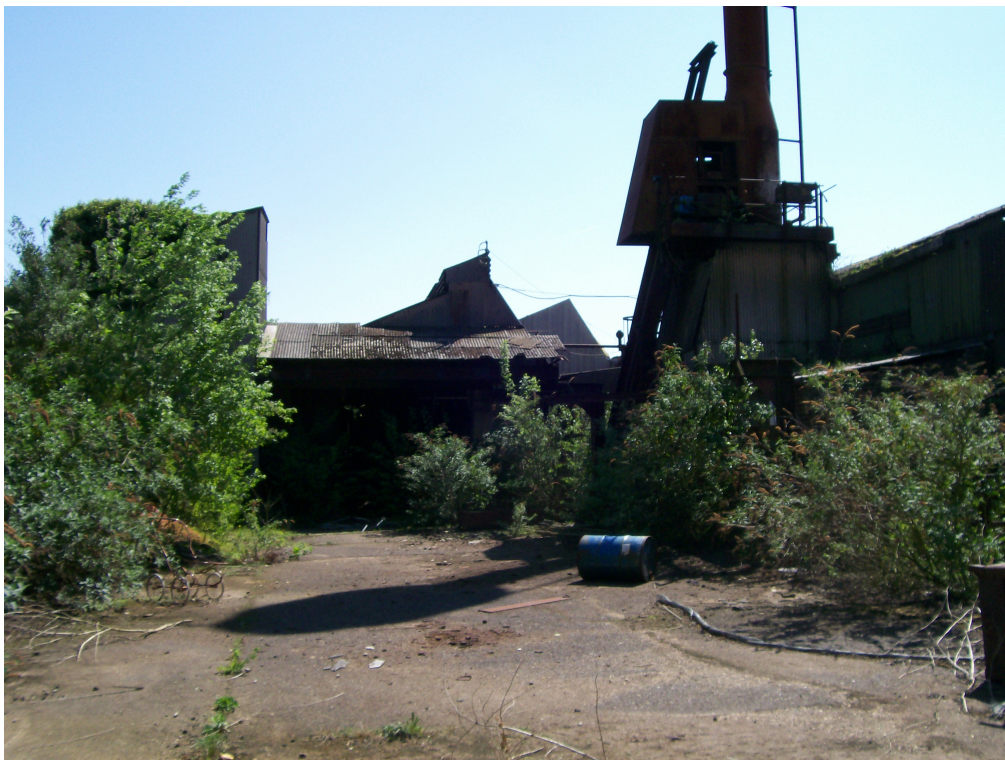
A1.14 Roper cupola chimney showing the automatic lift to the charge door, view south.

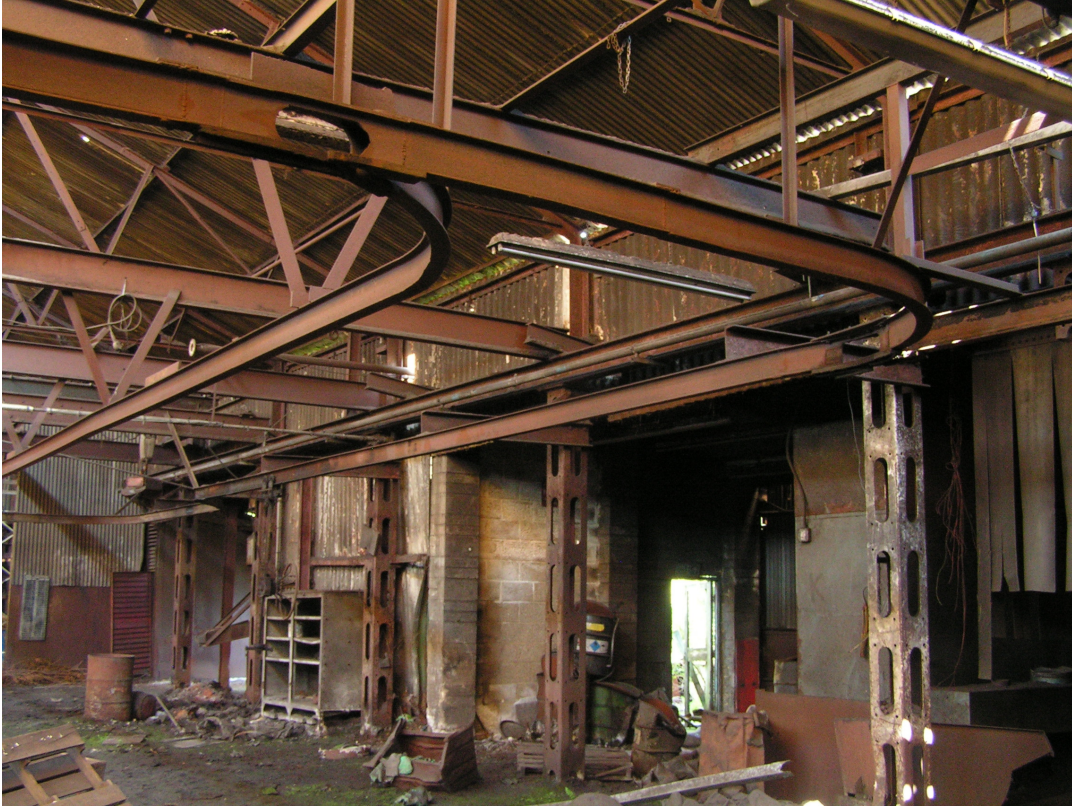
A1.15 The overhead monorail metal-handling system, view north-east.

When the iron was molten and the impurities drawn off, the liquid metal was poured into ladles suspended on hoists. These hoists were moved around the overhead monorail metal-handling system to the casting floor and the waiting moulds by chains pulled by the foundrymen. The ladles could rotate 360 degrees as well as being raised or lowered with the hoists; this allowed the four overhead rails to distribute to twice that number of casting rails. As the molten iron was poured into the moulds, the heat ignited particles of coal dust or manure in the sand, causing

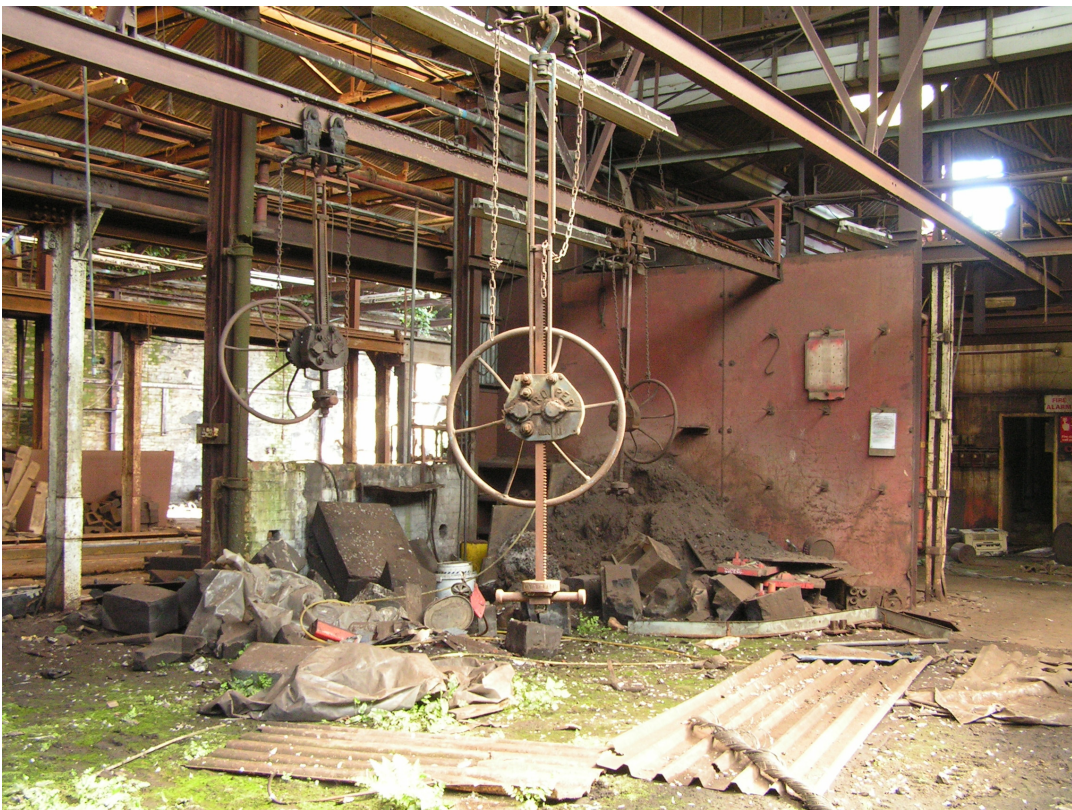
A1.16 The overhead monorail metal-handling system with ladle hoists, view north-east.

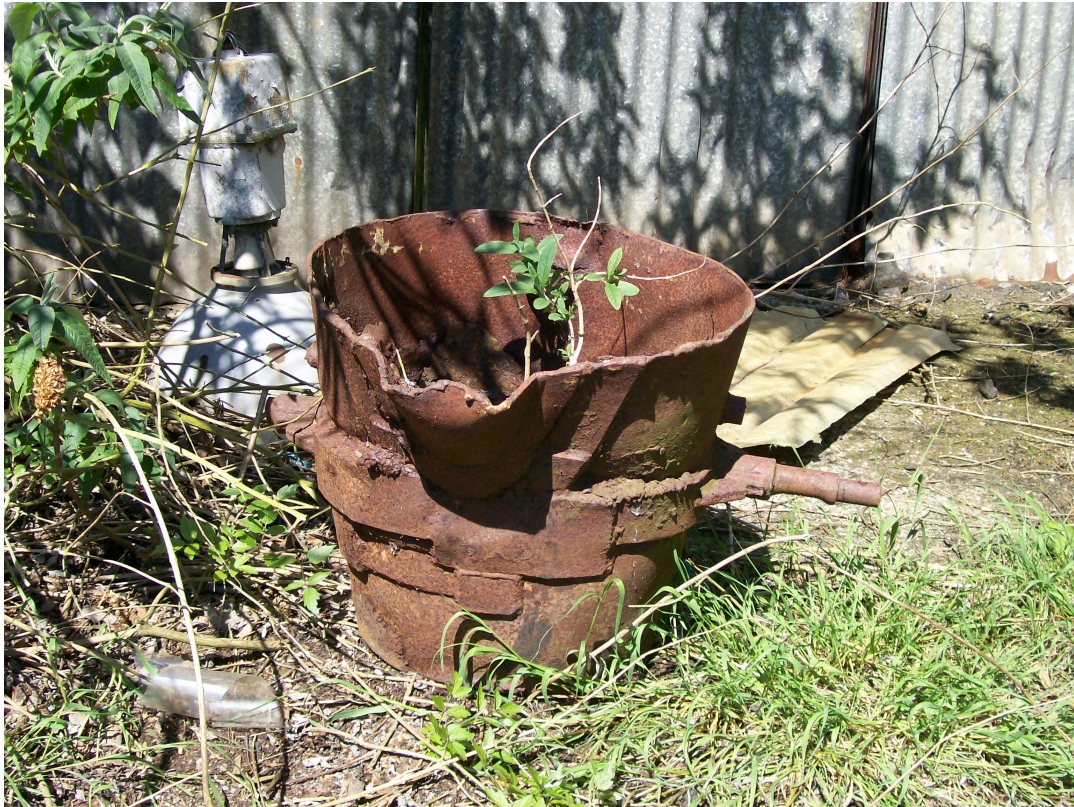
A1.17 Discarded suspended ladle.

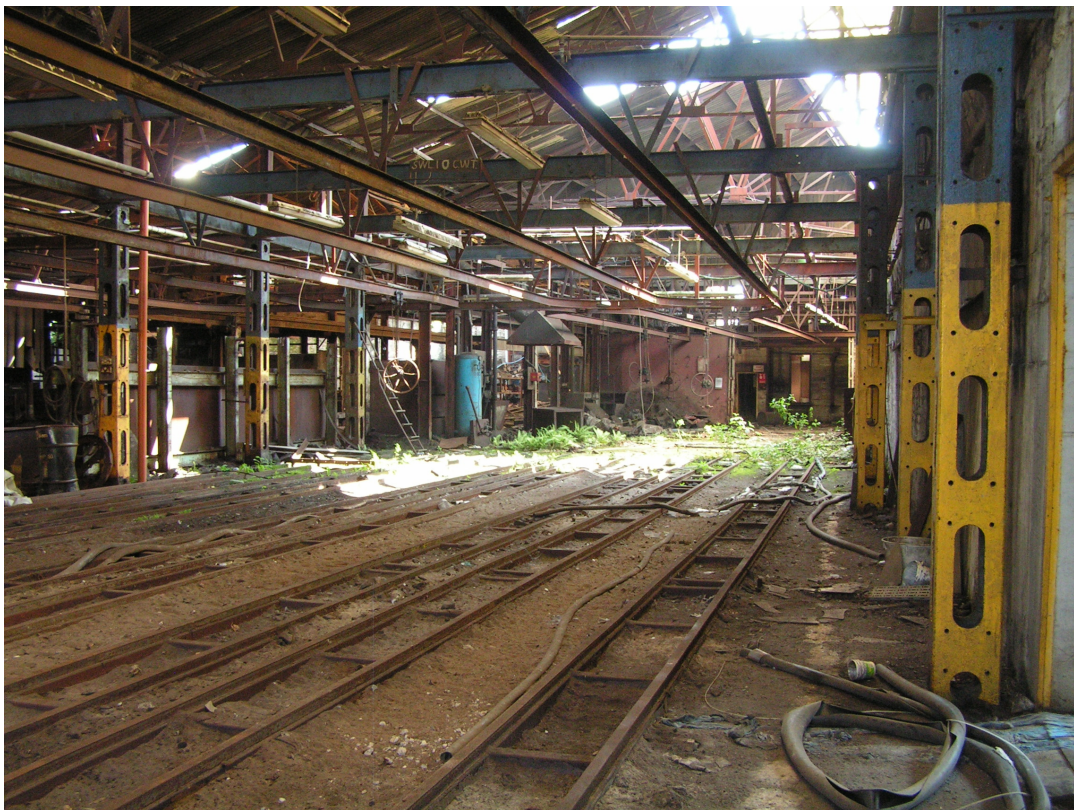
A1.18 Main foundry casting floor with overhead monorail metal-handling system, view south-east.

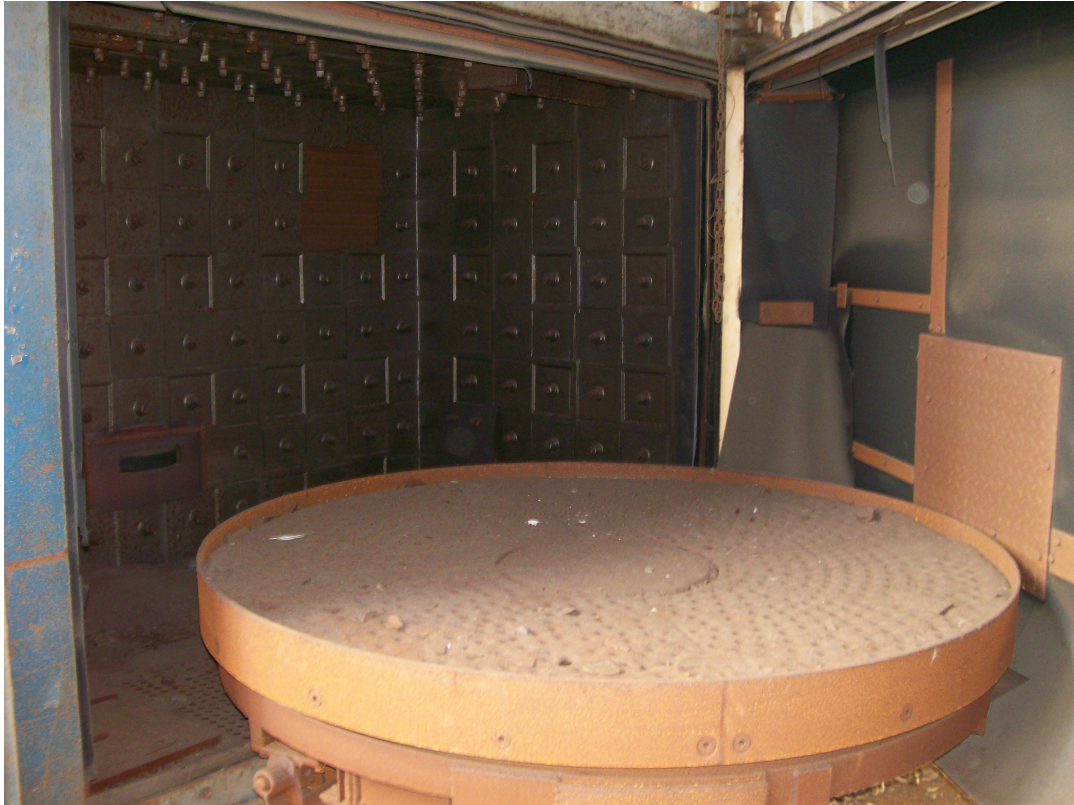
A1.19 Interior of Pangborn shot blasting machine, with blasting plate to the foreground, view north-west.

To the north of the moulding floor, past a deep sump with a metal ladder and another dust collector, was a fire exit. Opposite this was an area where finished and broken moulds were stored in preparation for recycling. North of the fire exit and attached to the exterior of the north-east foundry wall was the furnace. This was a British-made coke-fuelled **Roper cupola furnace**, standing 20m tall, capable of melting up to 18 tonnes of iron per day (Plates A1.12-14). The area to the east of this had an overhead monorail metal-handling system extending across the width of the foundry to the casting floor. Ladles of molten iron attached to hoists were pulled around the monorail by chains and delivered to the casting floor and the awaiting moulds. North of the furnace was a small brick and breezeblock building, housing the electric motor for the furnace air-injection system. In the far north-east corner of Building 1, just inside a large entrance, was an American-made Pangborn shot-blasting machine and two dust extractors (Plates A2.106-114).

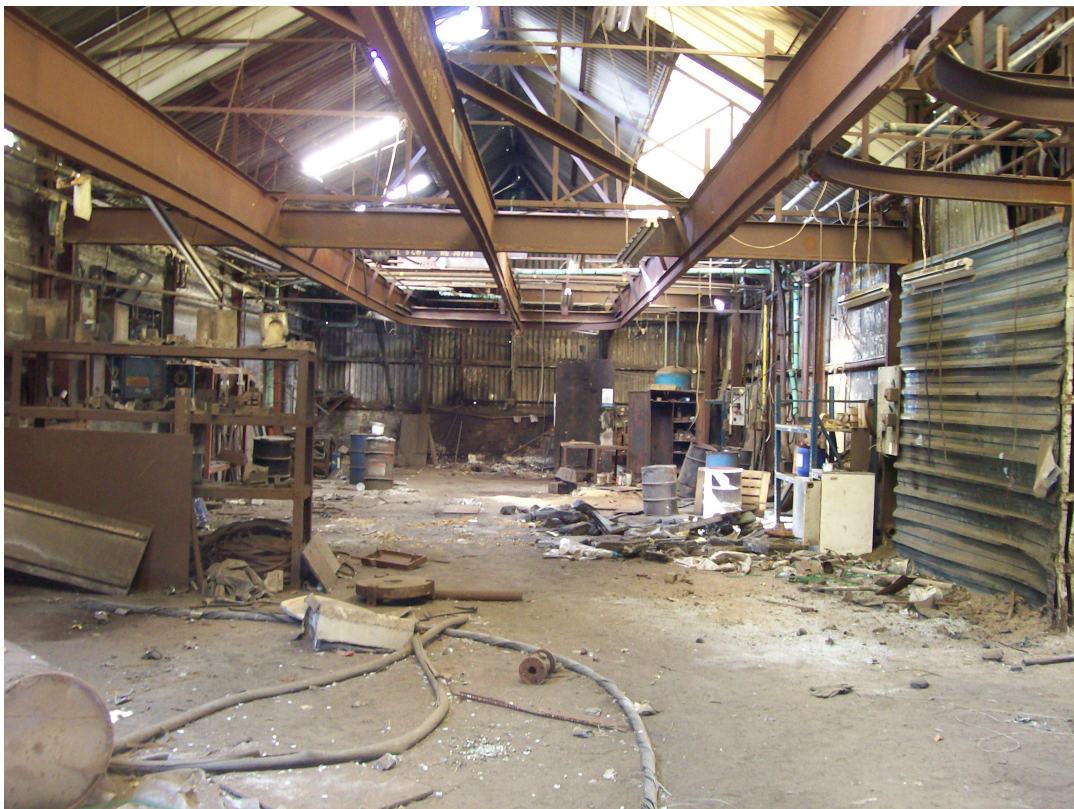
A1.20 Aluminium foundry with overhead monorail metal-handling system, view south-west.

The first part of the complex entered from the offices was the **aluminium foundry**, approximately 26m long by 9m wide. The west and north walls were of corrugated iron sheeting attached to upright steel stanchions that supported a framework of iron trusses covered by corrugated asbestos sheeting. A line of translucent corrugated plastic panels was centrally located in the northern side of the roof. A sliding door in the north wall provided access to an area marked 'Goods in'. The east wall was open to the moulding floor. In the north-east corner was a heat-extractor hood for an aluminium furnace with a trough cut into the concrete floor beneath it. Two smaller furnace troughs were located along the north wall, probably for copper-alloy working. None of the furnaces remained *in situ*. An iron rail was suspended from the roof trusses in front of the main aluminium furnace. This was the overhead monorail metal-handling system that carried molten metal to the casting floor of the aluminium foundry.

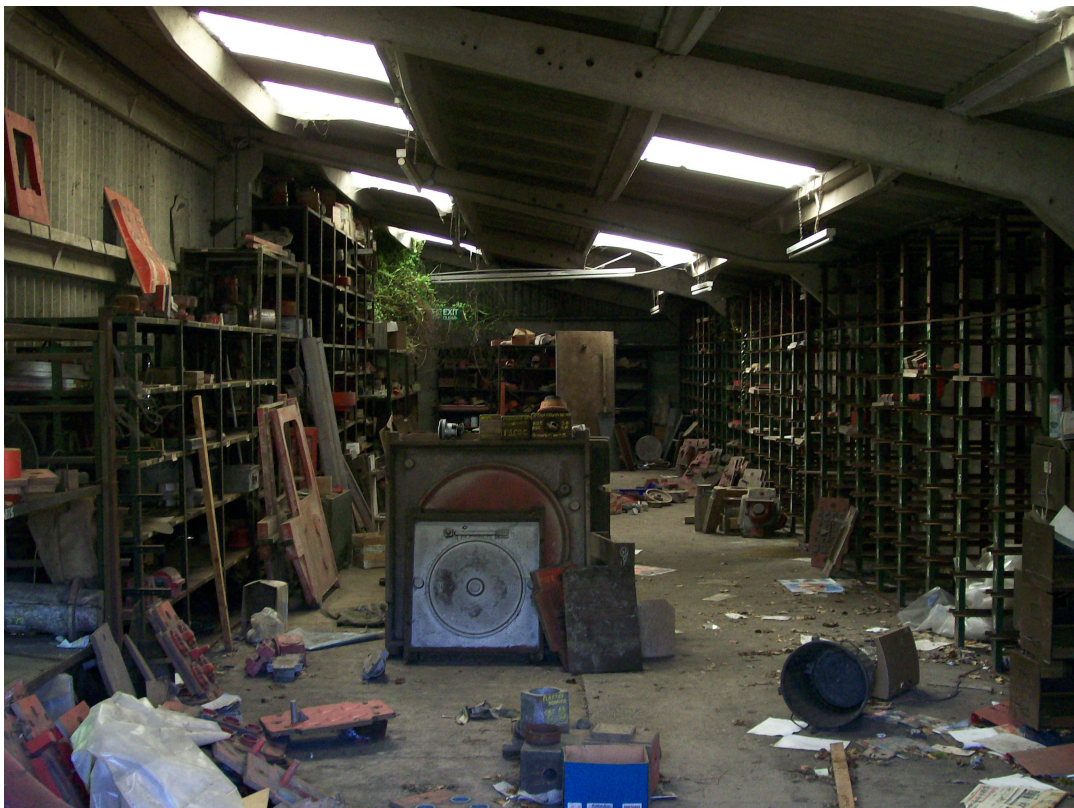
A1.22 Pattern store interior, view south-west.

Building 6, the main pattern store for Rayne Foundry, was constructed around a pre-cast concrete frame with the north and west walls of breezeblocks, whilst the south and east walls were of corrugated asbestos sheeting. The sloped roof was of corrugated asbestos sheeting with transparent panels set at spaced intervals. Access was through a single sliding wooden door in the east wall and there was a wooden fire exit at the west end of the south wall. The pattern store measured 24.6m by 6.2m and bore the legend 'ATCOST' above the door. The interior was shelved around the walls from floor to ceiling and was full of wooden patterns. It was constructed in the late 1980s.

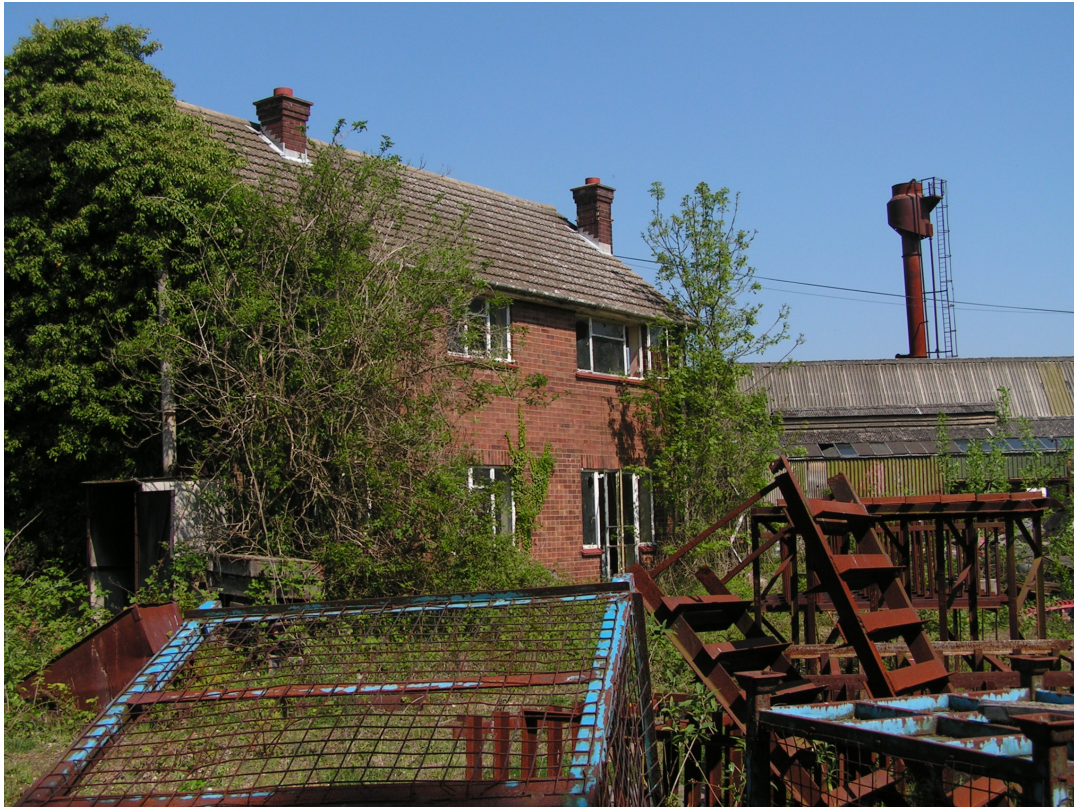
A1.23 Building 7: the former foundry manager's house with the main foundry complex and cupola chimney in the background, view east.

Building 7 was a two-storey brick-built house, with a tiled roof, 10.5m long by 5.6m wide. The doors and windows were single-glazed with metal frames and the house had two chimneys. This used to be the residence of the foundry manager but was later converted into offices and a laboratory for the quality-control testing of the iron produced during the casting process. The interior was judged unsafe to enter and no further comment can be made.
