**Historic building recording at the Coach House, Wakes
Colne Mills, Colchester Road, Wakes Colne, Colchester,
Essex, CO6 2BY**

May 2021

CAT Report 1698
November 2021

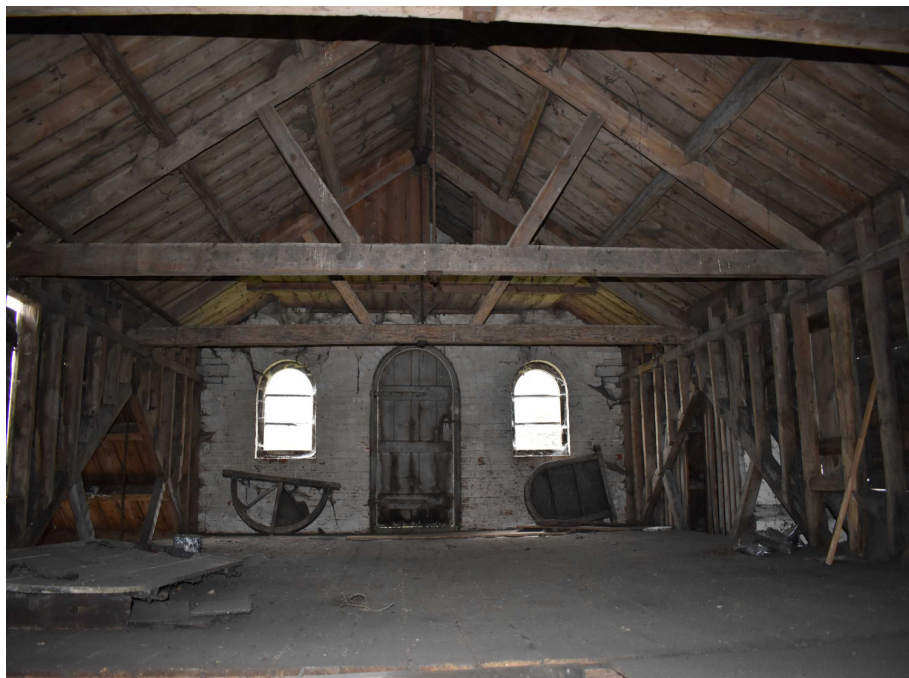
The first-floor of the cross-wing (Room 6) is centrally located above Room 1 (Photograph 18). The composition of the trusses in the first-floor roof are identical to those on the ground floor. The existing wooden floor-boards appear to be later replacements and two openings in these floor-boards, formed by the removal of seven of the joists, provide access to the ground floor, although no staircase or ladder is present (Photograph 19). This was likely the location of the original access point for the first floor, probably a fixed ladder rather than a staircase. The presence of a door in the south wall and the unfinished nature of the exposed beams suggest the first floor was designed as a hay loft rather than accommodation for grooms or coachmen.

Photograph 18 Room 6 - view south.

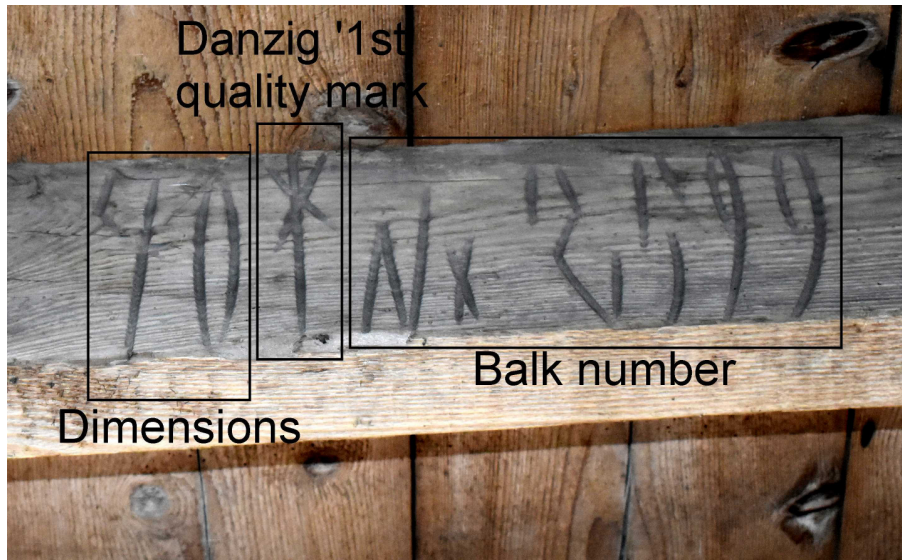
Numerous Baltic timber marks were observed on the frame of the coach house. Nearly all the marks that were decipherable bore the official quality mark associated with Danzig, a port in Prussia.

Photograph 22 Example of a Baltic timber mark. Photograph enhanced for legibility.

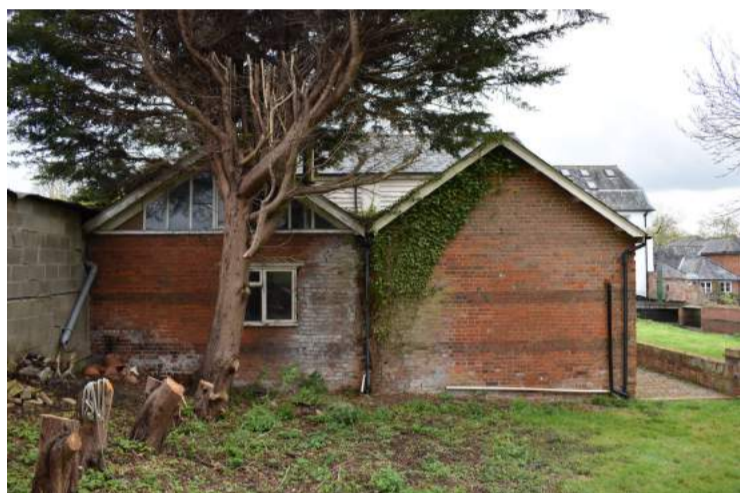
ECC4613_Photograph_027

The north wall displays evidence of extensive water damage, probably a direct result of the increase in ground level to the north of the coach house.

North elevation of coach house, showing built-up ground level against north...

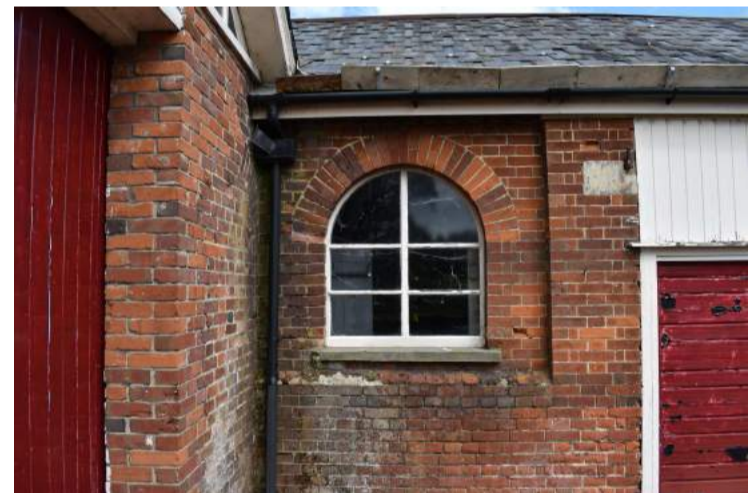
ECC4613_Photograph_044

Detail of south-east corner of coach house, showing rebuilding and differin...

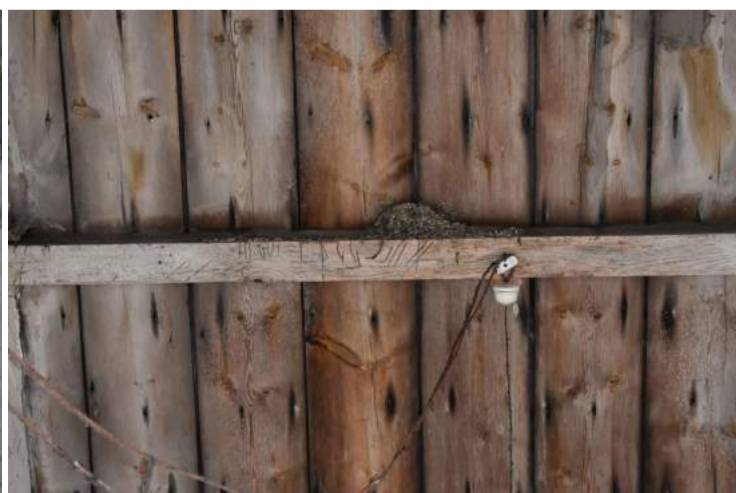
ECC4613_Photograph_046

Detail of roof in Room 4, showing southern pitch and baltic timber mark - vi...

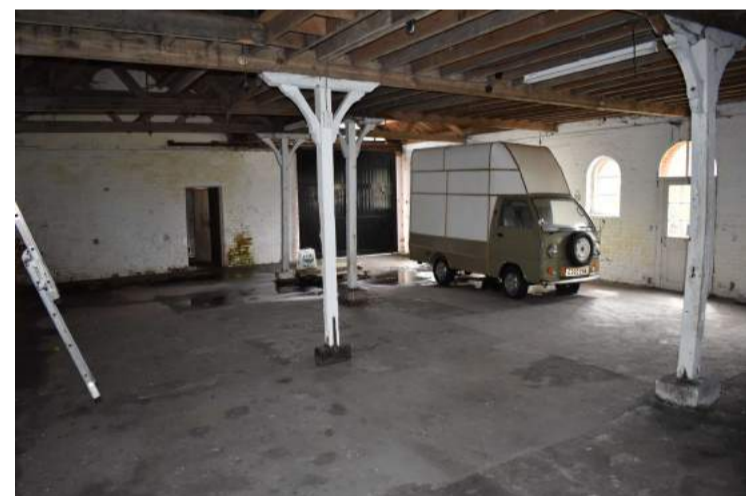
ECC4613_Photograph_054
Room 1, showing extensive water damage to northern wall - view north-east.

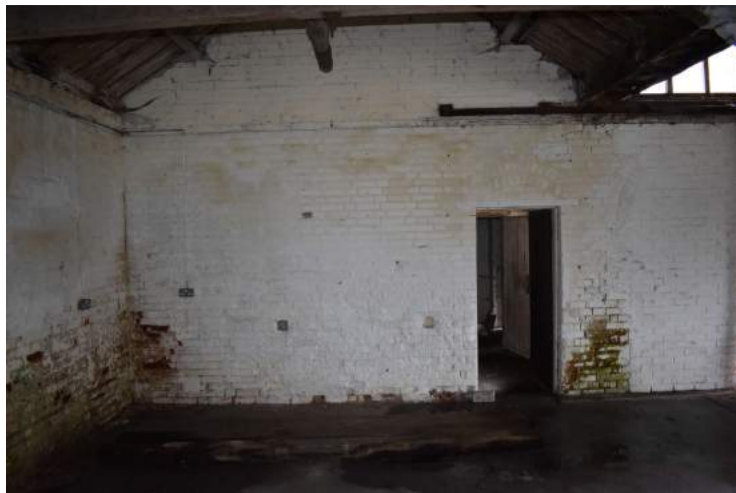
ECC4613_Photograph_062
Detail of water damage along northern wall of Room 1 - view north-west.

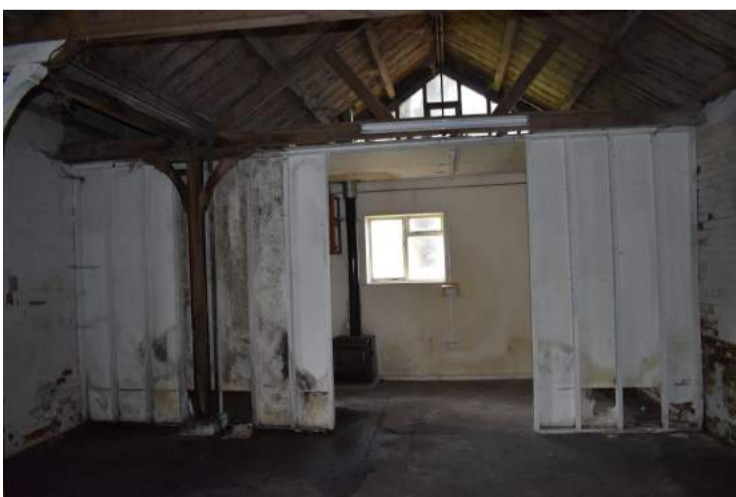
ECC4613_Photograph_070
Detail of inserted stud wall and original post in western end of Room 1 - view north-east.

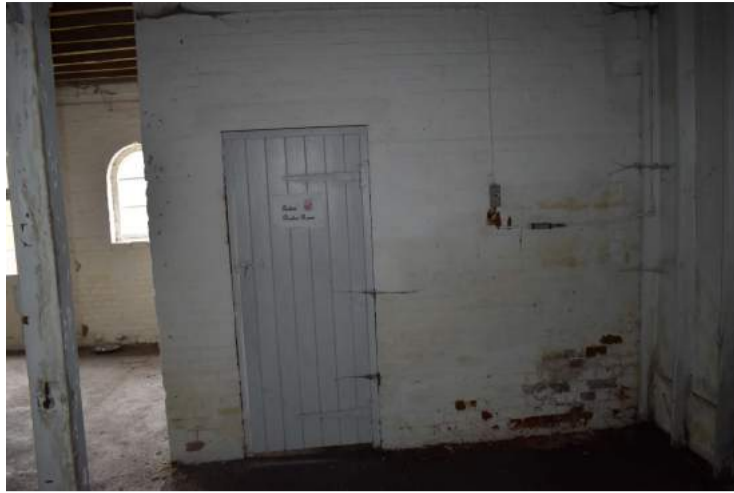
ECC4613_Photograph_074
Brick-built modern W.C. insertion into Room 1 - view south.

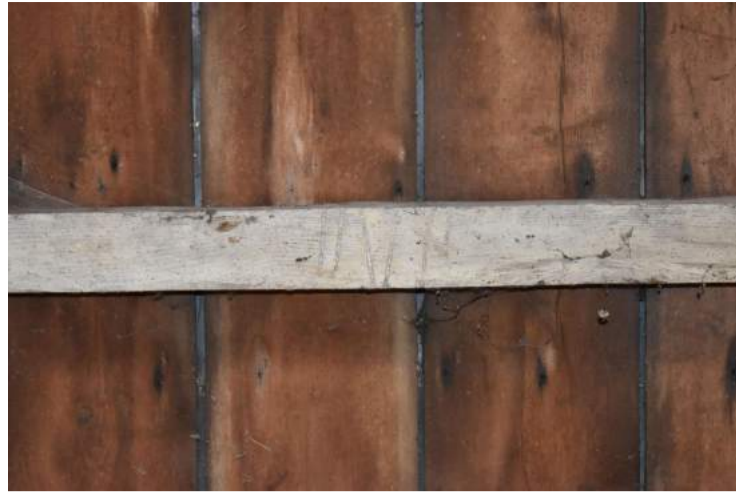
ECC4613_Photograph_086
Detail of Baltic timber marks in northern roof pitch above Room 2 - view north-west.

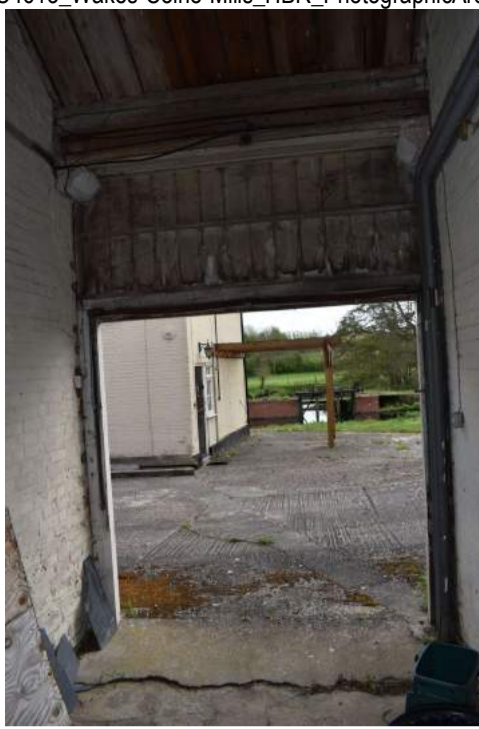
ECC4613_Photograph_146

Room 4 - view south.

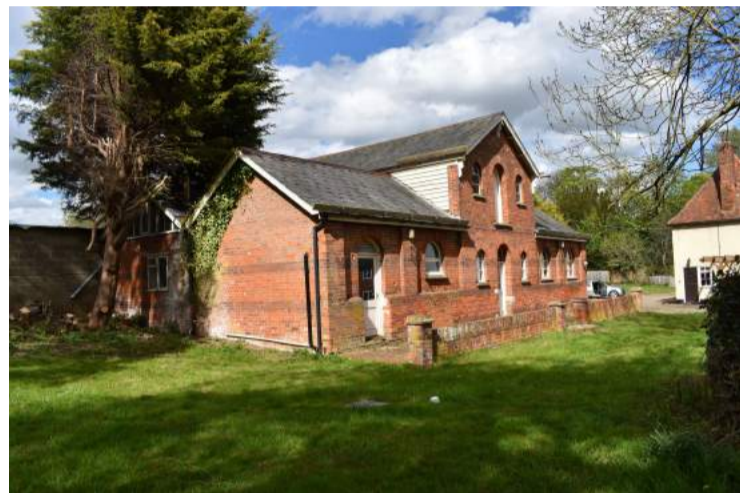
ECC4613_Photograph_148

Southern and western elevations of coach house - view north-east.

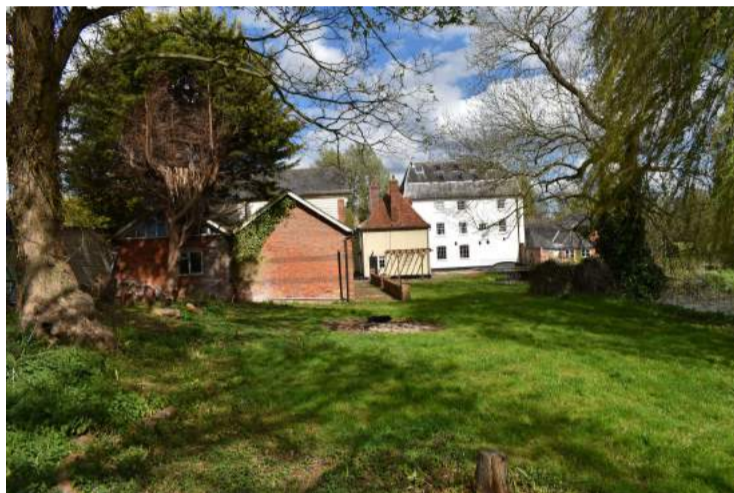
ECC4613_Photograph_149

Western elevation of coach house with converted mill in background - view ...
